GEOTECHNICAL STUDY PINEVIEW @ RADFORD HILLS HUNTSVILLE, UTAH

TITAN DEVELOPMENT
6085 SOUTH 900 EAST, SUITE 202
MURRAY, UT 84121

ETE JOB NO.: 06-0020

MARCH 23, 2006

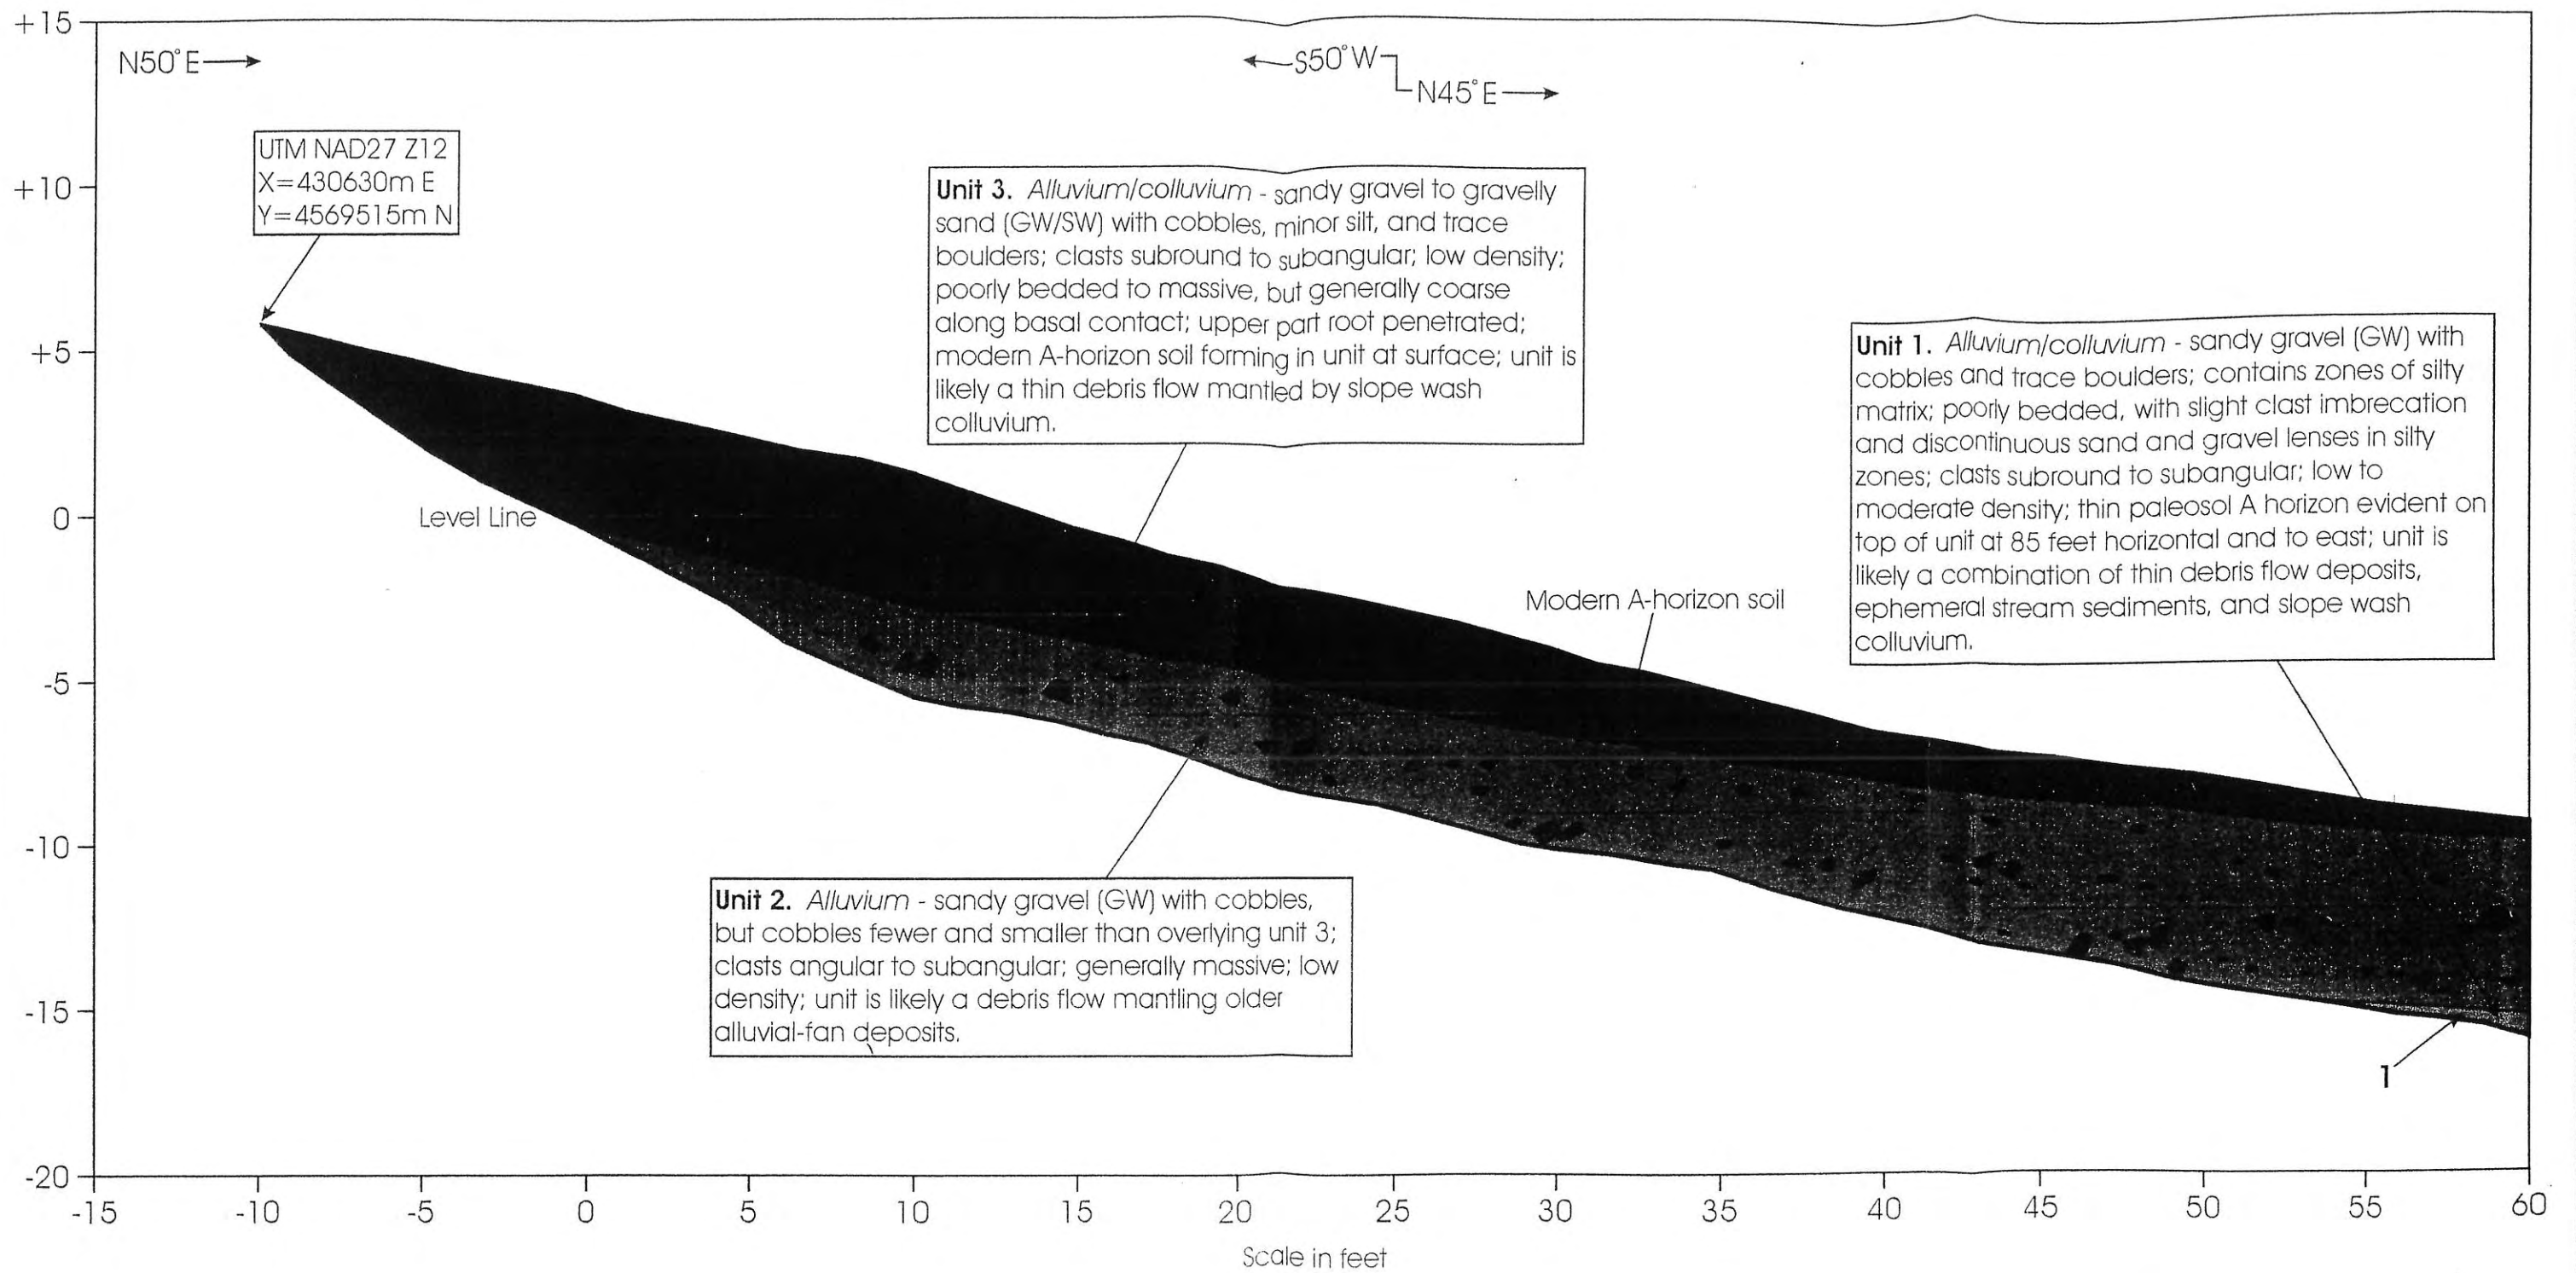
FIGURE 4A

Unit 3. *Alluvium/colluvium* - sandy gravel to gravelly sand (GW/SW) with cobbles, minor silt, and trace boulders; clasts subround to subangular; low density; poorly bedded to massive, but generally coarse along basal contact; upper part root penetrated; modern A-horizon soil forming in unit at surface; unit is likely a thin debris flow mantled by slope wash colluvium.

Unit 1. *Alluvium/colluvium* - sandy gravel (GW) with cobbles and trace boulders; contains zones of silty matrix; poorly bedded, with slight clast imbrication and discontinuous sand and gravel lenses in silty zones; clasts subround to subangular; low to moderate density; thin paleosol A horizon evident on top of unit at 85 feet horizontal and to east; unit is likely a combination of thin debris flow deposits, ephemeral stream sediments, and slope wash colluvium.

To evaluate subsurface conditions at the site, a field exploration was developed to excavate one trench across the West Ogden Valley fault trace and 11 test pits in other areas of the property (Figures 2 and 3). The trench extended southwestward from the upper road at the site for a total distance of 191 feet. Figures 4a-c are a detailed log of the north trench wall at a scale of 1 inch equals 5 feet (1:60). Figures 5a-c shows logs of the test pits.

from the slopes to the west (unit 1, Figures 4a-c). A thin paleosol A horizon was evident on top of unit 1 east of 85 feet horizontal (Figures 4b-c). Unit 1 is overlain by a matrix-rich debris flow deposit comprised of gravelly sand with cobbles and silt (unit 2, Figures 4a-b), which buried the paleosol A horizon in the eastern half of the trench. Unit 2 is in turn overlain by additional alluvium and colluvium that displays a coarse basal lense (unit 3, Figures 4a-c), likely representing a thin clast-supported debris flow combined with subsequent slope wash colluvium. The modern A-horizon soil is forming in all these units at the surface. No evidence of water was observed in the trench, and the exposed sediments appeared dry and generally firm.

Test pit 1 was excavated at the toe of the small landslide in the northwestern part of the site (Figures 2 and 3), and exposed landslide colluvium consisting of blocks of clay-rich weathered Norwood Tuff (Figure 4a). At this location, down-to-the-east normal faulting would place the Norwood Tuff near the ground surface on the upthrown side of the West Ogden Valley fault, and deep beneath the surface on the downthrown side to the east. The landslide thus may represent an old failure of a stranded Norwood Tuff bedrock exposure on the upthrown (western) side of the fault. No exposures of the Norwood Tuff are mapped along the western site margin on the upthrown side of the fault, but are found on the downthrown side further to the east. No other landslide deposits were observed in the remaining test pits at the site. Test pits 2, 3, 4, 6, 8, and 11 (Figures 4a-c) exposed alluvium of the fan depositional sequence discussed in the Site Reconnaissance section above. Competent tuffaceous siltstone and sandstone was encountered in test pits 5 and 7; test pits 9 and 10 exposed weathered clay-rich tuffaceous bedrock overlain by alluvium and colluvium (Figures 4b-c). The test pit exposures thus appear to be consistent with the geologic mapping on Figure 2. No water was observed in the test pits, although surficial sediments in some of the test pits appeared moist, particularly where underlain by weathered clay-rich bedrock.

The air photo and geologic map (Figure 2) show a small landslide in and upslope of lot 6 at the site (Figure 3). Test pit 1 (Figure 4a) exposed colluvium at the toe of the slide derived from failure of an exposure of clay-rich Norwood Tuff, which is no longer evident or mapped upslope to the west. Topography of the landslide also appears subdued on the air photos of the site. The landslide thus may be a failed block of Norwood Tuff that was stranded by faulting in the geologic past, and is likely an old failure that occurred during wetter periods such as during the Pleistocene.

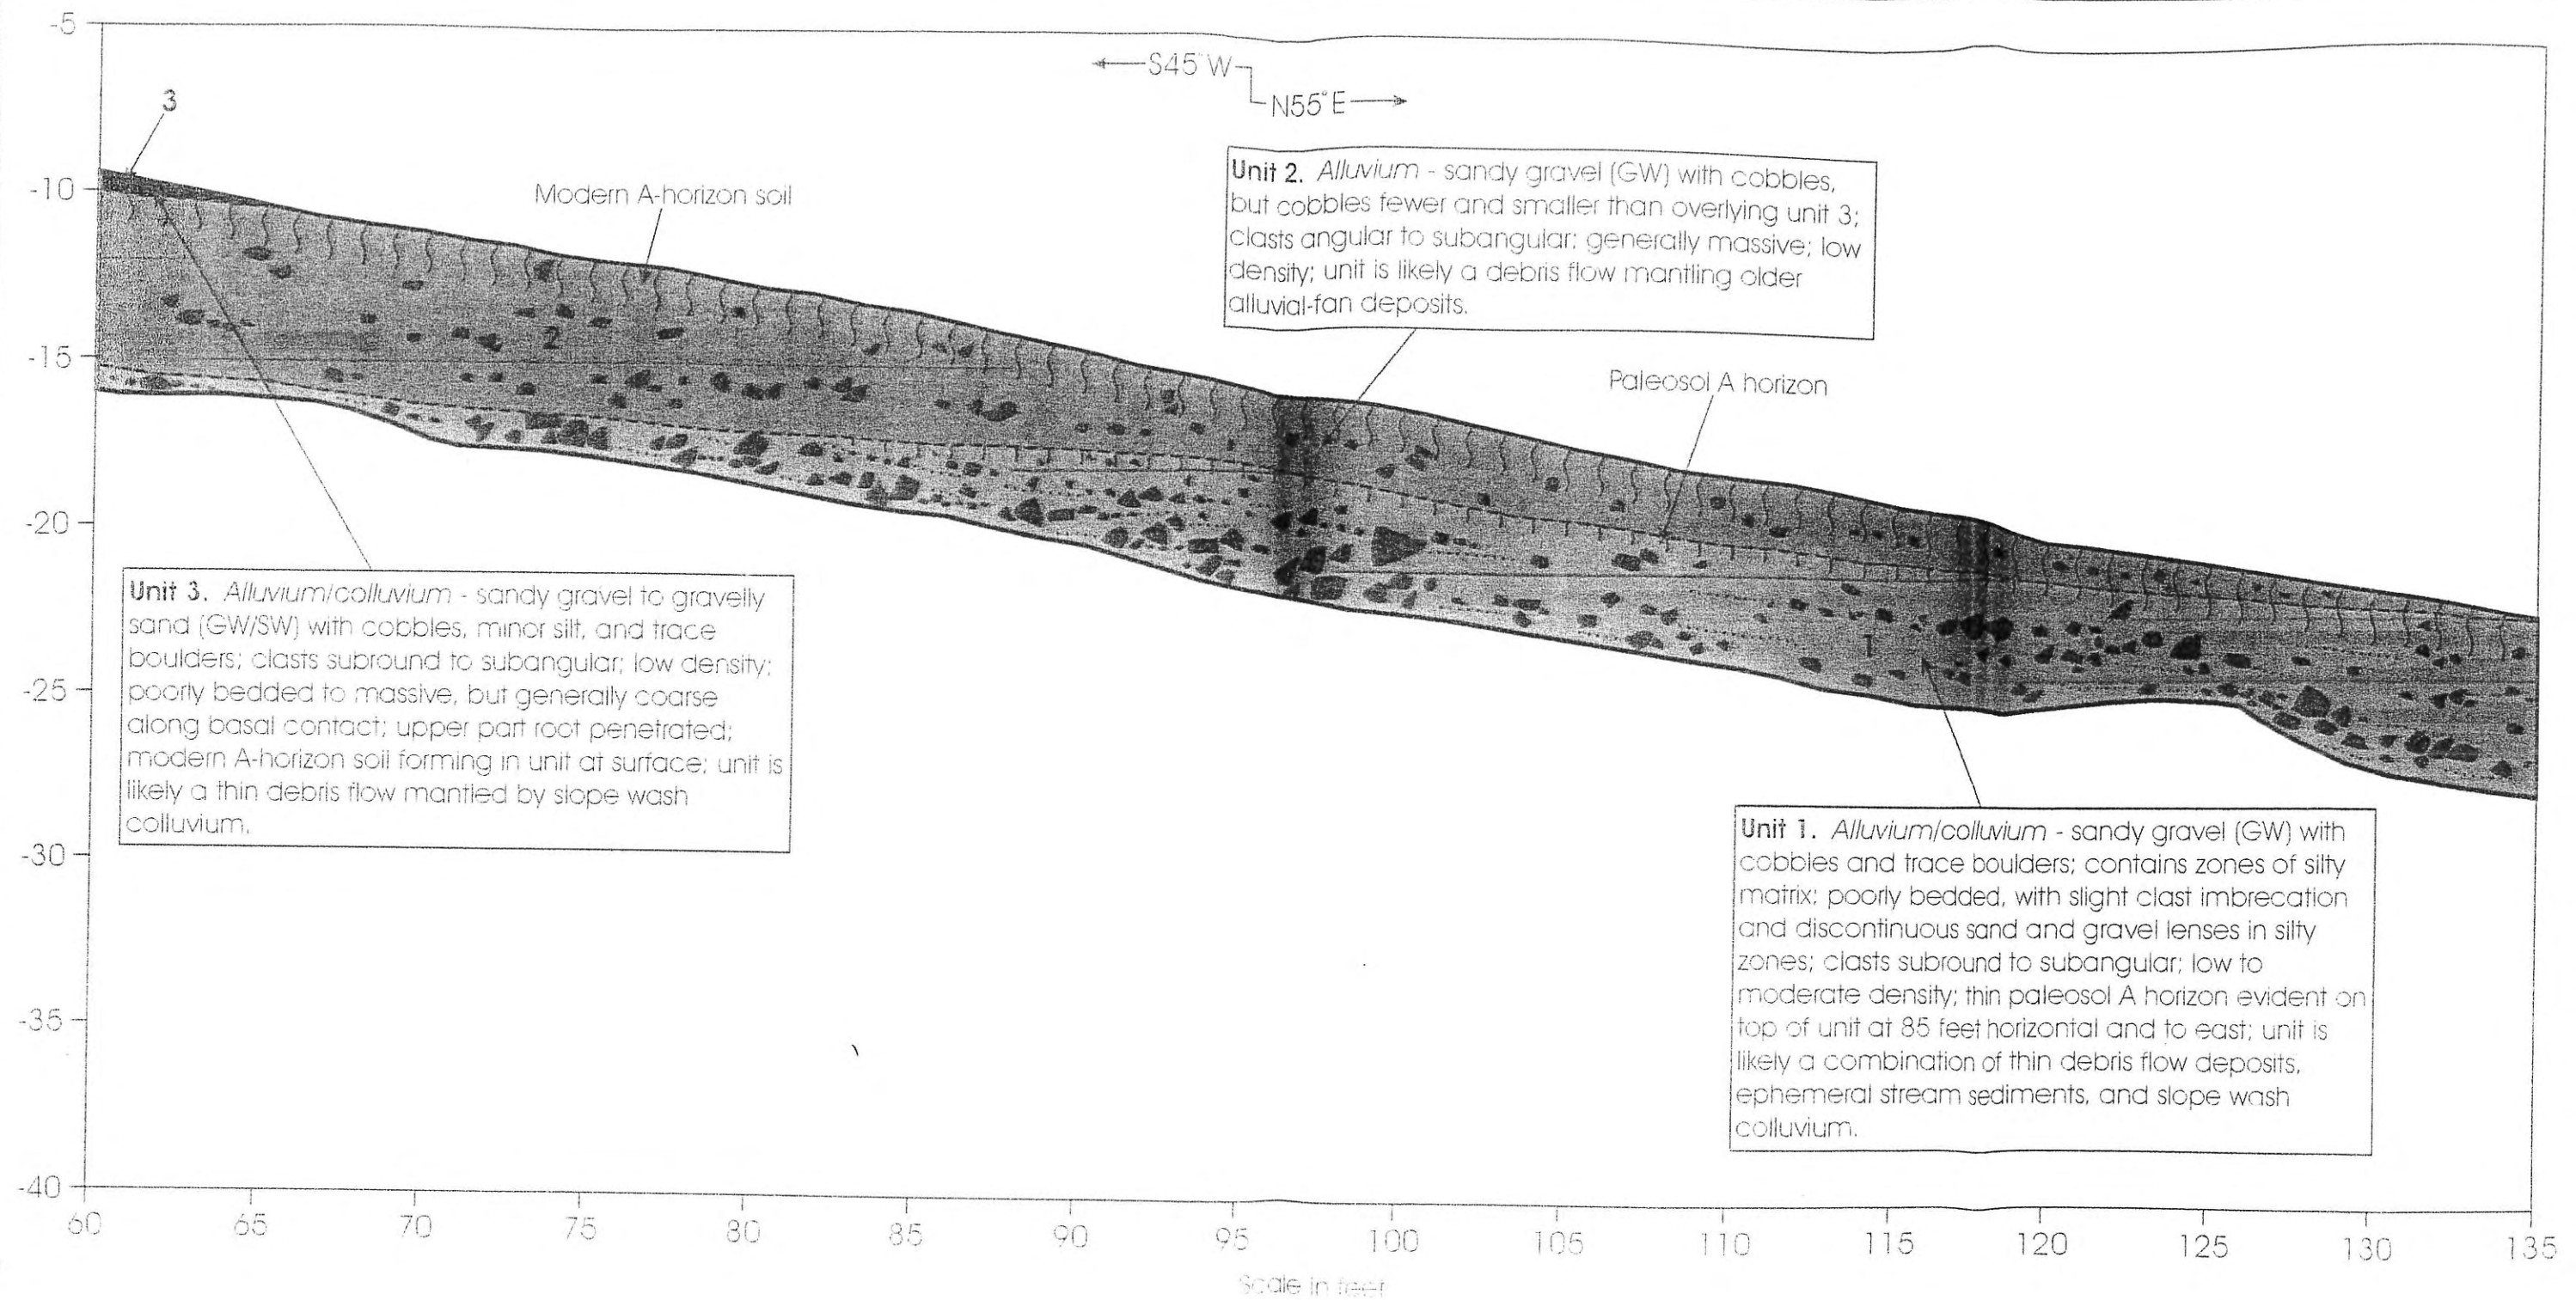
FIGURE 4B

SCALE: Trench = 5 feet
 (no vertical exaggeration)
 North Trench Wall logged

Trench logged by Bill Black, R.G. on
 January 23, 2006
 reviewed by Craig Nelson, R.G., R/S, C.E.G.
