**GEOTECHNICAL INVESTIGATION  
AND GEOLOGIC HAZARD STUDY**

**PROPOSED WATER TANK**

**4200 NORTH 5300 EAST**

**WEBER COUNTY, UTAH**

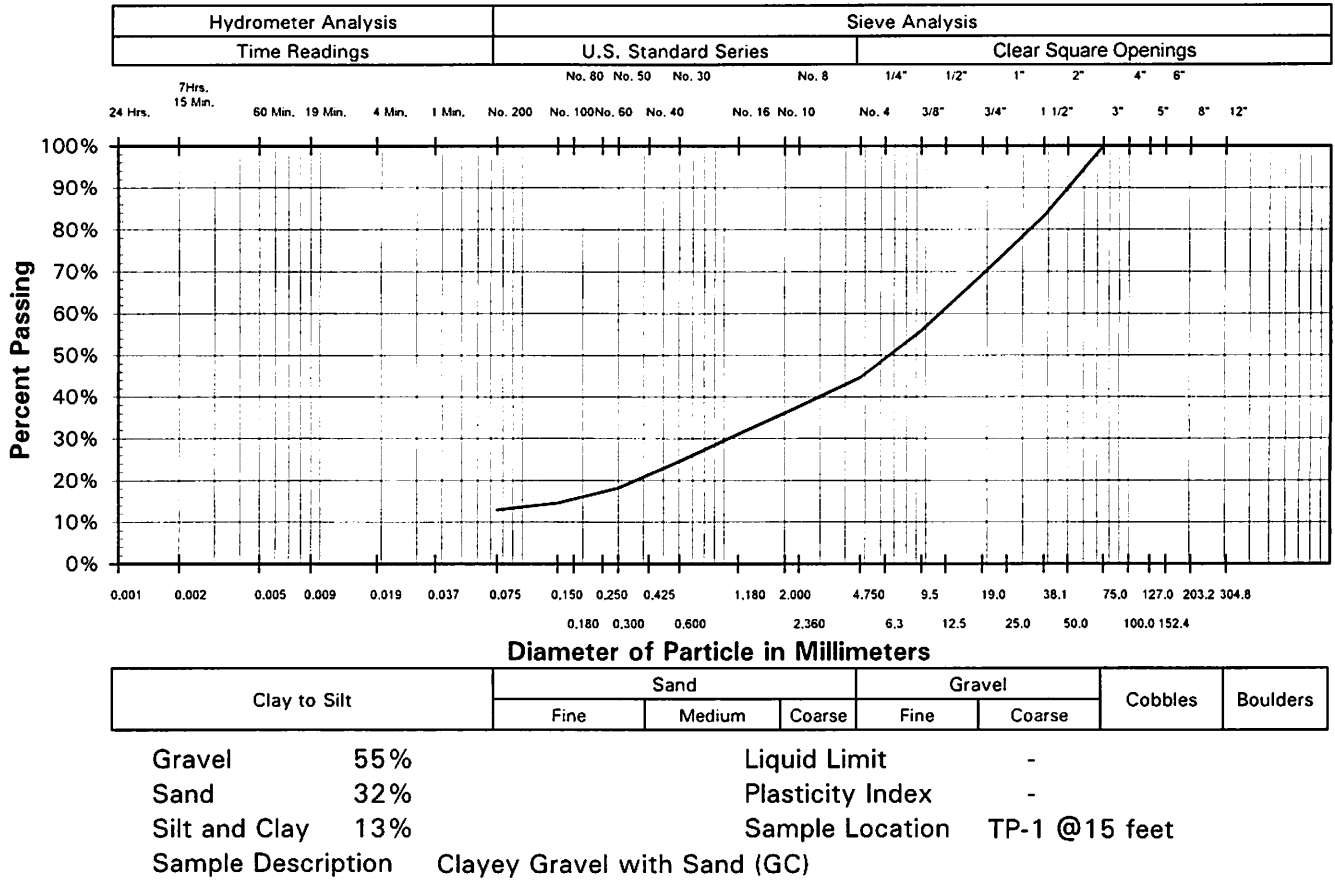
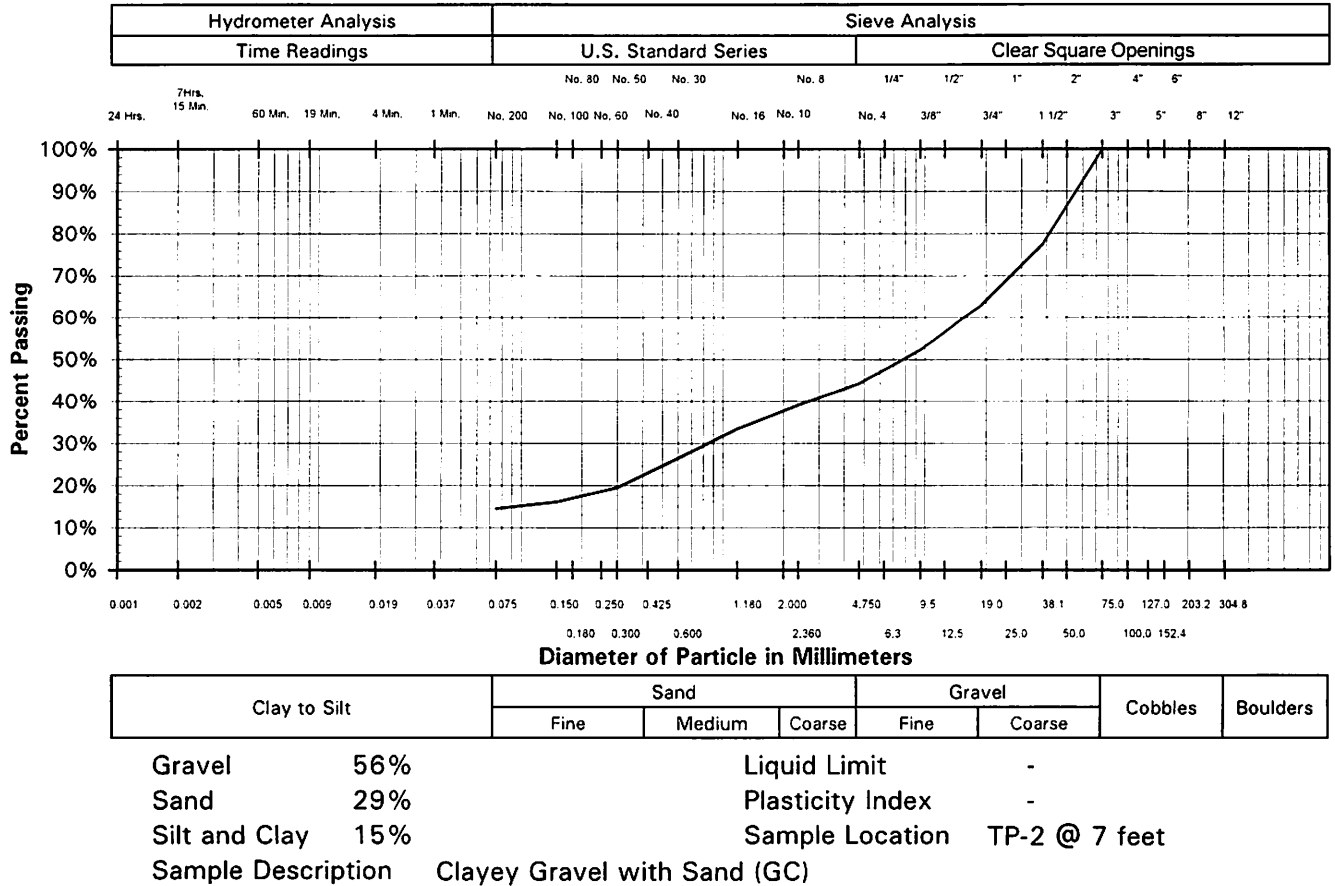
Laboratory tests conducted on samples of the gravel indicate it has natural moisture contents ranging from 6 to 10 percent. Results of gradation tests performed on the gravel are presented on Figure 3.
