Subject: Geotechnical Consultation
Proposed Summerset Farms, Phase 2
2375 South 3875 West
Taylor, Utah
Project No. 1190435

Applied Geotechnical Engineering Consultants, Inc. (AGEC) was requested to provide geotechnical consultation for Phase 2 of the Summerset Farms residential development located at 2375 South 3875 West in Taylor, Utah.

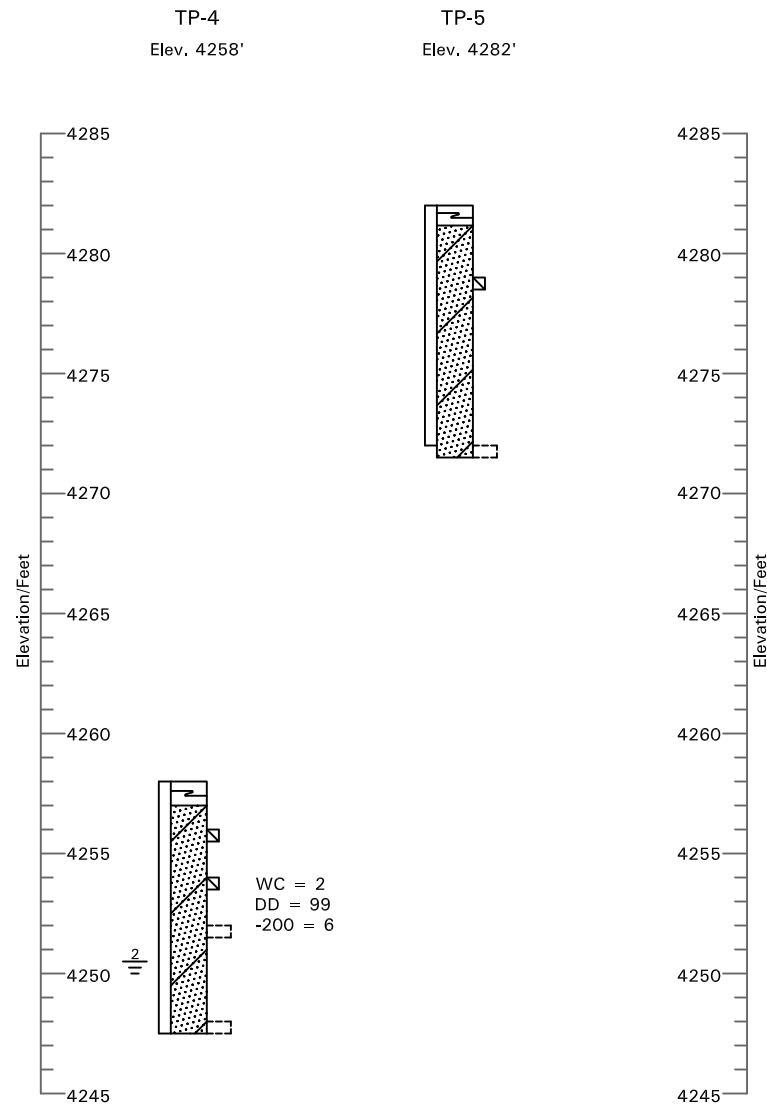
- Topsoil; silty sand, slightly moist, brown, roots and organics.
- Poorly-graded Sand with Silt (SP-SM); small to moderate amounts of silt, medium dense, slightly moist to wet, light brown to dark brown.
- Indicates relatively undisturbed hand drive sample taken.
- Indicates disturbed sample taken.
- Indicates the depth to free water and the number of days after drilling the measurement was taken.
- Indicates slotted 1 1/2-inch PVC pipe installed in the test pit to depth indicated.

The field study was conducted on November 4, 2020. Two test pits (TP-4 and TP-5) were excavated in the area of Phase 2 at the approximate locations shown on Figure 1. The test pits were excavated using a rubber-tired backhoe. The test pits were logged and soil samples obtained by an engineer from AGECE. A log of the subsurface conditions encountered in Test Pits TP-4 and TP-5 are graphically shown on Figure 2.

Results of the laboratory tests are summarized on Table I and are included on the logs of exploratory test pits, Figure 2.
