# Staff Report for Administrative Approval Hillside Review – Notice of Conditional Approval

**Application Request:** Consideration and action on a request to approve a Hillside Review for the Mariani residence located on Lot 5 in the Big Sky No. 1 Subdivision.

**File Number:** HSR 2016-09

# REPORT

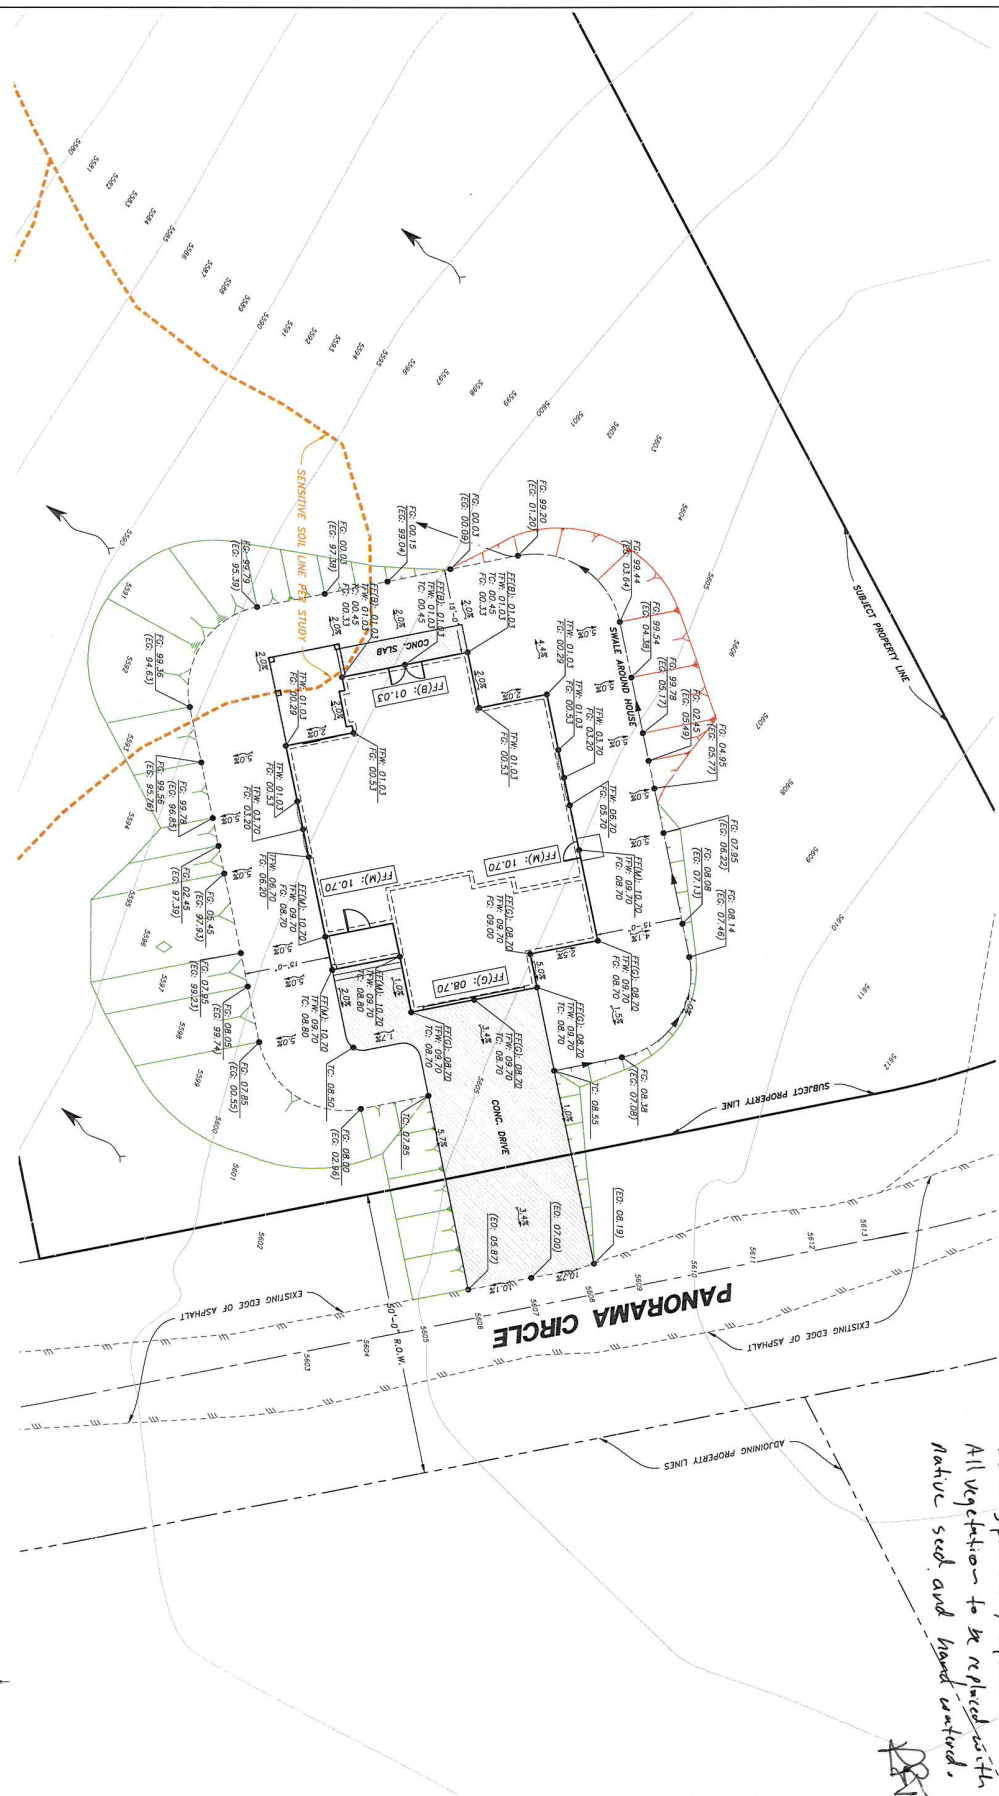
**MARIANI RESIDENCE**  
GRADING & DRAINAGE PLAN

20' will be disturbed around the perimeter of the home. There will be no sprinkling system installed. All vegetation to be replaced with native seed and hand watered.

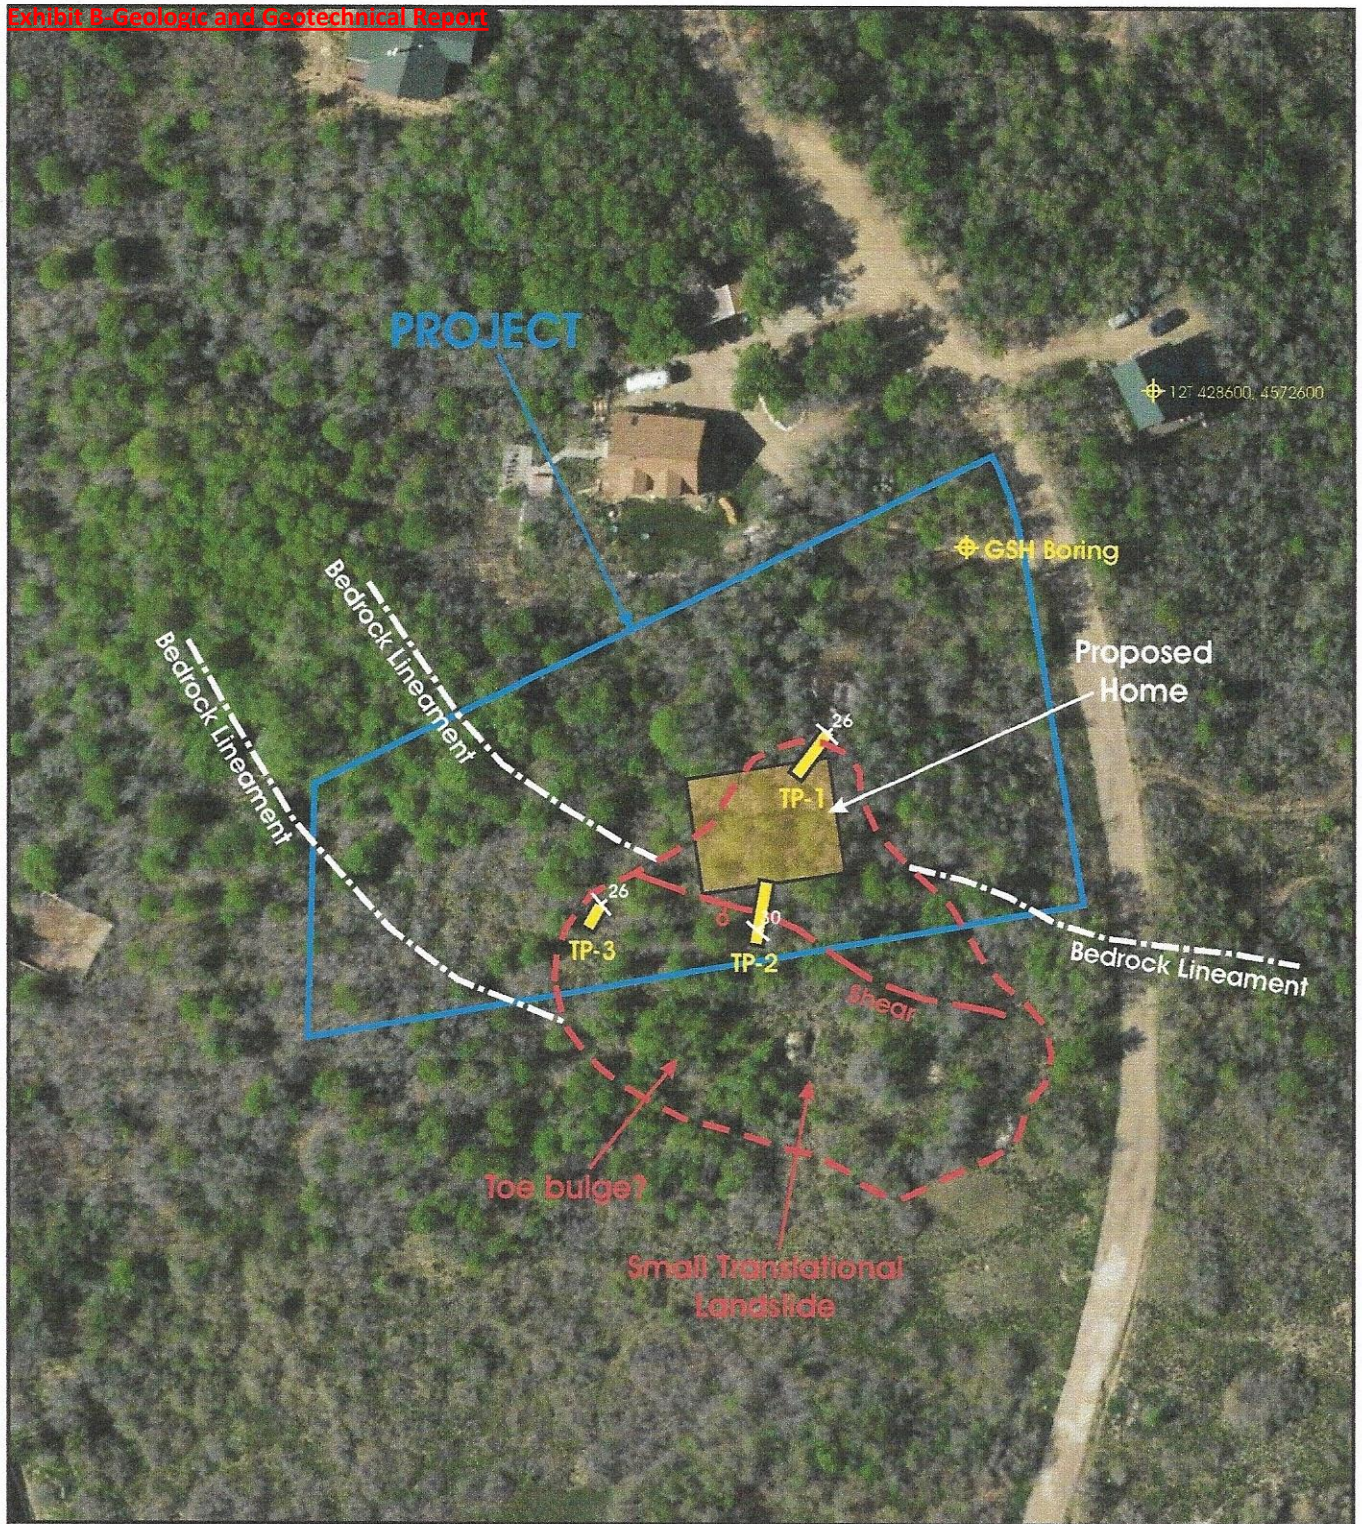
FIGURE 3A

Source: Utah AGRC, 2012 High-Resolution Orthophoto, 6-inch resolution.

High-resolution orthophotography from 2012 and 1-meter bare earth DEM LIDAR from 2011 available from the Utah AGRC (Figures 3A and 3B) were reviewed to obtain information about the geomorphology of the site area. Several bedrock lineaments (presumably contacts between subunits in the Norwood Formation) are evident of Figures 3A and 3B that are obscured across the Project by what appears to be a small landslide. The landslide head is slightly north of the proposed home; the failure then widens and descends downslope to the southwest to about 85-90 feet southwest of the home. A slight bulge is evident on both the 2012 aerial photo and 2011 LIDAR image in the toe area (Figures 3A and 3B). We note that this bulge is not evident on the surveyed topography on Figure 3C, which may be just an anomaly of the surveying methodology. Morphology of the landslide appears subdued or obscured, suggesting it may be an older feature (possibly latest Pleistocene to early Holocene in age). No evidence of other geologic hazards were observed on the air photos in the site area.

Three test pits were excavated at the property in April 2016 to evaluate subsurface conditions. Test pit locations are shown on Figures 3A-3C, and were measured using a

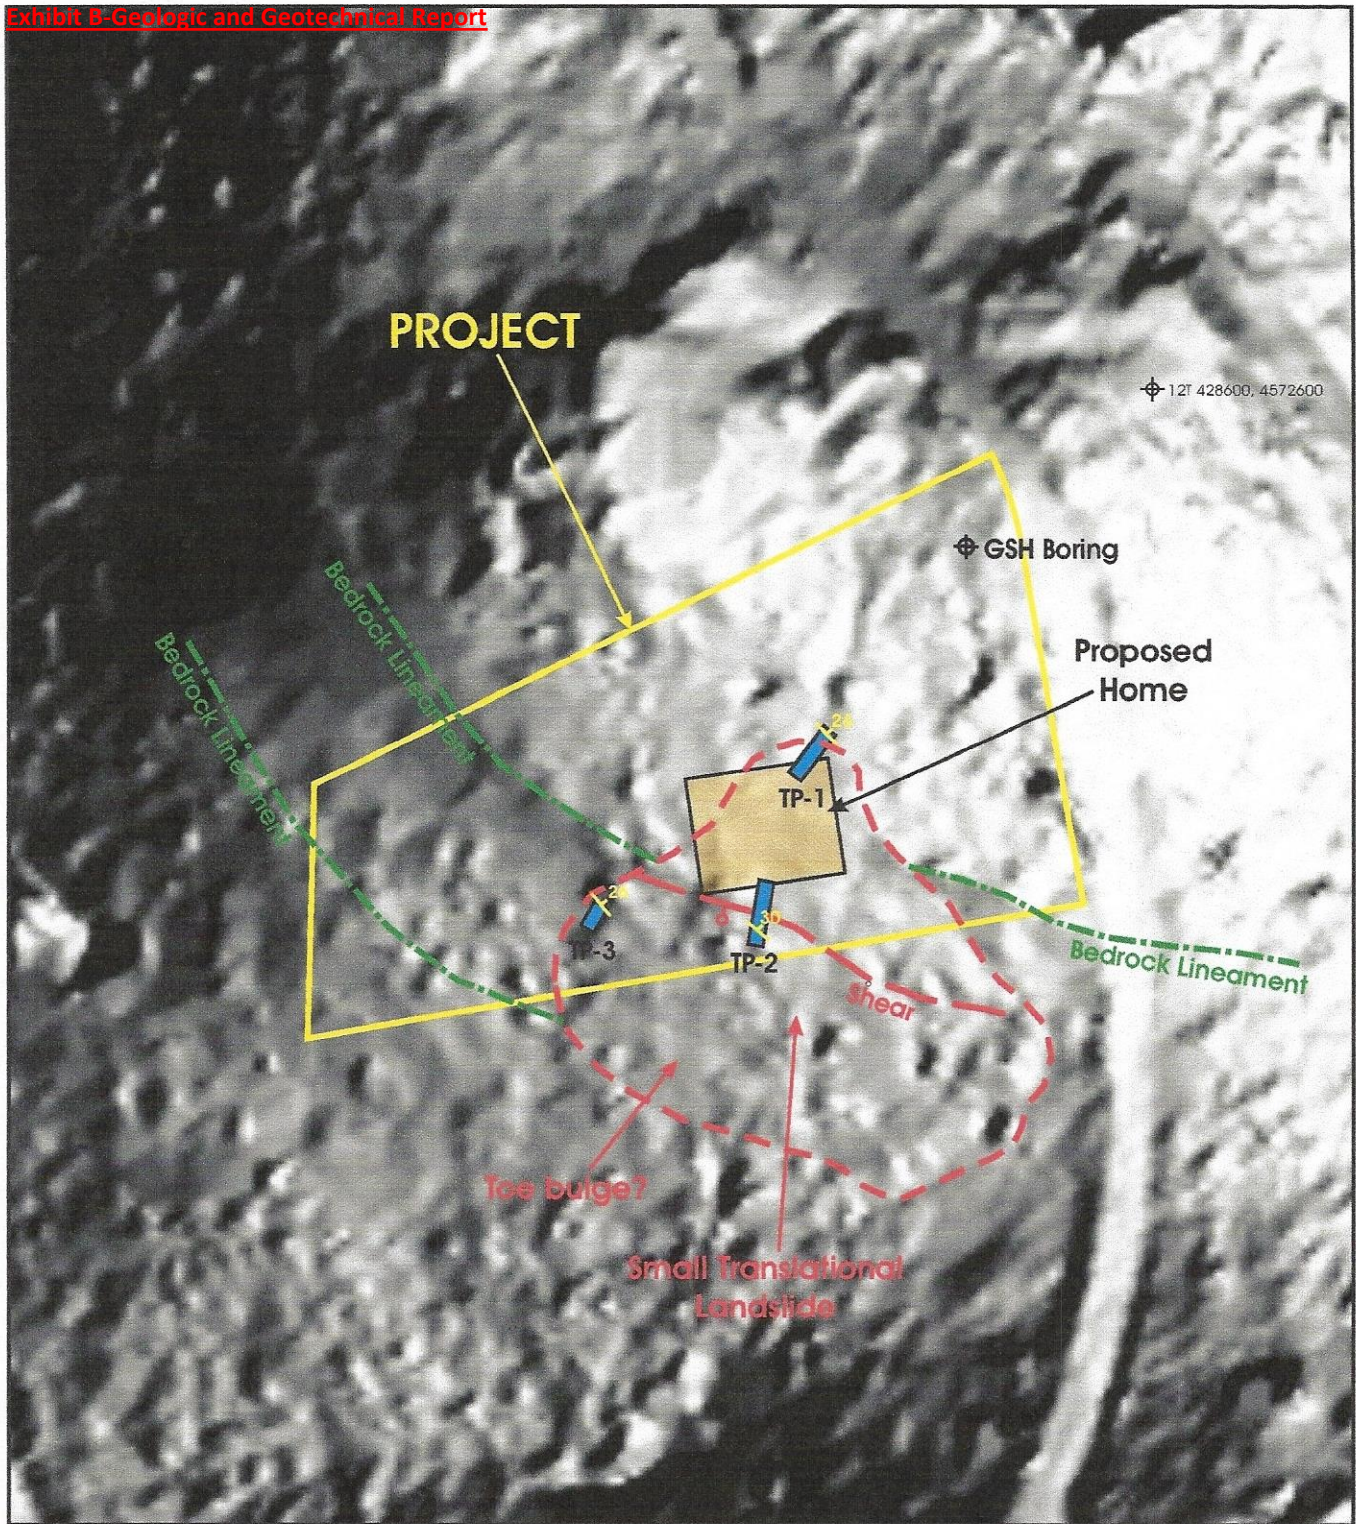
**FIGURE 3B**

Source: Utah AGRC, 2011 LIDAR Bare Earth DEM.

Test pit 2 (Figure 4B) exposed fractured and sheared sandstone bedrock (units 1 and 2) overlain by landslide colluvium (unit 3). Bedding in unit 1 near 9 feet horizontal (Figure 3B) showed a strike/dip of N50°W 30° NE, which suggests only a few degrees of backtilting and horizontal rotation. Many of the shears appeared to die out slightly above the trench floor, although several showed down-to-the-southwest displacements of up to several feet and continued below the test pit bottom. Trend of the shears ranged between N63° W to N76° W, generally similar to topographic contour trends.

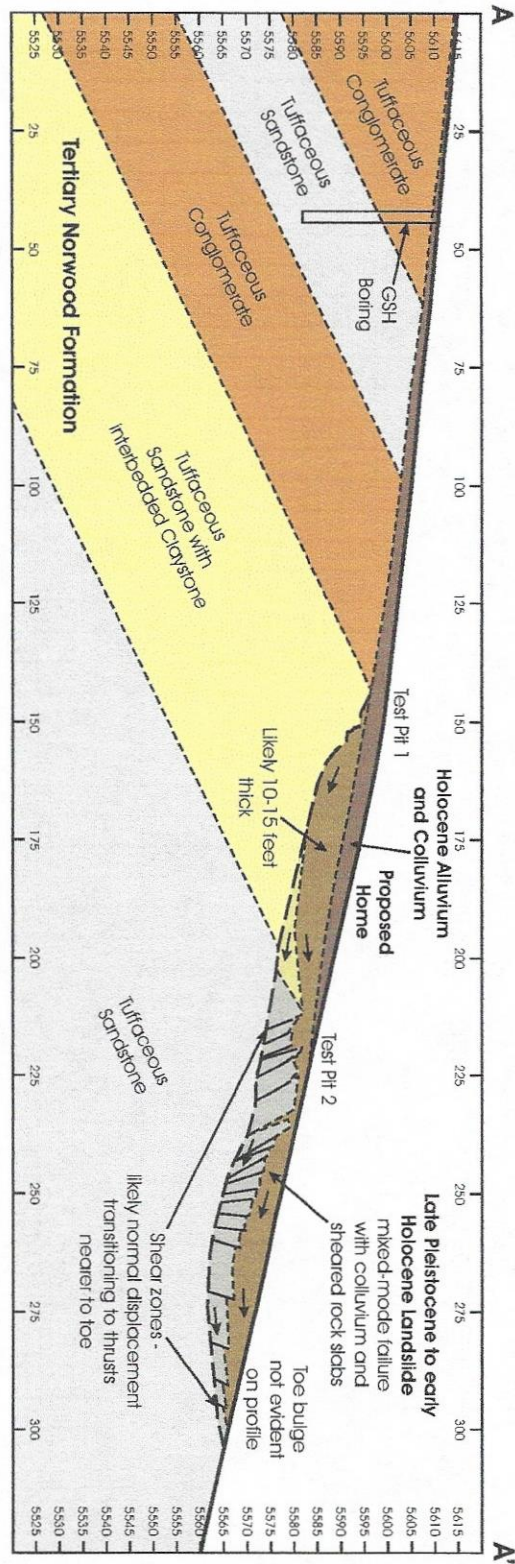
**CROSS SECTION**

SCALE: 1 inch = 25 feet  
 No vertical exaggeration  
 Contacts based on subsurface  
 data and are inferred in  
 unexplored areas and/or depth

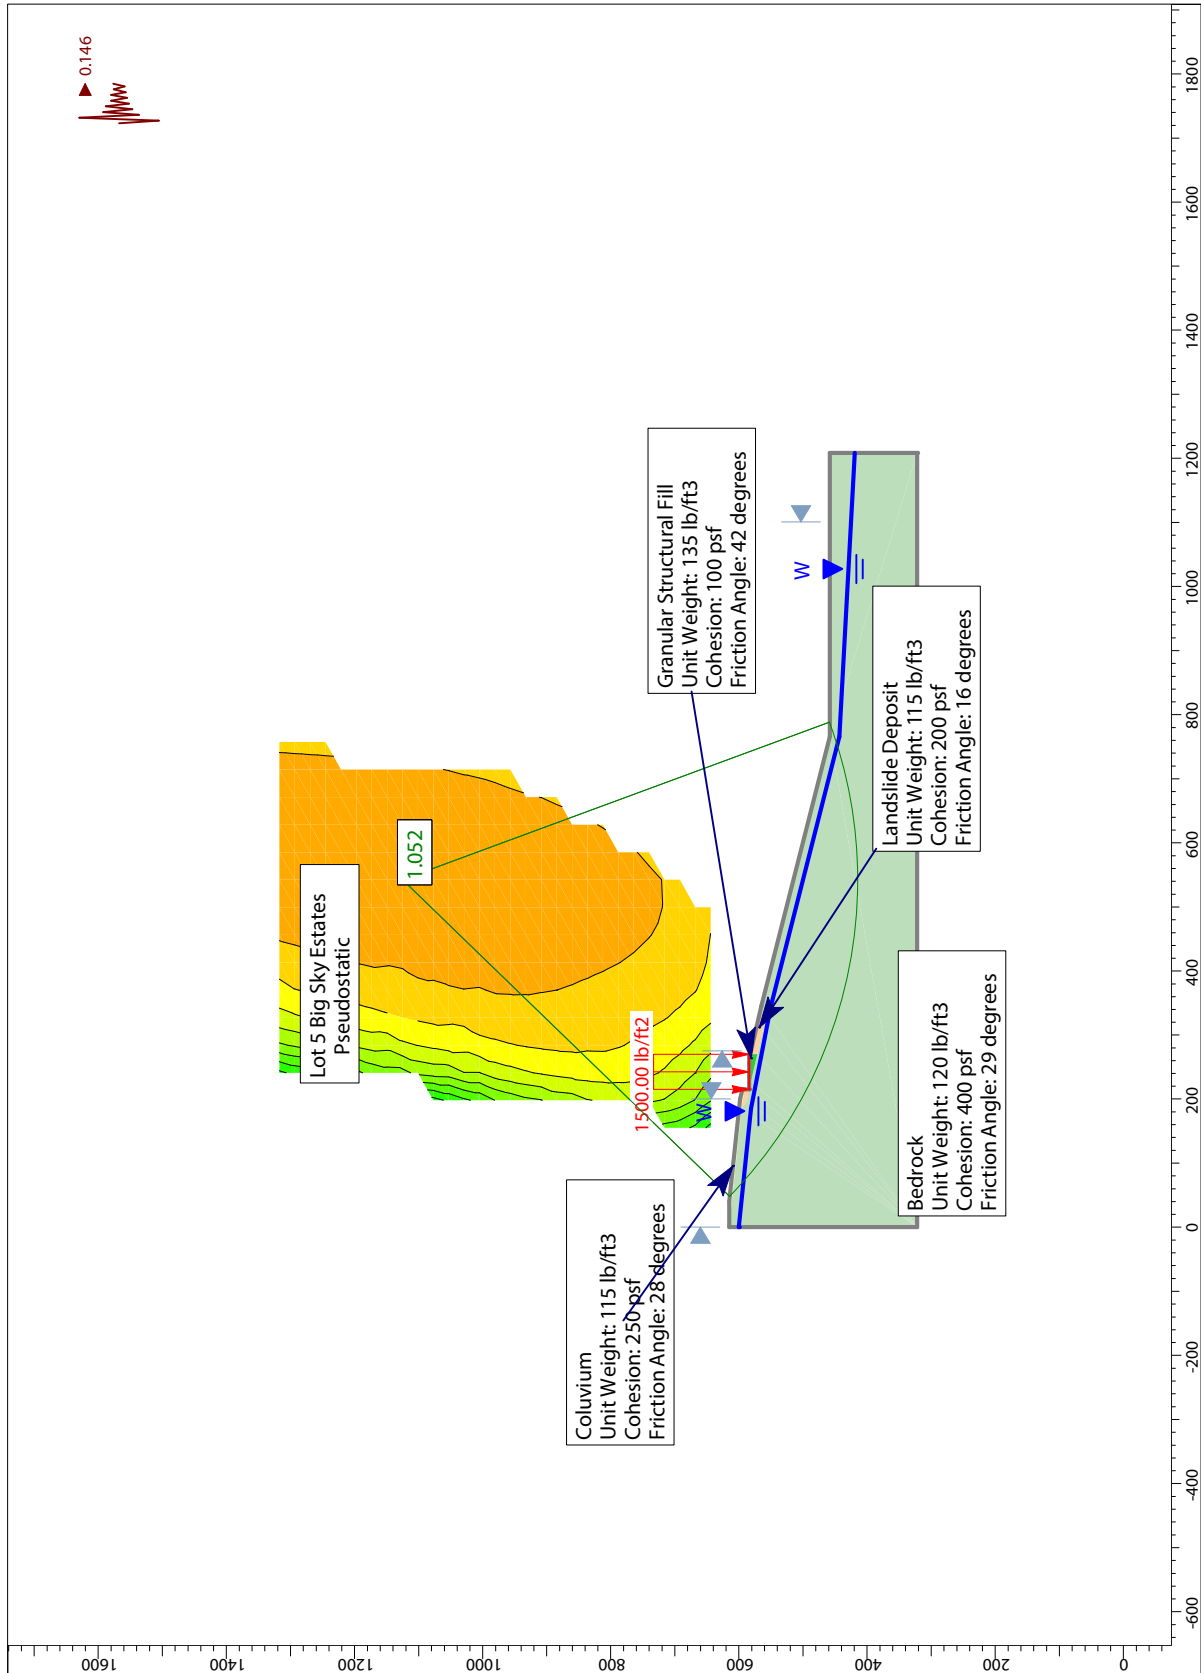
# STABILITY RESULTS

## LOT 5 BIG SKY ESTATES
