GEOTECHNICAL AND GEOLOGIC HAZARD INVESTIGATION
Lot 79R of Summit Eden Phase 1C
8469 E. Spring Park Road
Summit Powder Mountain Resort
Weber County, Utah

IGES Project No. 02904-001

October 30, 2018

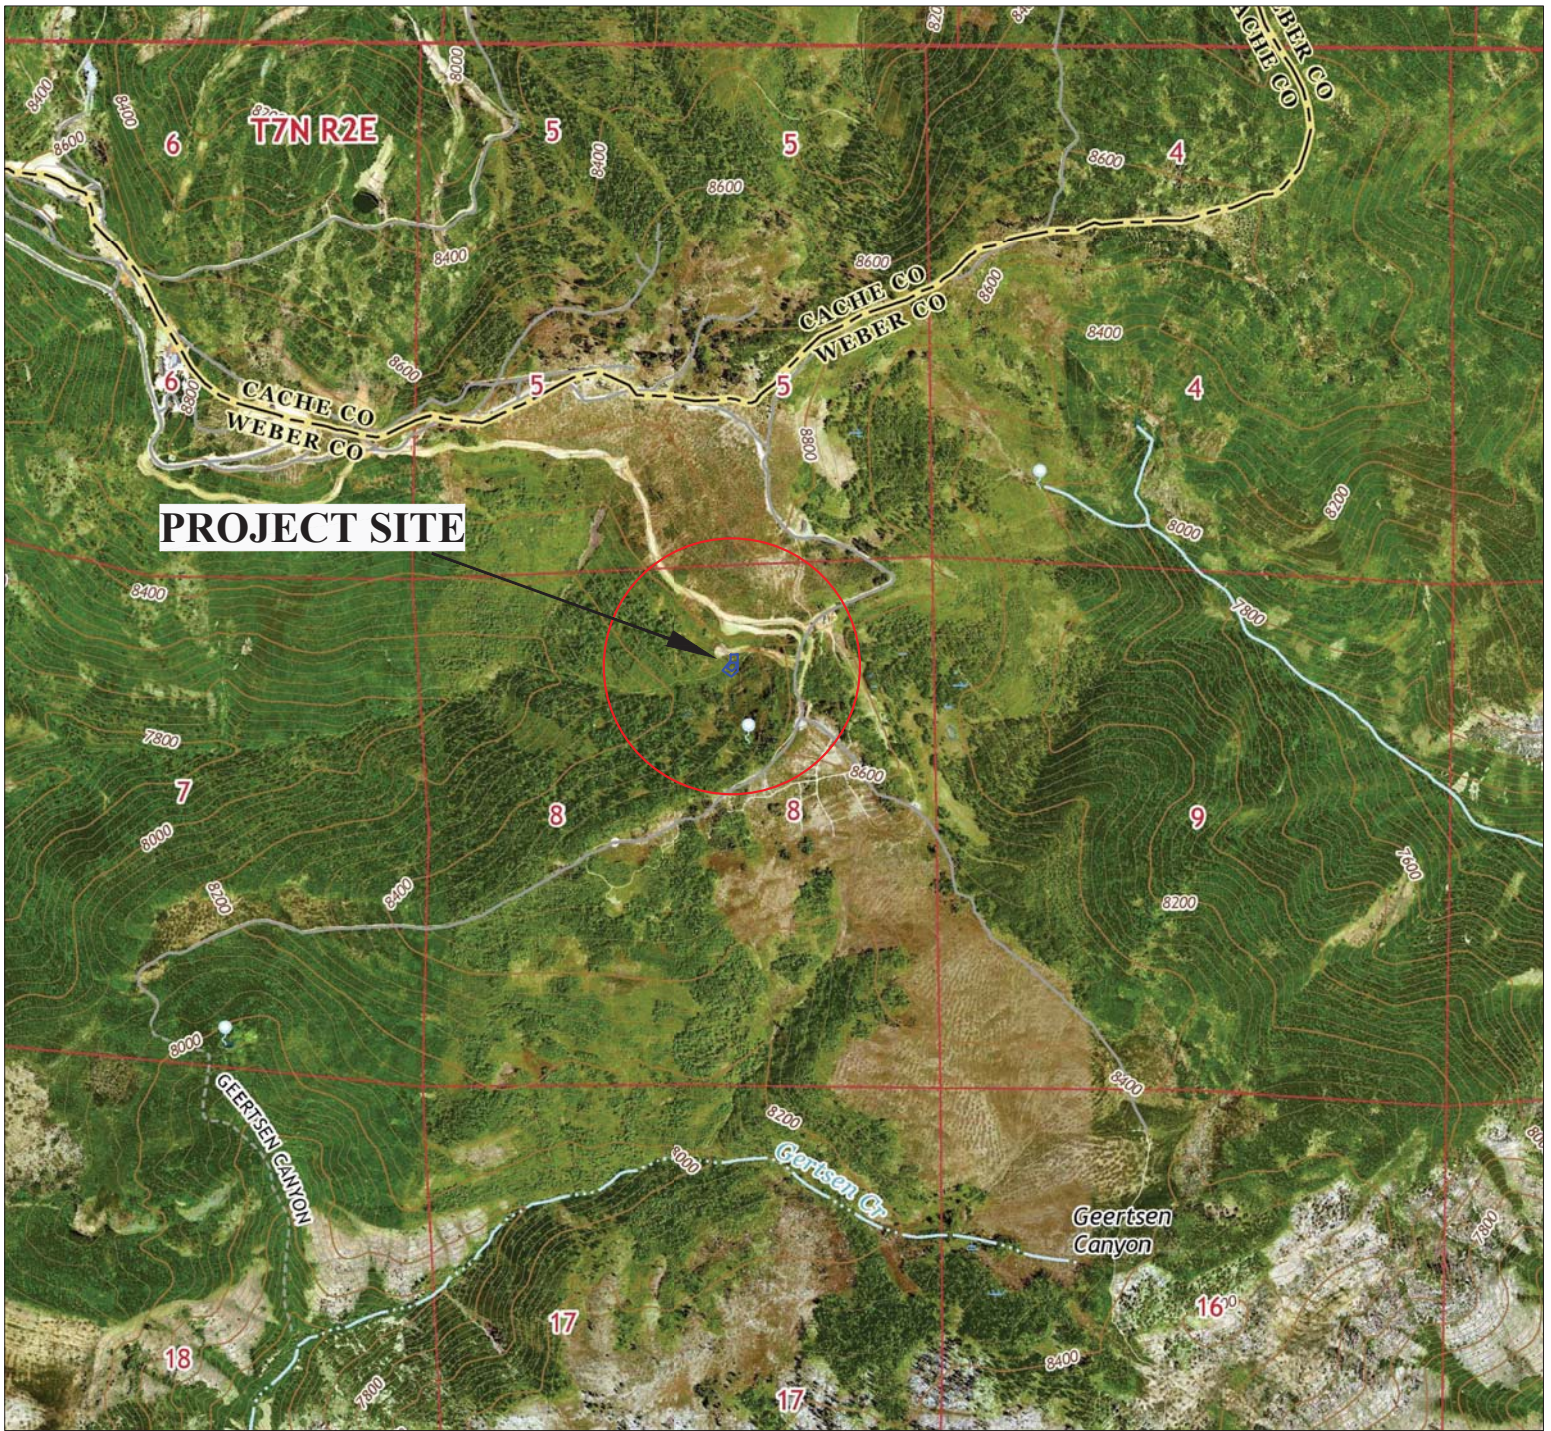
A-1

Base Maps:

-USGS Huntsville, Brown's Hole, James Peak and Sharp Mountain 7.5-Minute Quadrangles (2017)

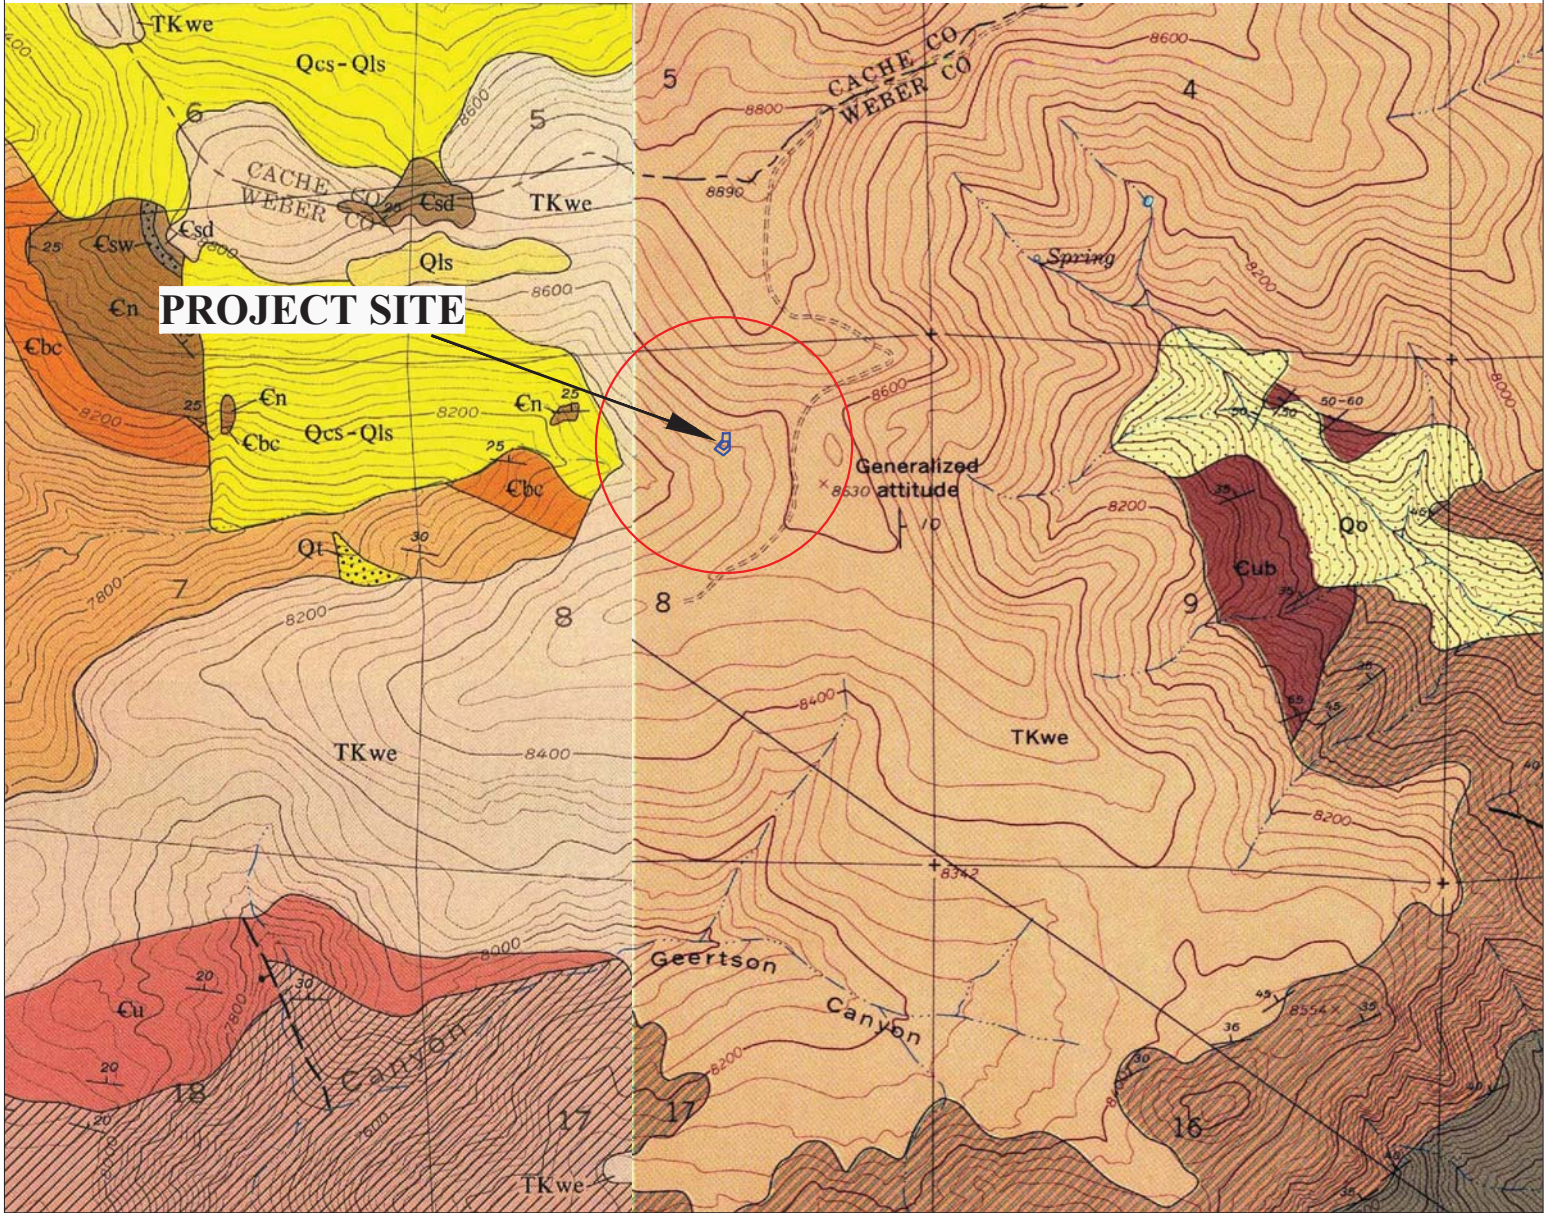
A-2c

Base Maps:

-USGS *Huntsville* 7.5-Minute Geologic Quadrangle Map (GQ-1503), Sorensen and Crittenden Jr. (1979)

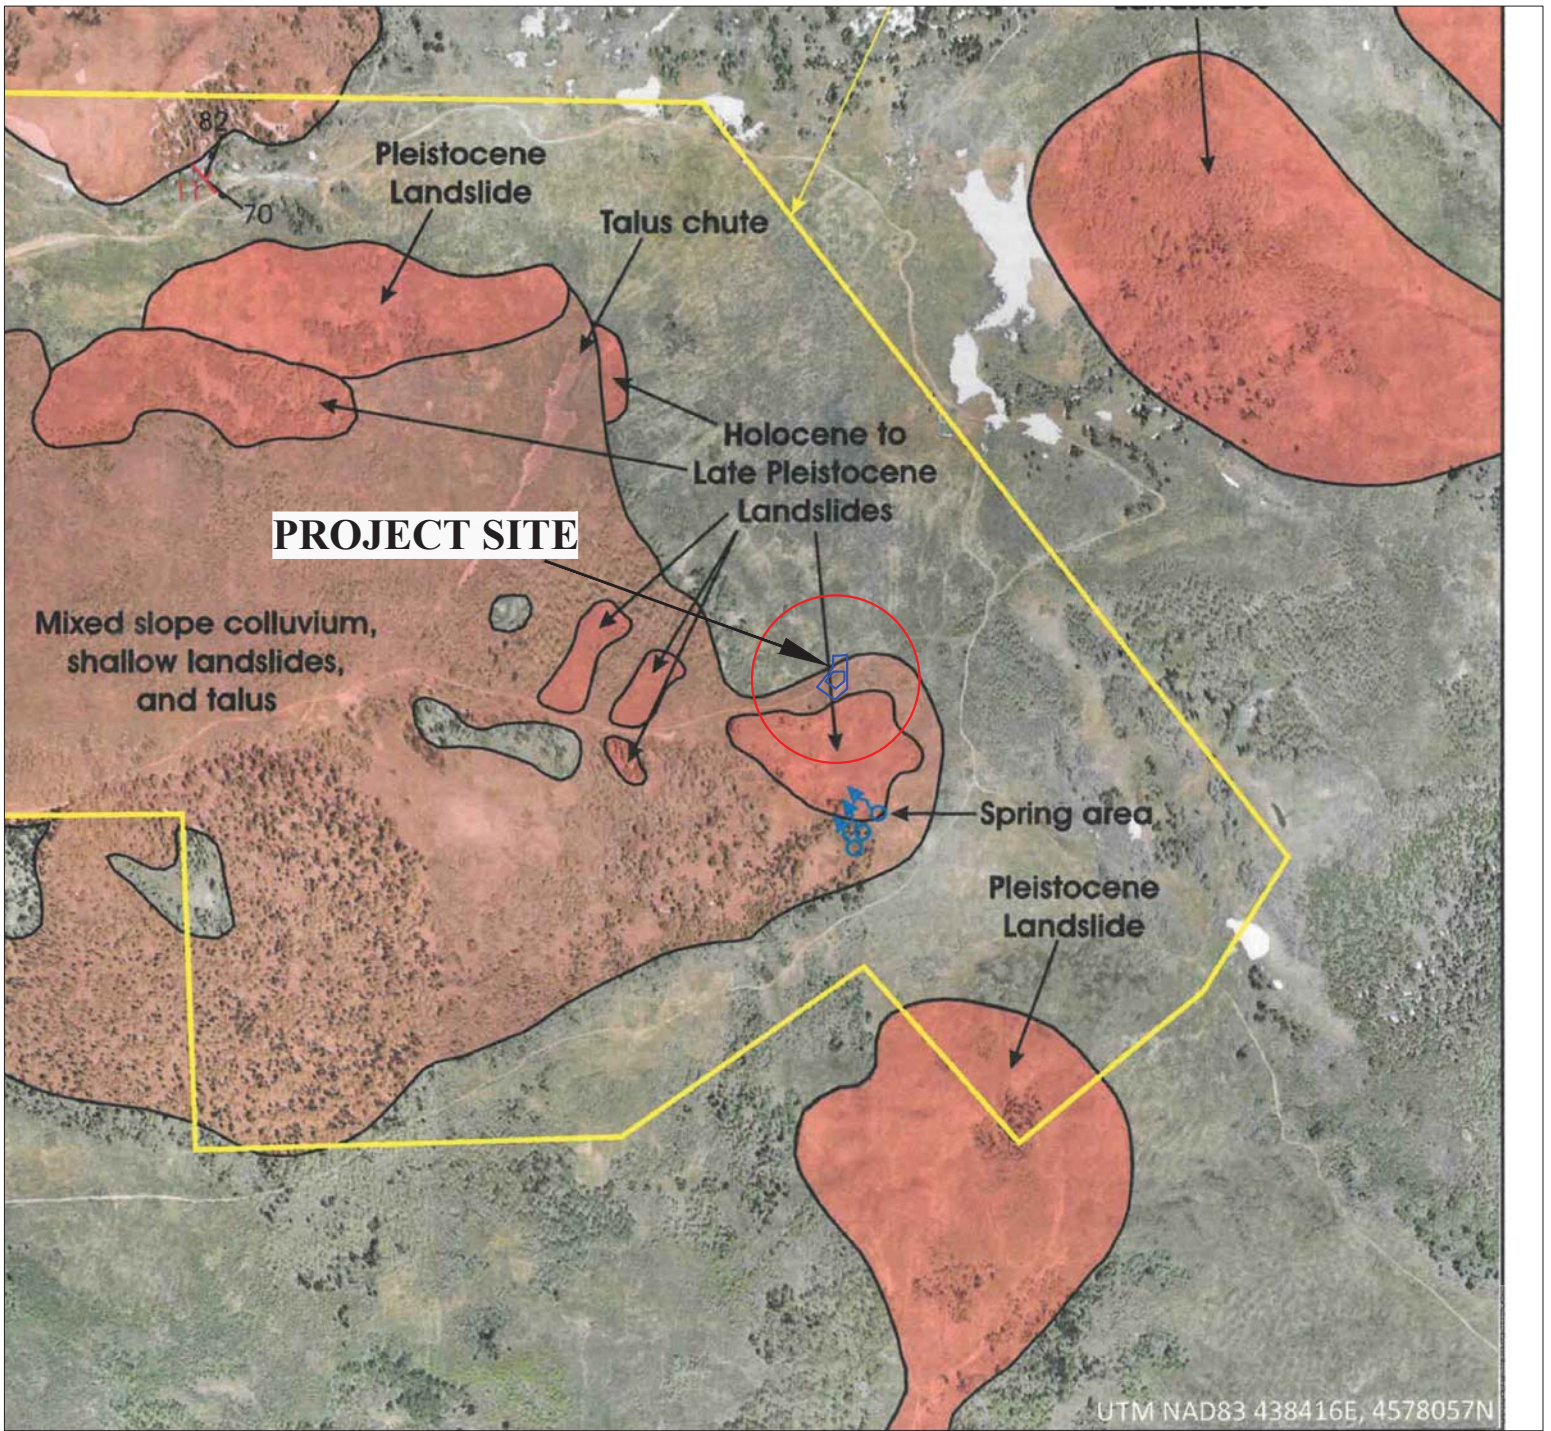
A-3

Base Maps:

-Western Geologic (2012) Geologic Hazards Reconnaissance Report, Figure 3

Two regional-scale landslide hazard maps have been produced that cover the project area. Colton (1991) does not show the property to be underlain by landslide deposits, though south and west-trending landslide deposits are noted nearby to the west and south. Elliott and Harty (2010) show the property to be located within mapped landslide deposits described as “Landslide undifferentiated from talus and/or colluvial deposits”. As noted above, both Western Geologic (2012; Figure A-3) and Coogan and King (2016; Figure A-4) show the property to be located within mapped landslide deposits.

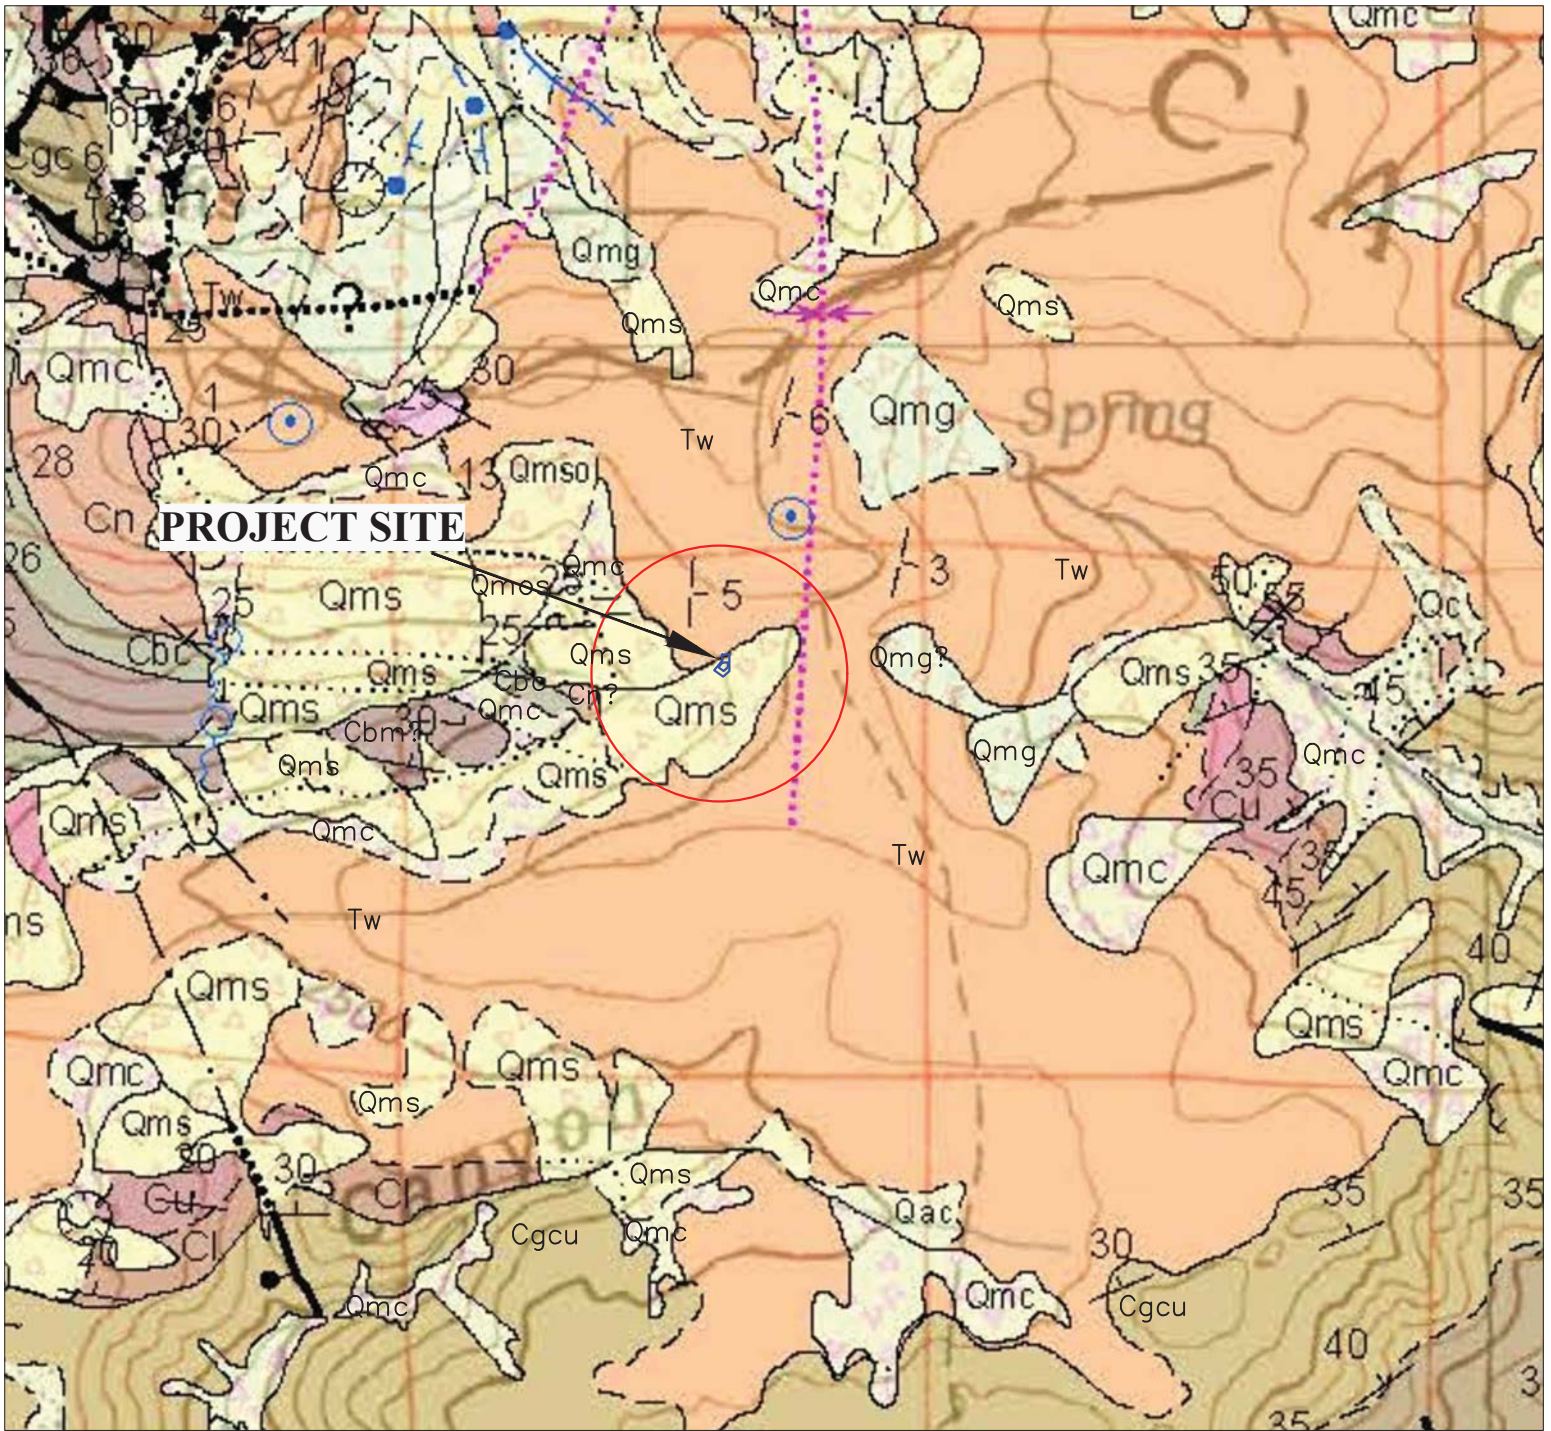
Base Maps:

-UGS Ogden 30' x 60' Geologic Quadrangle Map (OFR-635DM), Coogan and King (2016)

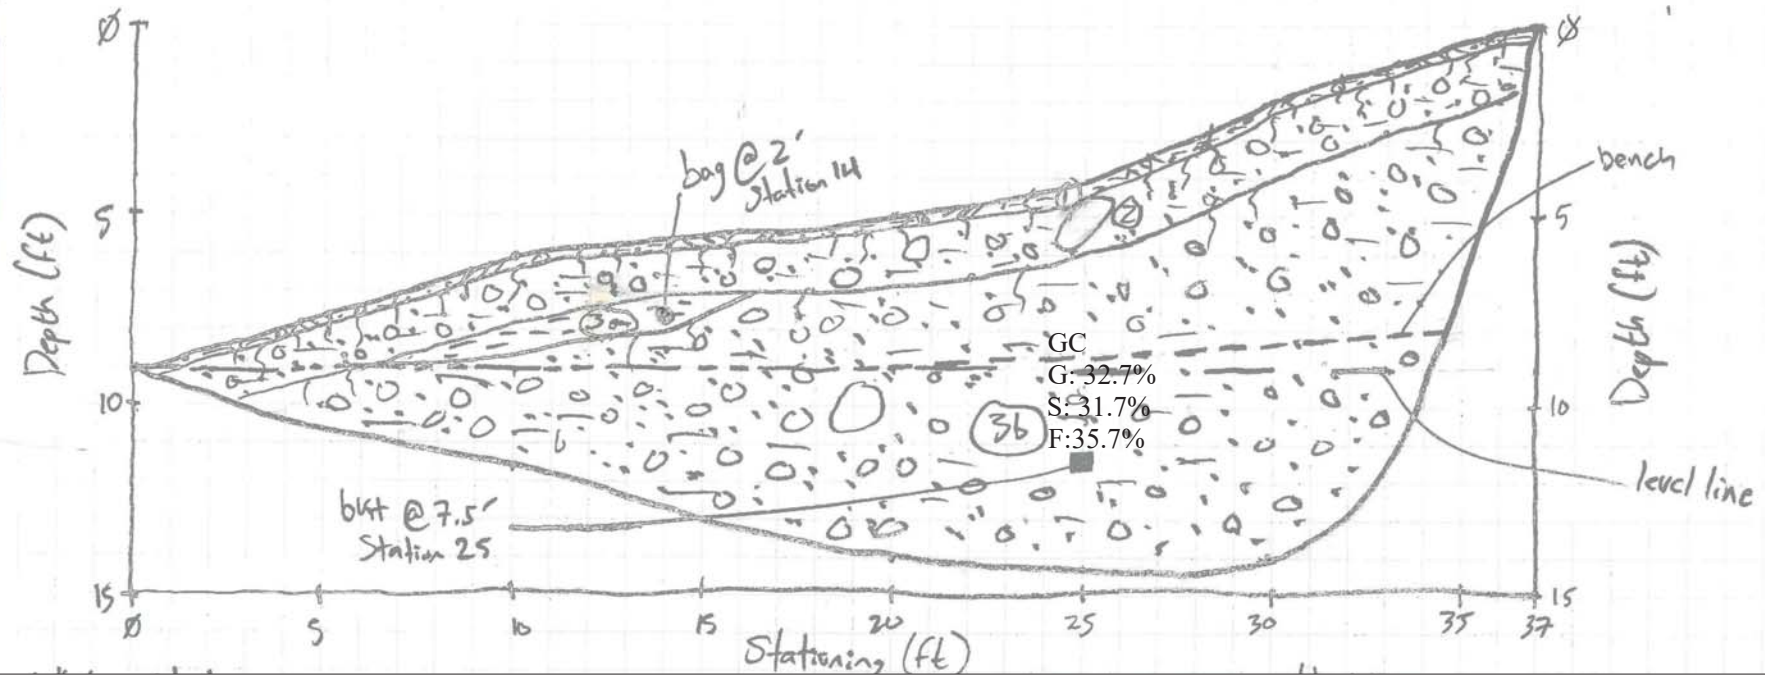
Total Depth: ~12'
 * No GW encountered

1" = 5'
 H&V

LITHOLOGIC UNIT DESCRIPTIONS

- 1. **A/B Soil Horizon:** ~4-6" thick; pale yellowish brown (10YR 5/2) sandy lean CLAY with gravel (CL); loose, dry, low plasticity, massive; gravel and larger sized clasts comprise ~15-20% of the unit; clasts are subrounded to subangular moderate orange pink (5Y 8/4), light gray (N7), and grayish purple (5P 4/2) quartzite up to 2-3' in diameter, though mode clast size is ~1"; abundant plant and tree roots; gradational, irregular basal contact.

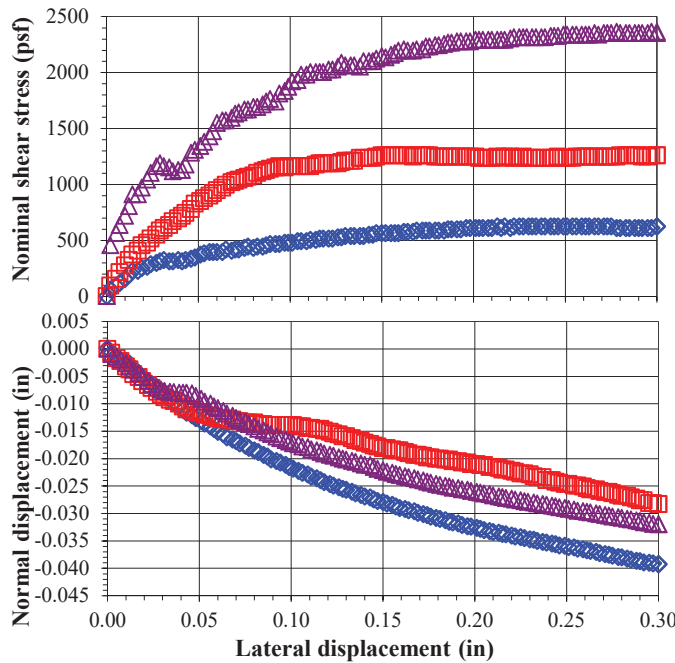
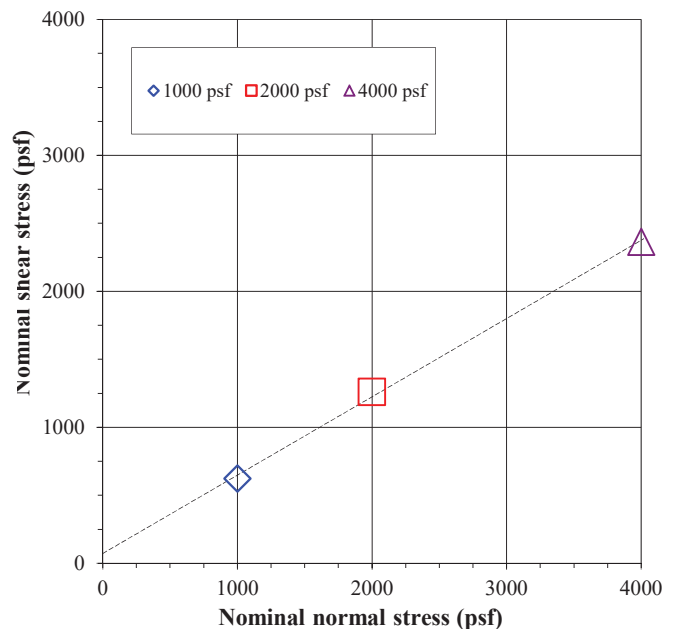
Direct Shear Test for Soils Under Drained Conditions

Dry unit weight (pcf)		98.2	106.3

*Pre-shear saturation set to 100% for phase calculations

Comments:

Test specimens remolded to estimated 90% of maximum dry unit weight at estimated optimum water content.

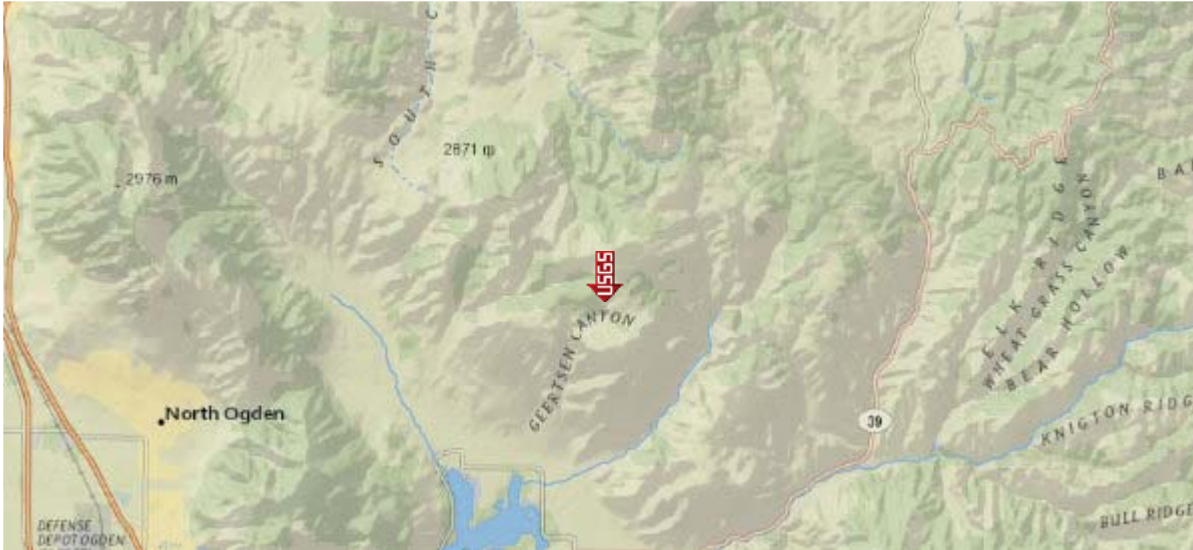
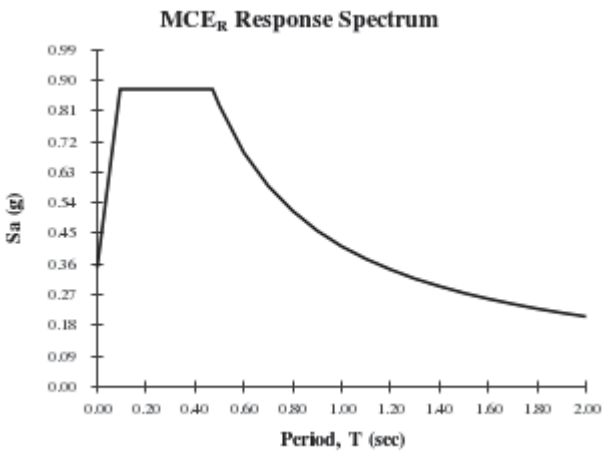
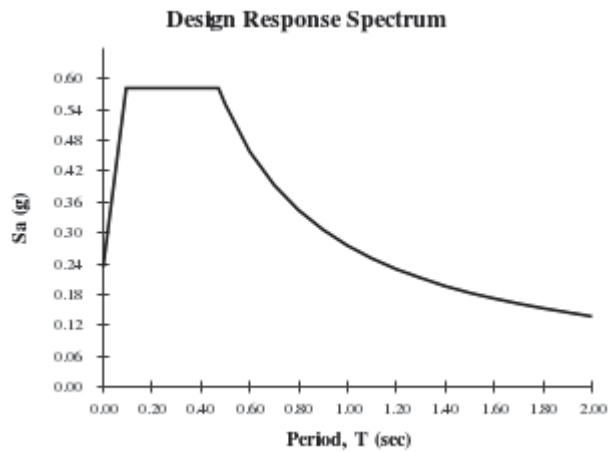
USGS Design Maps Summary Report

Site Soil Classification Site Class C – “Very Dense Soil and Soft Rock”

USGS-Provided Output

$S_S = 0.813 \text{ g}$	$S_{MS} = 0.873 \text{ g}$	$S_{DS} = 0.582 \text{ g}$
$S_1 = 0.269 \text{ g}$	$S_{M1} = 0.412 \text{ g}$	$S_{D1} = 0.275 \text{ g}$

Following the criteria outlined in the 2015 International Building Code (IBC, 2015), spectral response at the site was evaluated for the *Maximum Considered Earthquake* (MCE) which equates to a probabilistic seismic event having a two percent probability of exceedance in 50 years (2PE50). Spectral accelerations were determined based on the location of the site using the *U.S. Seismic “DesignMaps” Web Application* (USGS, 2012/15); this software incorporates seismic hazard maps depicting probabilistic ground motions and spectral response data developed for the United States by the U. S. Geological Survey as part of NEHRP/NSHMP (Frankel et al., 1996). These maps have been incorporated into both *NEHRP Recommended Provisions for Seismic Regulations for New Buildings and Other Structures* (FEMA, 1997) and the *International Building Code* (IBC) (International Code Council, 2015).

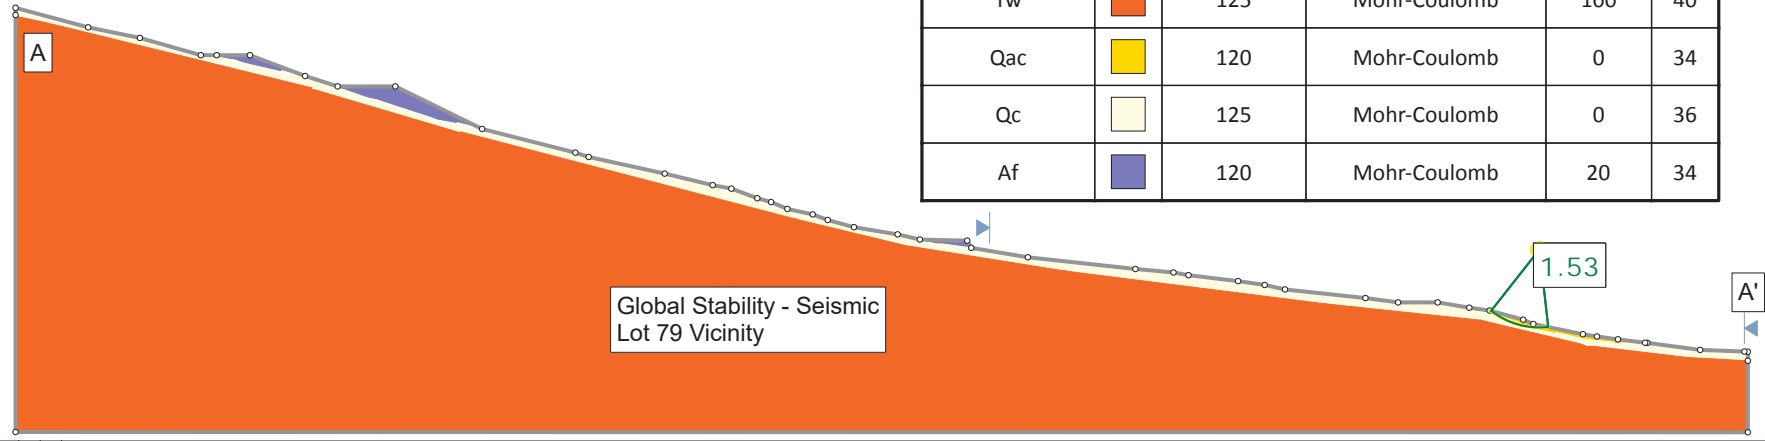
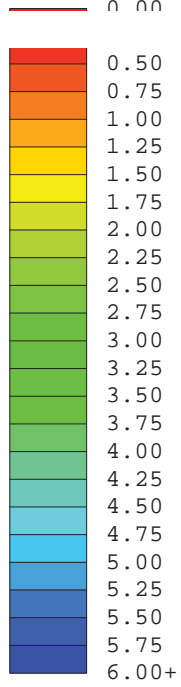
Project		Lot 79R of Summit Eden Phase 1C	
Analysis Description		A-A' 02904-001	
Drawn By	EBF	Scale	1:1
Date	10/30/2018	Company	IGES Inc
		File Name	A-A'.slim

Safety Factor

Material Name	Color	Unit Weight (lbs/ft ³)	Strength Type	Cohesion (psf)	Phi (deg)
Tw		125	Mohr-Coulomb	100	40
Qac		120	Mohr-Coulomb	0	34
Qc		125	Mohr-Coulomb	0	36
Af		120	Mohr-Coulomb	20	34
