GEOTECHNICAL AND GEOLOGIC HAZARD INVESTIGATION
Lot 86R of Summit Eden Phase 1C
8549 E. Spring Park
Summit Powder Mountain Resort
Weber County, Utah

IGES Project No. 03091-001

July 1, 2019

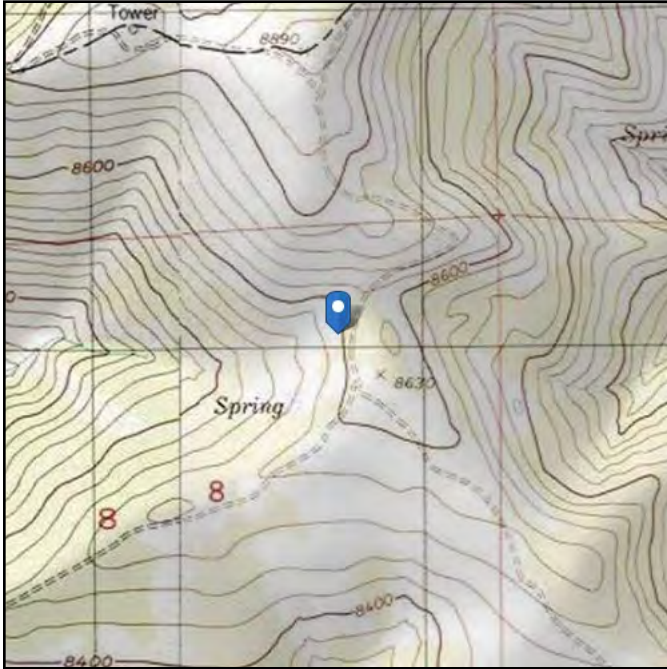
Standard: ASCE/SEI 7-16
Risk Category: III
Soil Class: C - Very Dense
Soil and Soft Rock

Site Soil Class: C - Very Dense Soil and Soft Rock

S_s :	0.802	S_{D1} :	0.277
S_1 :	0.277	T_L :	8
F_a :	1.2	PGA :	0.349
F_v :	1.5	PGA _M :	0.419
S_{MS} :	0.963	F_{PGA} :	1.2
S_{M1} :	0.415	I_e :	1.25
S_{DS} :	0.642	C_v :	1.051

Seismic Design Category D
