Staff Report for Administrative Hillside Review Approval

Application Request: Consideration and action on a Hillside Review Application for 1013 N Valley View Dr., Eden.
Type of Decision: Administrative
Applicant: Ronald A. Barone Living Trust
File Number: HSR 2021-03

Project Area: 1.49 Acres
Zoning: Forest Valley (FV-3) Zone
Existing Land Use: Vacant
Proposed Land Use: Residential
Parcel ID: 20-105-0002

The applicant is requesting approval of a Hillside Review for lot 2R of The Reserve at Crimson Ridge Cluster Subdivision Phase 1 (see **Exhibit A**). Only two lots within this subdivision were platted as restricted lots due to their steep slopes.

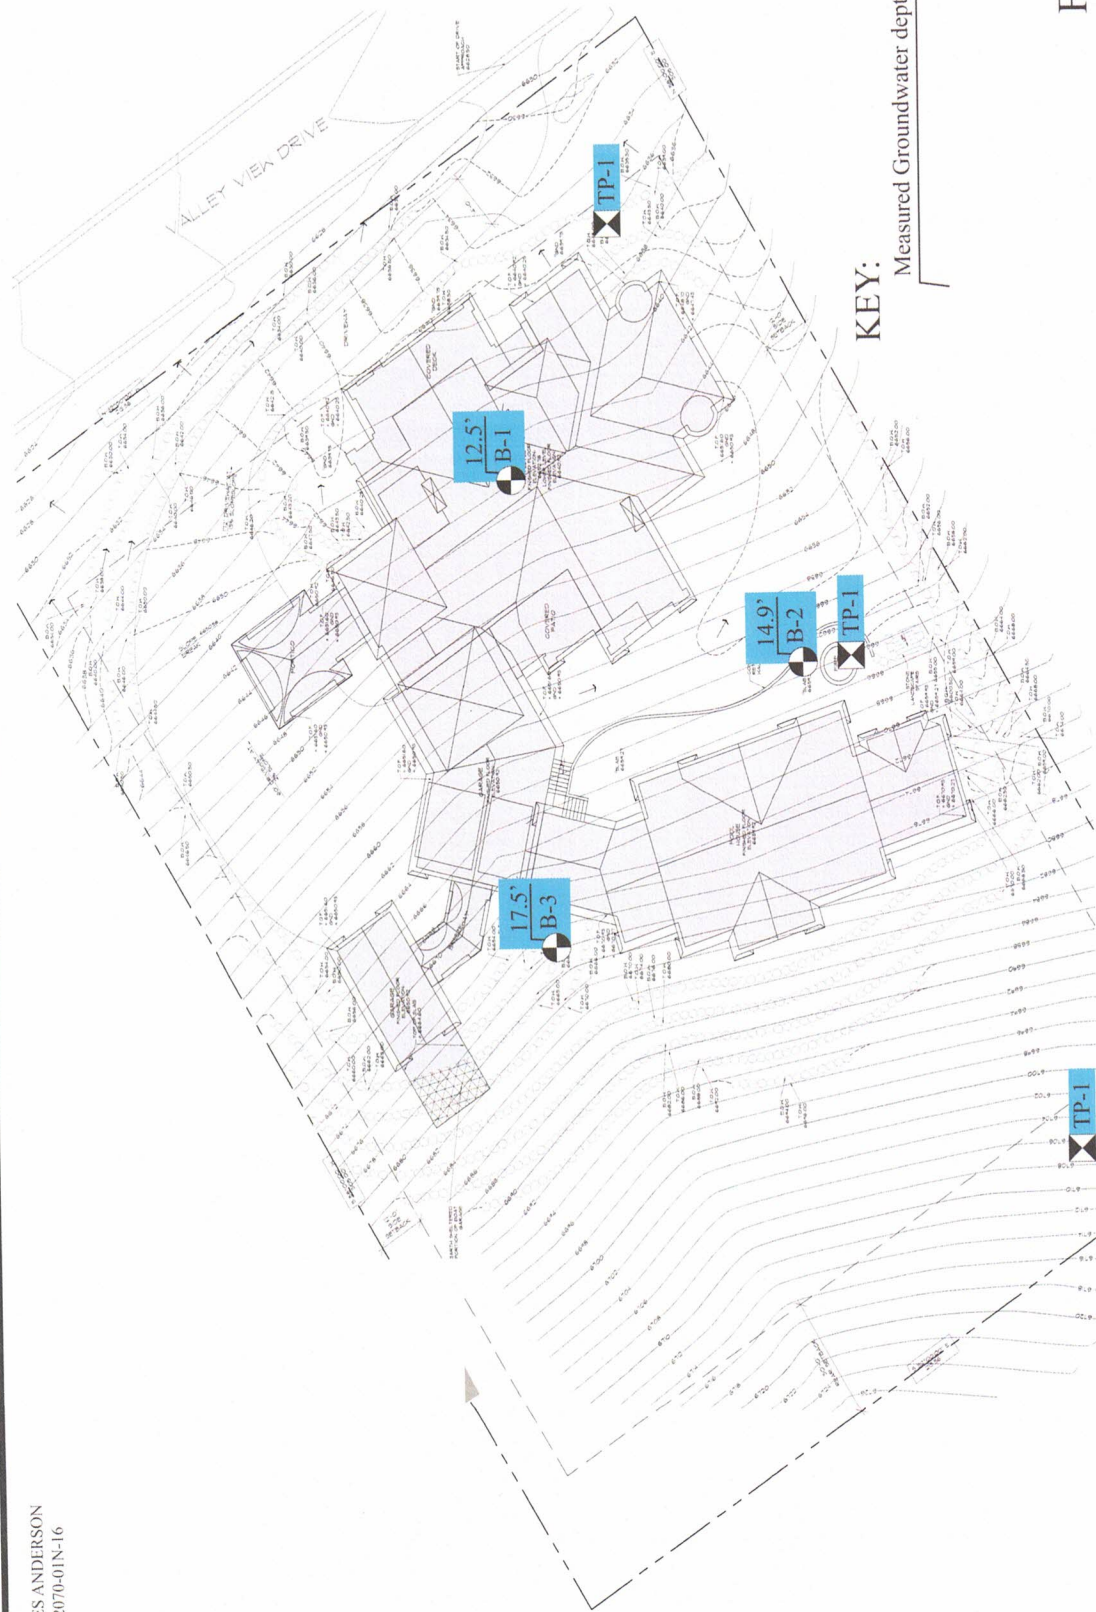
KEY: Measured Groundwater depth (feet)

WATER LEVEL	U S C S	DESCRIPTION	DEPTH (FT.)	BLOW COUNT	SAMPLE SYMBOL	MOISTURE (%)	DRY DENSITY (PCF)	% PASSING 200	LIQUID LIMIT (%)	PLASTICITY INDEX	REMARKS	
		Ground Surface	0								moist stiff	
	CL	SILTY CLAY with trace fine to coarse sand; trace fine and coarse gravel; major roots (topsoil) to 3'; brown to dark brown		14	X	25	84					
	SC	CLAYEY FINE TO COARSE SAND brown	5	11	X	15		21	35	17		
				11	X							
	CL	SILTY CLAY with trace fine to coarse sand; gray	10	15	X	28	91					
		grades with coarse gravel		24	X							very stiff
	CL	SILTY CLAY/WEATHERED CLAYSTONE with trace fine to coarse sand; trace fine and coarse gravel; gray	15	80	X							moist hard
				71	X							
			20	86	X	26	91					
		End of Exploration at 21.5' No groundwater encountered at time of drilling										
			25

See Subsurface Conditions section in the report for additional information.

The field portion of our study was under the direct control and continual supervision of an experienced member of our geotechnical staff. During the course of the excavating and drilling operations, a continuous log of the subsurface soil conditions encountered was maintained. In addition, samples of the typical soils encountered were obtained and placed in sealed bags and plastic containers for subsequent laboratory testing and examination. The soils were classified in the field based upon visual and textural examination. These classifications have been supplemented by subsequent inspection and testing in our laboratory. Detailed graphical representation of the subsurface conditions encountered is presented on Figures 3A through 3C, Boring Log, and on Figures 4A through 4C, Test Pit Log. Soils were classified in accordance with the nomenclature described on Figure 5, Key to Boring Log (USCS) and on Figure 6, Key to Test Pit Log (USCS).

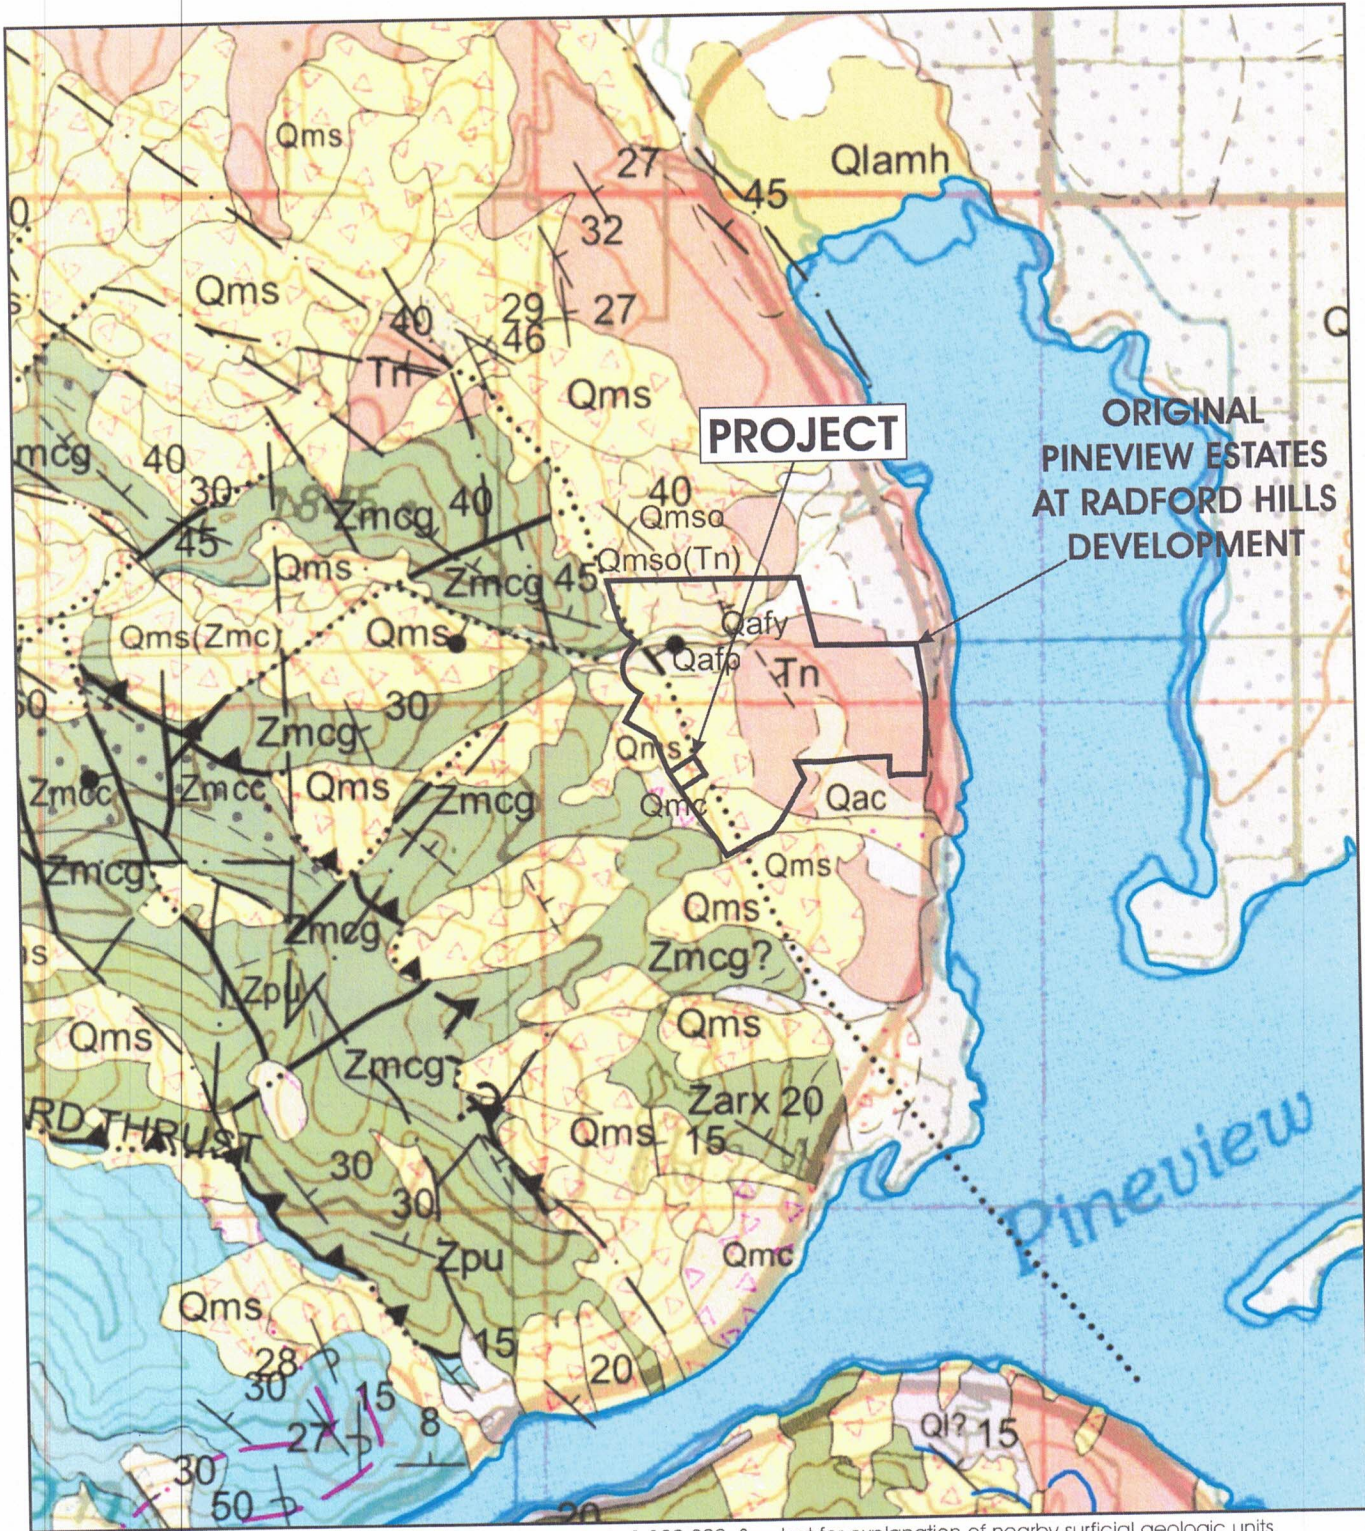
FIGURE 2

Source: Coogan and King (2016); original map scale 1:100,000. See text for explanation of nearby surficial geologic units.
