**Geotechnical Investigation  
Eden Crossing Development  
5204 East 2500 North  
Eden, Weber County, Utah**

**July 11, 2025**

**Geotechnical Investigation  
Eden Crossing Development  
5204 East 2500 North  
Eden, Utah  
CG Project No.: 133-025**

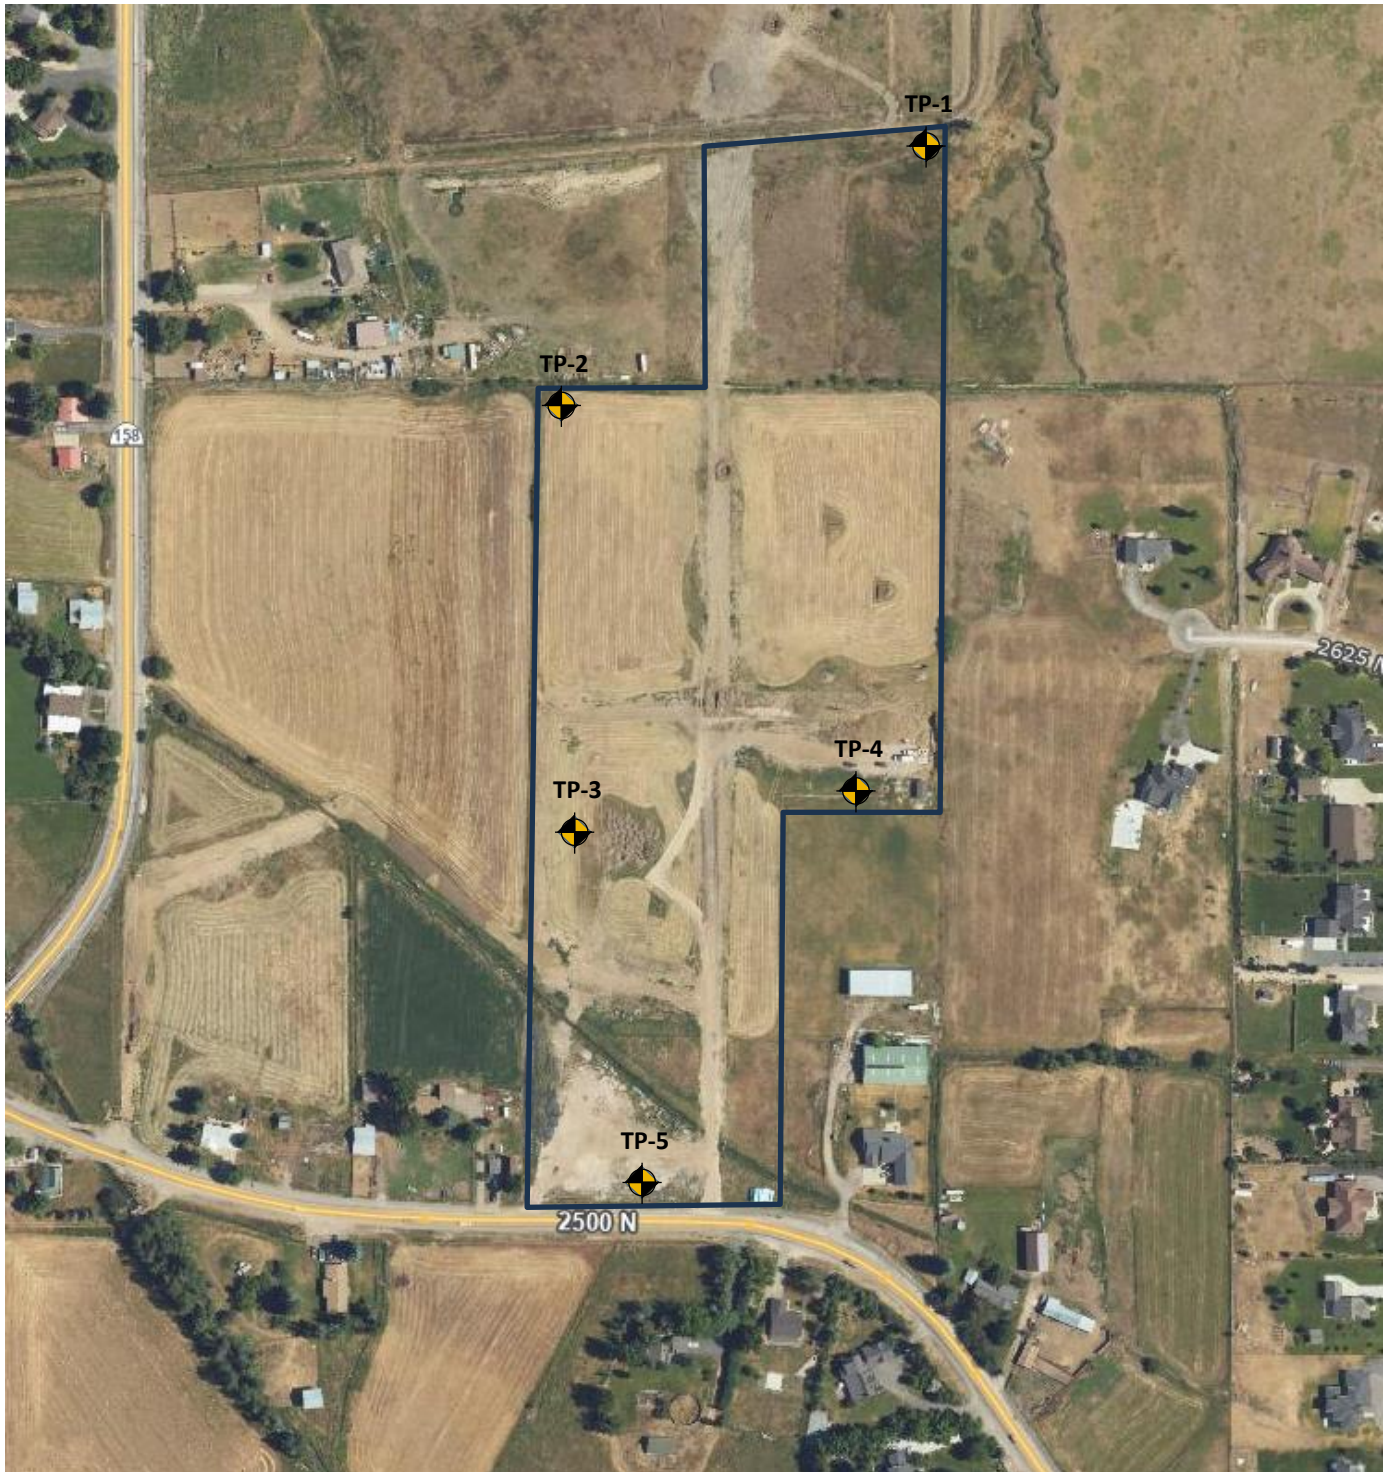
Plate  
2

Approximate Test Pit Location

Exploration Location Map

The subsurface conditions at the site were explored by excavating five test pits to depths of approximately 10 feet below the existing site grade. The approximate test pit locations are shown on the Exploration Location Map, Plate 2. The subsurface conditions as encountered in the test pits were recorded and are presented on the attached Test Pit Logs, Plates 3 to 7. A key to the symbols and terms used on the Test Pit Logs may be found on Plate 8.

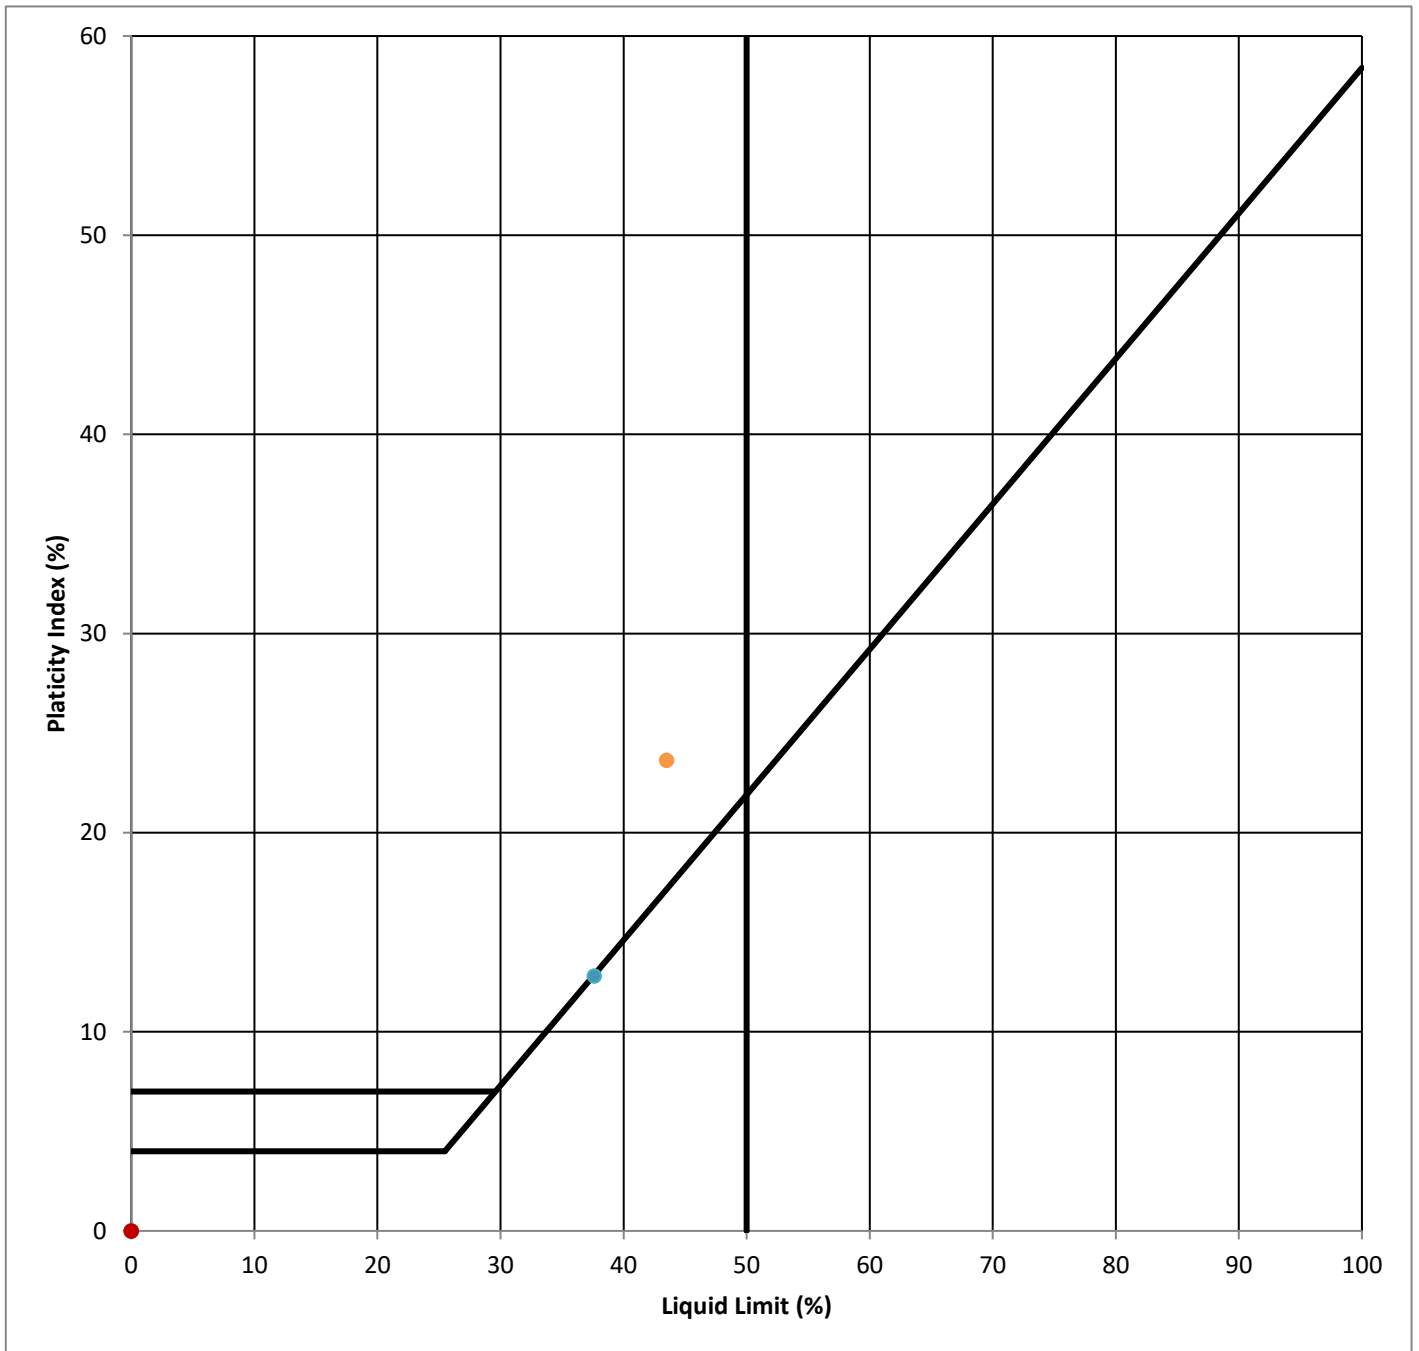
| | <b>Eden Valley Opportunity LLC</b><br><b>Eden Crossing Development</b><br><b>Eden, Weber County, Utah</b><br><b>Project No.: 133-025</b> | <b>Plate</b><br><br><b>9</b> |

# Atterberg Limits

| Location | Depth (ft) | | Classification | Liquid Limit | PI |
|---|---|---|---|---|---|
| TP-1 | 8 | ● | Lean CLAY | 38 | 13 |

The results of our laboratory tests are also presented on the Test Pit Logs, Plates 3 through 7, and more detailed laboratory results are presented on the laboratory testing plates, Plates 9 through 11.

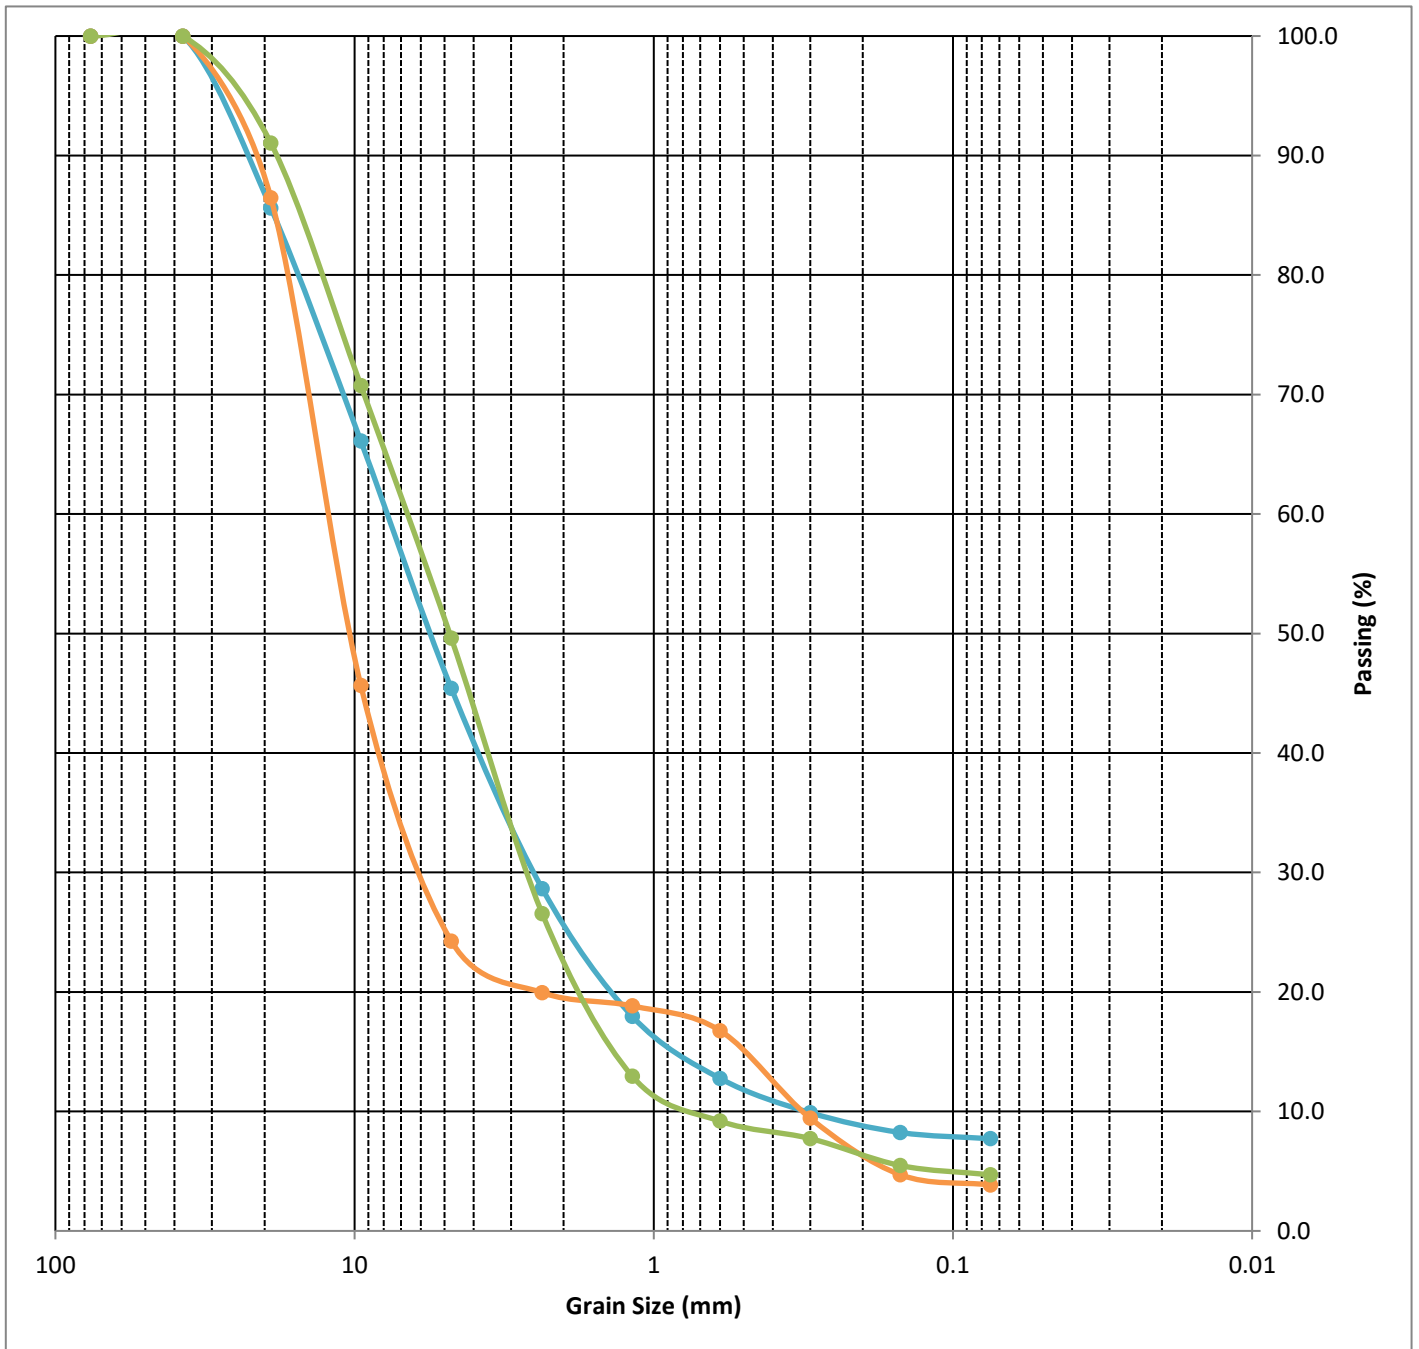
# Grain Size Distribution

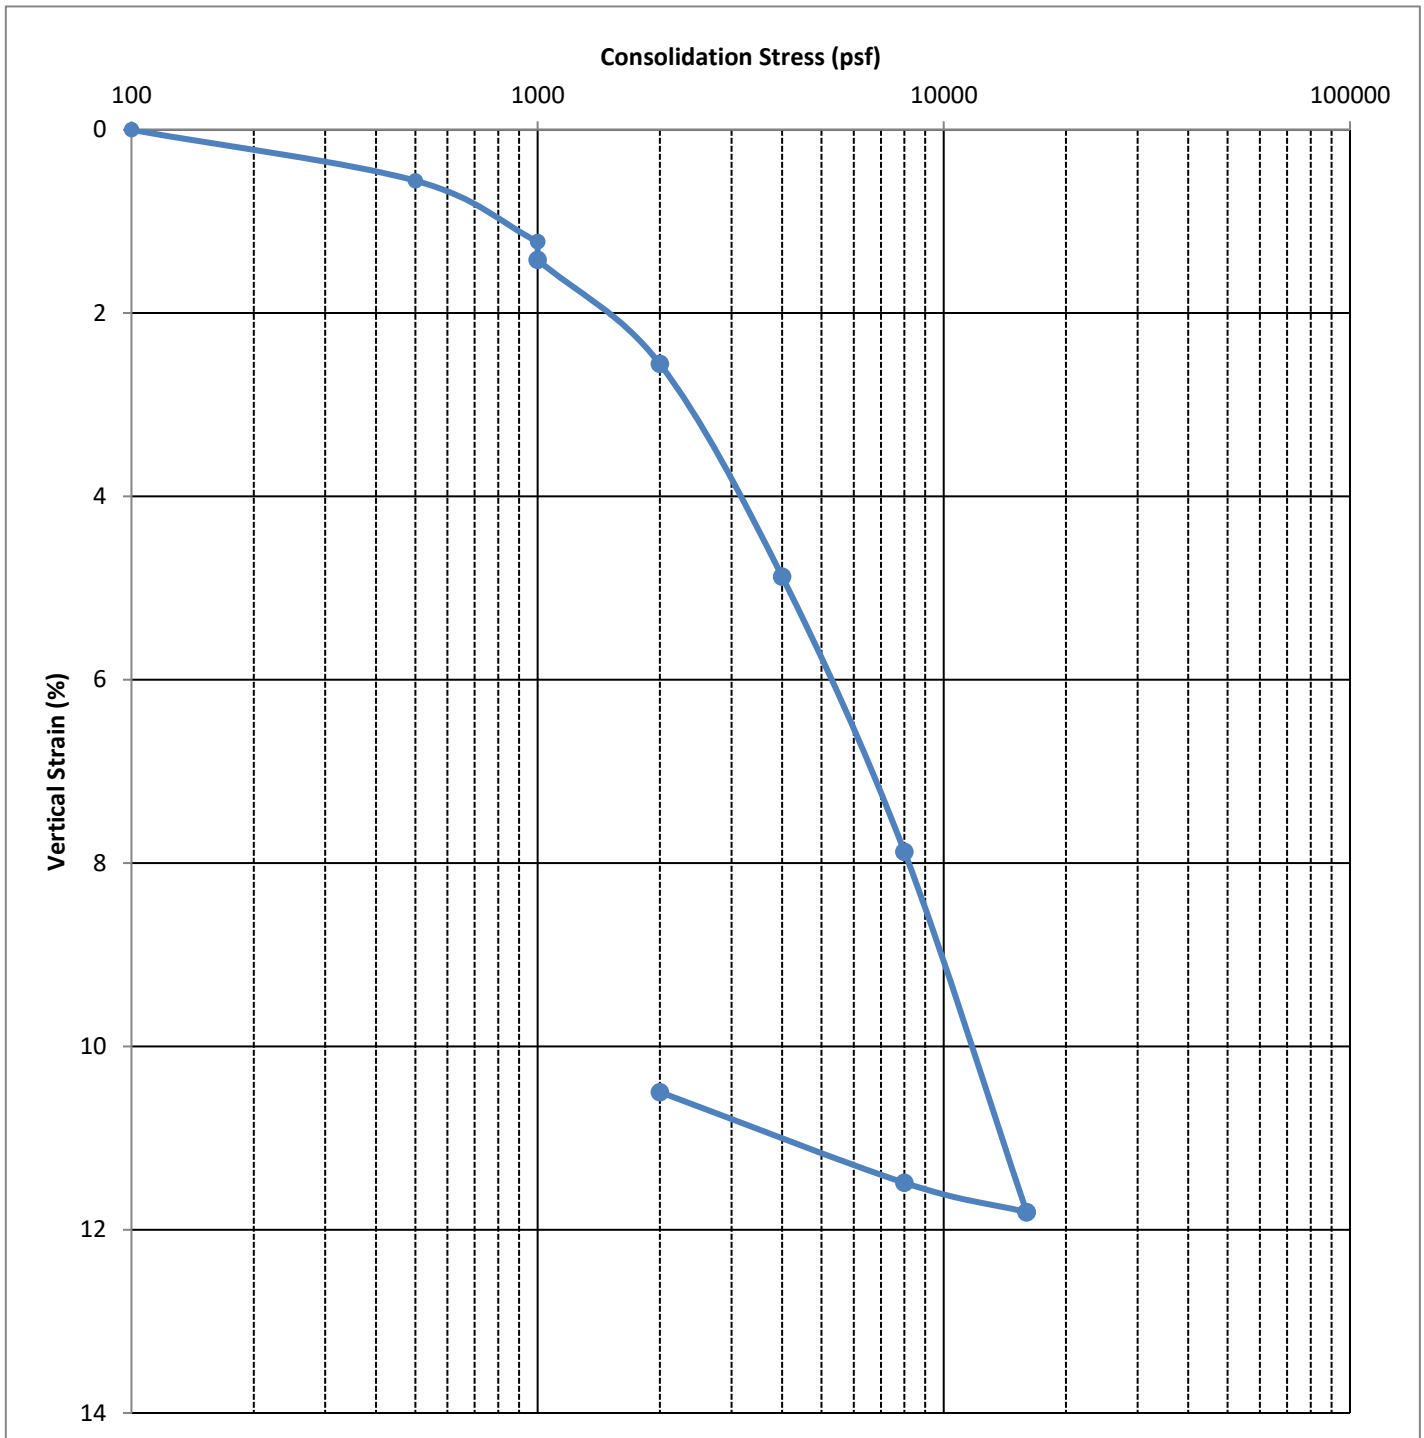
# 1-D Consolidation

| Location | Depth (ft) | Dry Density (pcf) | Moisture Content (%) | $\sigma_o$ (psf) | $\sigma_p$ (psf) | $C_c$ | $C_r$ | OCR |
| TP-2 | 3 | 102.1 | 20.9 | 400 | 3,000 | 0.115 | 0.015 | 7.5 |
