**GEOTECHNICAL AND GEOLOGIC
HAZARD INVESTIGATION (Rev. 2)
The Overlook at Powder Mountain
Summit Powder Mountain Resort
Weber County, Utah**

IGES Project No. 01628-027

February 12, 2019

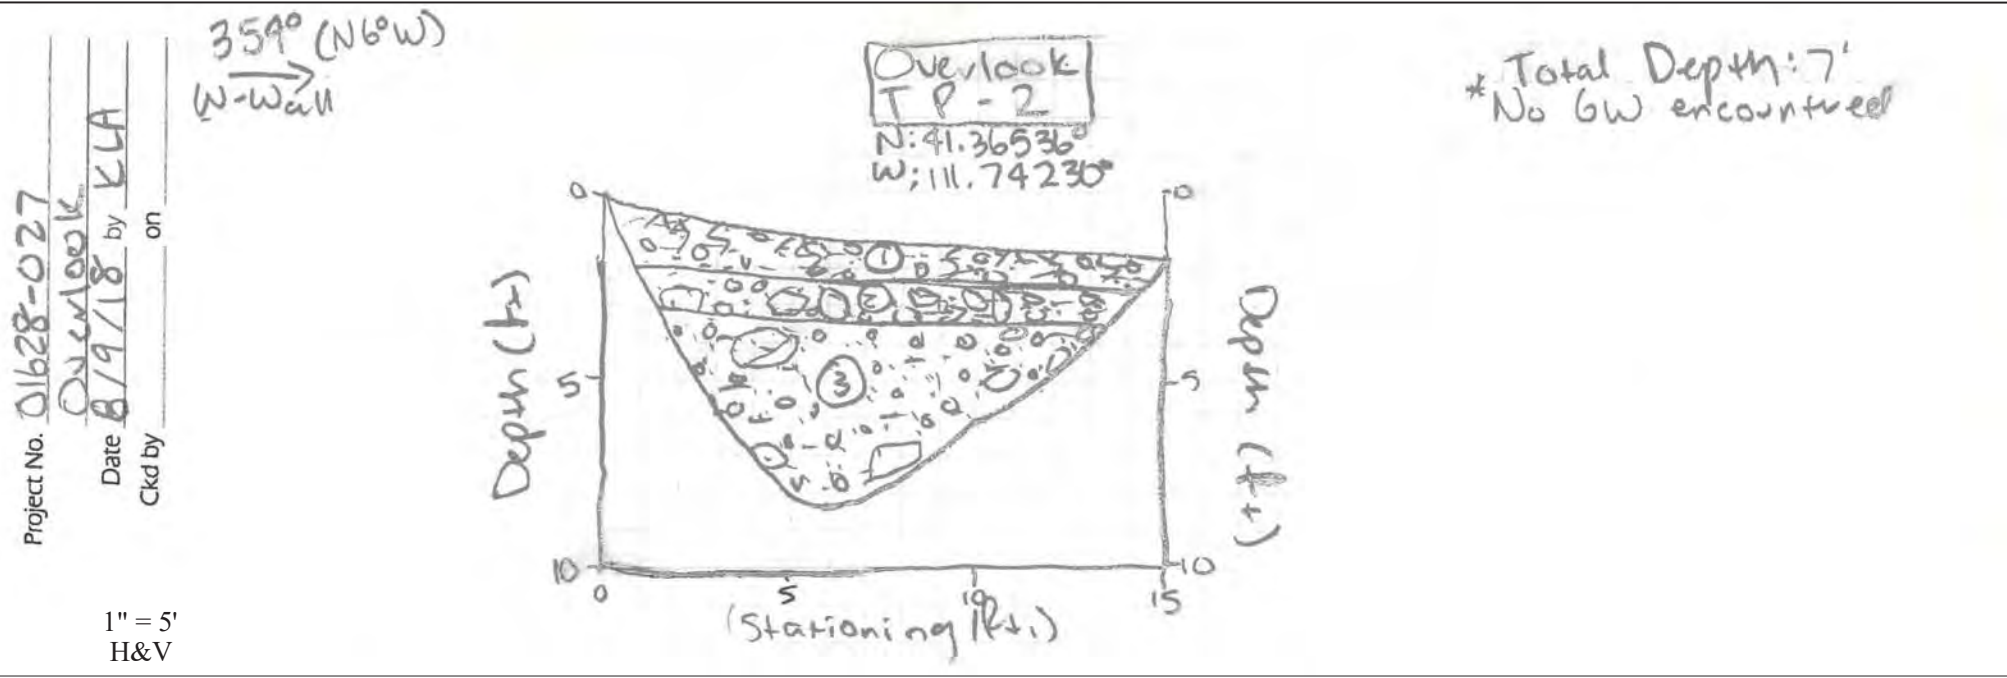
A-4

1. A/B Soil Horizon: ~1' thick; pale yellowish brown (10YR 5/2) sandy lean CLAY with gravel (CL), loose to medium stiff, dry, low plasticity, massive; gravel and larger sized clasts comprise ~10-20% of the unit; clasts are subrounded to subangular light brown (5YR 4/2) to moderate orange pink (10R 7/4) quartzite up to 3" in diameter, though mode clast size is ~1/2-1"; abundant plant and tree roots; gradational, irregular basal contact.
