**Geotechnical Engineering and
Geological Reconnaissance Study
Proposed Single-Family Residence
About 5597 East Highway 39
Huntsville, Weber County, Utah**

CMT Project No. 12714

July 9, 2019

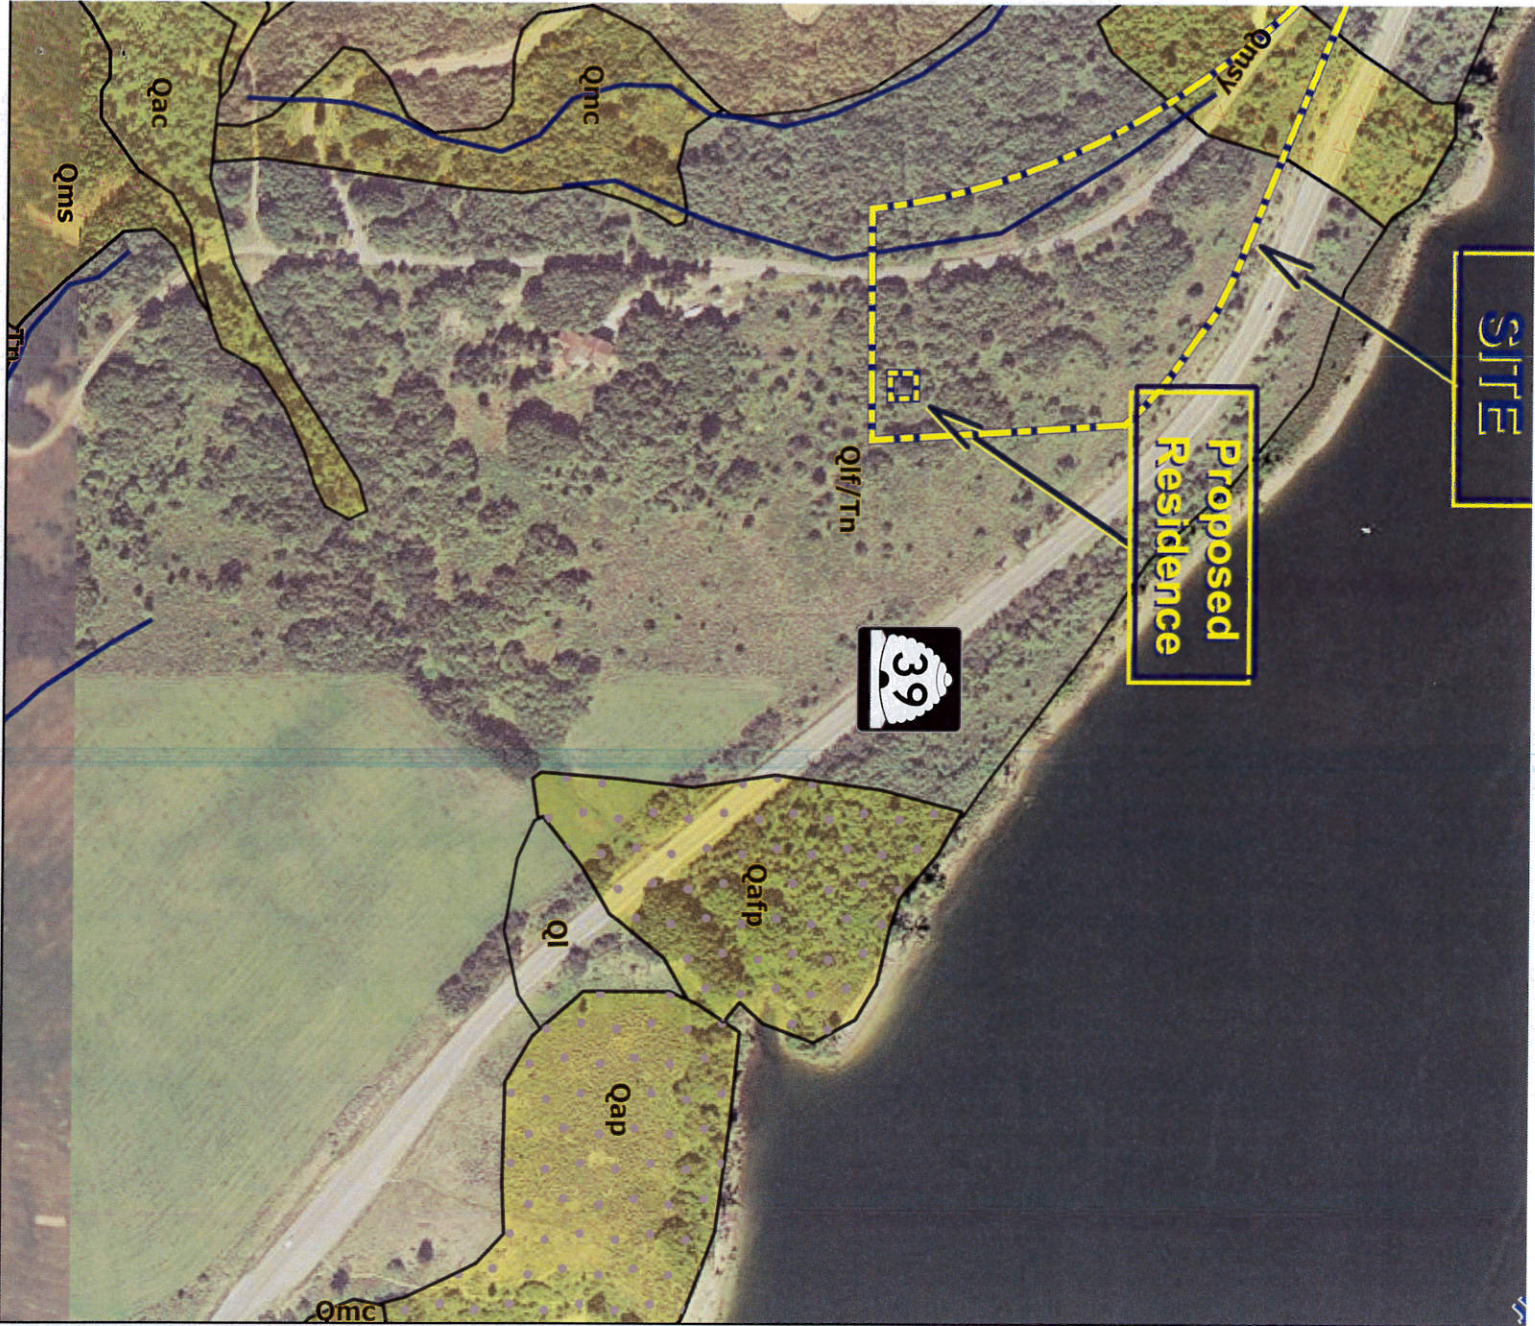
Geology after King and Others, 2008

- Qh - Human disturbance (Historical) - Obscure or removal...
- Qaf - Alluvial-fan deposits (Holocene and Pleistocene) - gravel that is poorly bedded and poorly sorted in drainages and at drainage mouths...

- Ql? - Lake Bonneville lacustrine silt, sand and gravel...
- Qlf/Tn - Lake Bonneville deposits, undivided cobbly gravel over Norwood Formation (lower Pleistocene)...

- Tn - Norwood Formation (lower Oligocene and upper Eocene) - light-gray to light brown, altered tuff (claystone and conglomerate)...
- Lake Bonneville Shoreline

The proposed residence location is shown on Figure 3 to be on **Qlf/Tn** - Lacustrine fine grained deposits (Pleistocene) - over Norwood Formation rocks... Based upon our findings from this evaluation, these deposits (**Qmc** and **Qlf/Tn**) are considered presently inactive under the existing site slope conditions, and are not expected to move under the present environmental conditions.

Alluvial fan deposits indicative of processes including flash flooding and debris flow hazard do not appear to occur on the site. The nearest debris flow process deposits are mapped as **Qafy** by King and others (2008), and occur over a mile southeast of the site. These deposits and processes are not shown on Figure 3, do not appear to be a potential impact to the site location.

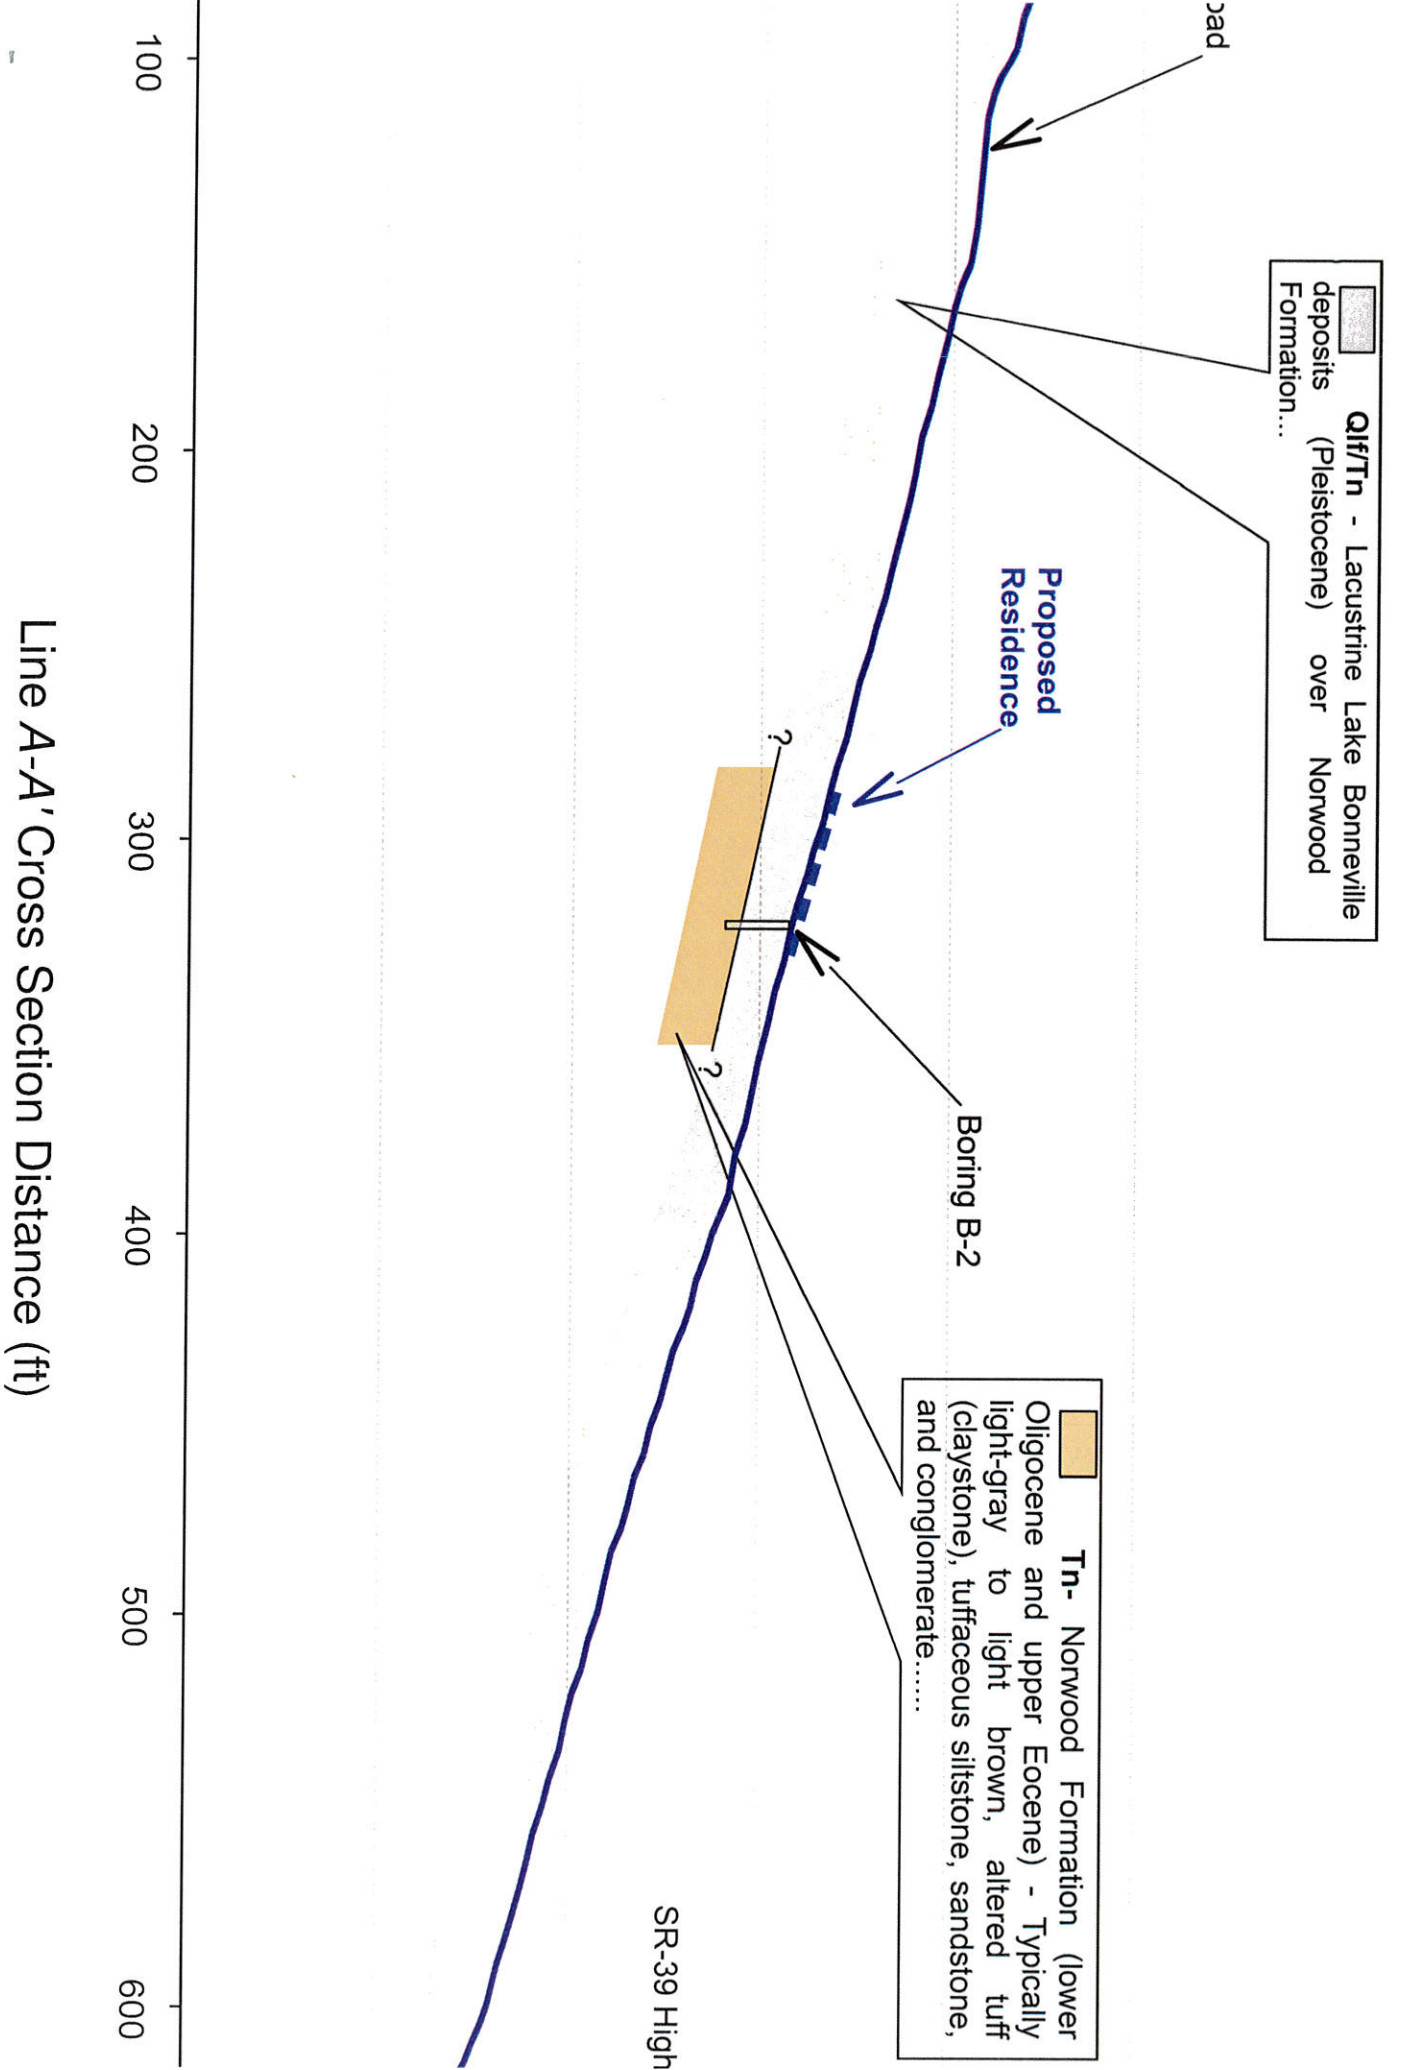
Qlf/Tn - Lacustrine Lake Bonneville deposits (Pleistocene) over Norwood Formation...

Tn- Norwood Formation (lower Oligocene and upper Eocene) - Typically light-gray to light brown, altered tuff (claystone), tuffaceous siltstone, sandstone, and conglomerate.....

Line A-A' Cross Section Distance (ft)

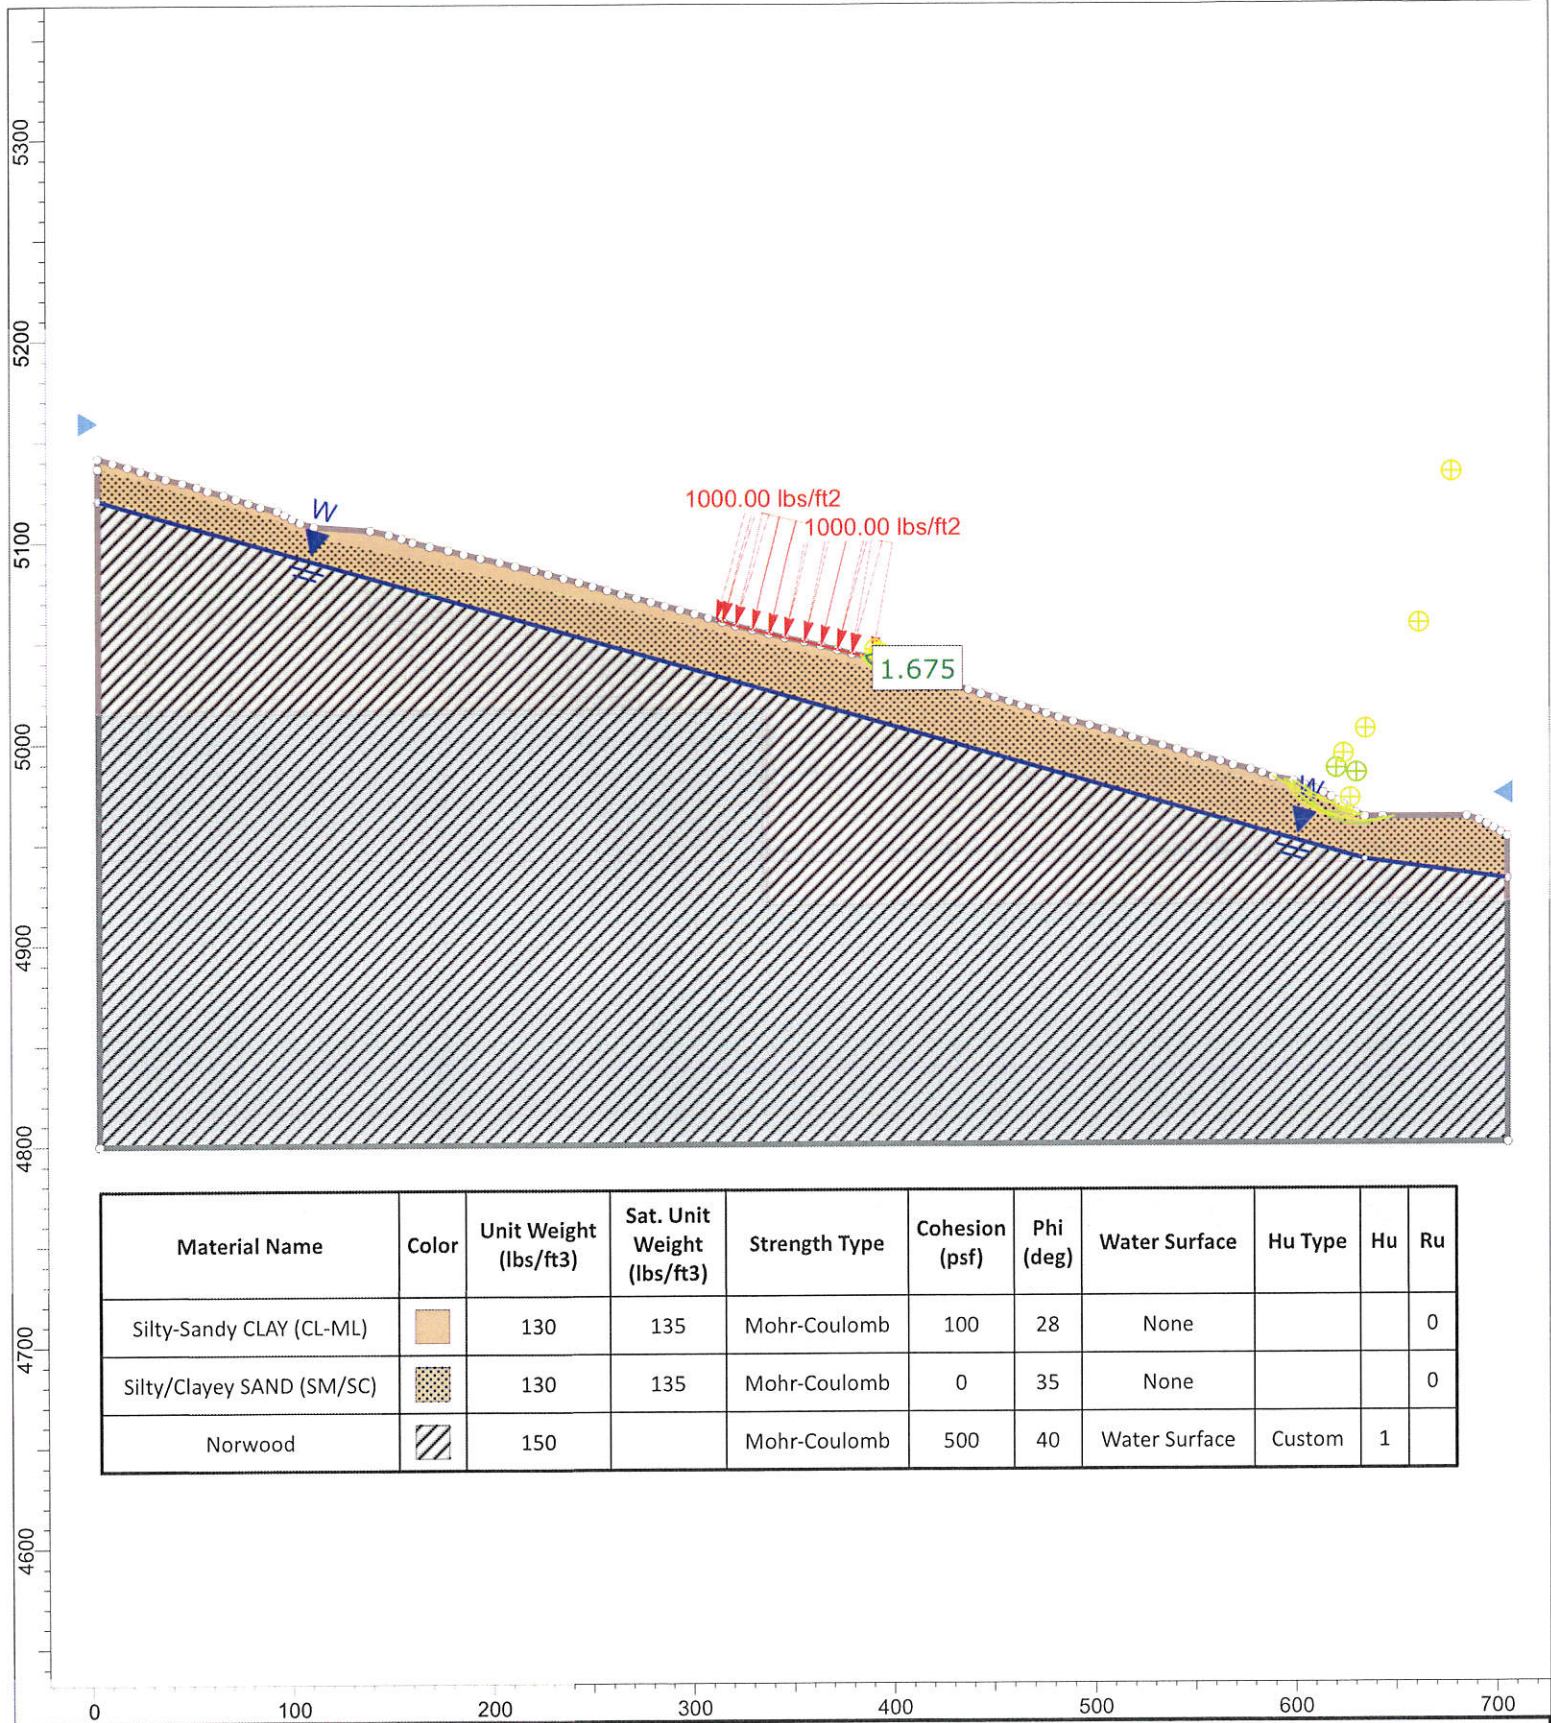
Figure: 11

Material Name	Color	Unit Weight (lbs/ft3)	Sat. Unit Weight (lbs/ft3)	Strength Type	Cohesion (psf)	Phi (deg)	Water Surface	Hu Type	Hu	Ru
Silty-Sandy CLAY (CL-ML)		130	135	Mohr-Coulomb	100	28	None			0
Silty/Clayey SAND (SM/SC)		130	135	Mohr-Coulomb	0	35	None			0
Norwood		150		Mohr-Coulomb	500	40	Water Surface	Custom	1

The properties of the clay and sand soils observed at the site in the subsurface explorations were based upon direct shear testing of samples collected in the explorations. Accordingly, we estimated the following parameters for use in the stability analyses:

Typically, the required minimum factors of safety are 1.5 for static conditions and 1.1 for seismic (pseudostatic) conditions. The results of our analyses indicate that the slope in its present configuration meets both these requirements provided our recommendations are followed. The slope stability data are included as Figures 13 and 14, attached. We recommend that CMT be retained to re-evaluate the stability based upon proposed cuts and fills at the site once this information has been developed.
