GEOTECHNICAL ENGINEERING AND GEOLOGIC STUDY

Proposed Hansen Property Development

About 1000 North 7300 East
Huntsville, Weber County, Utah
CMT PROJECT NO. 900125

March 19, 2021

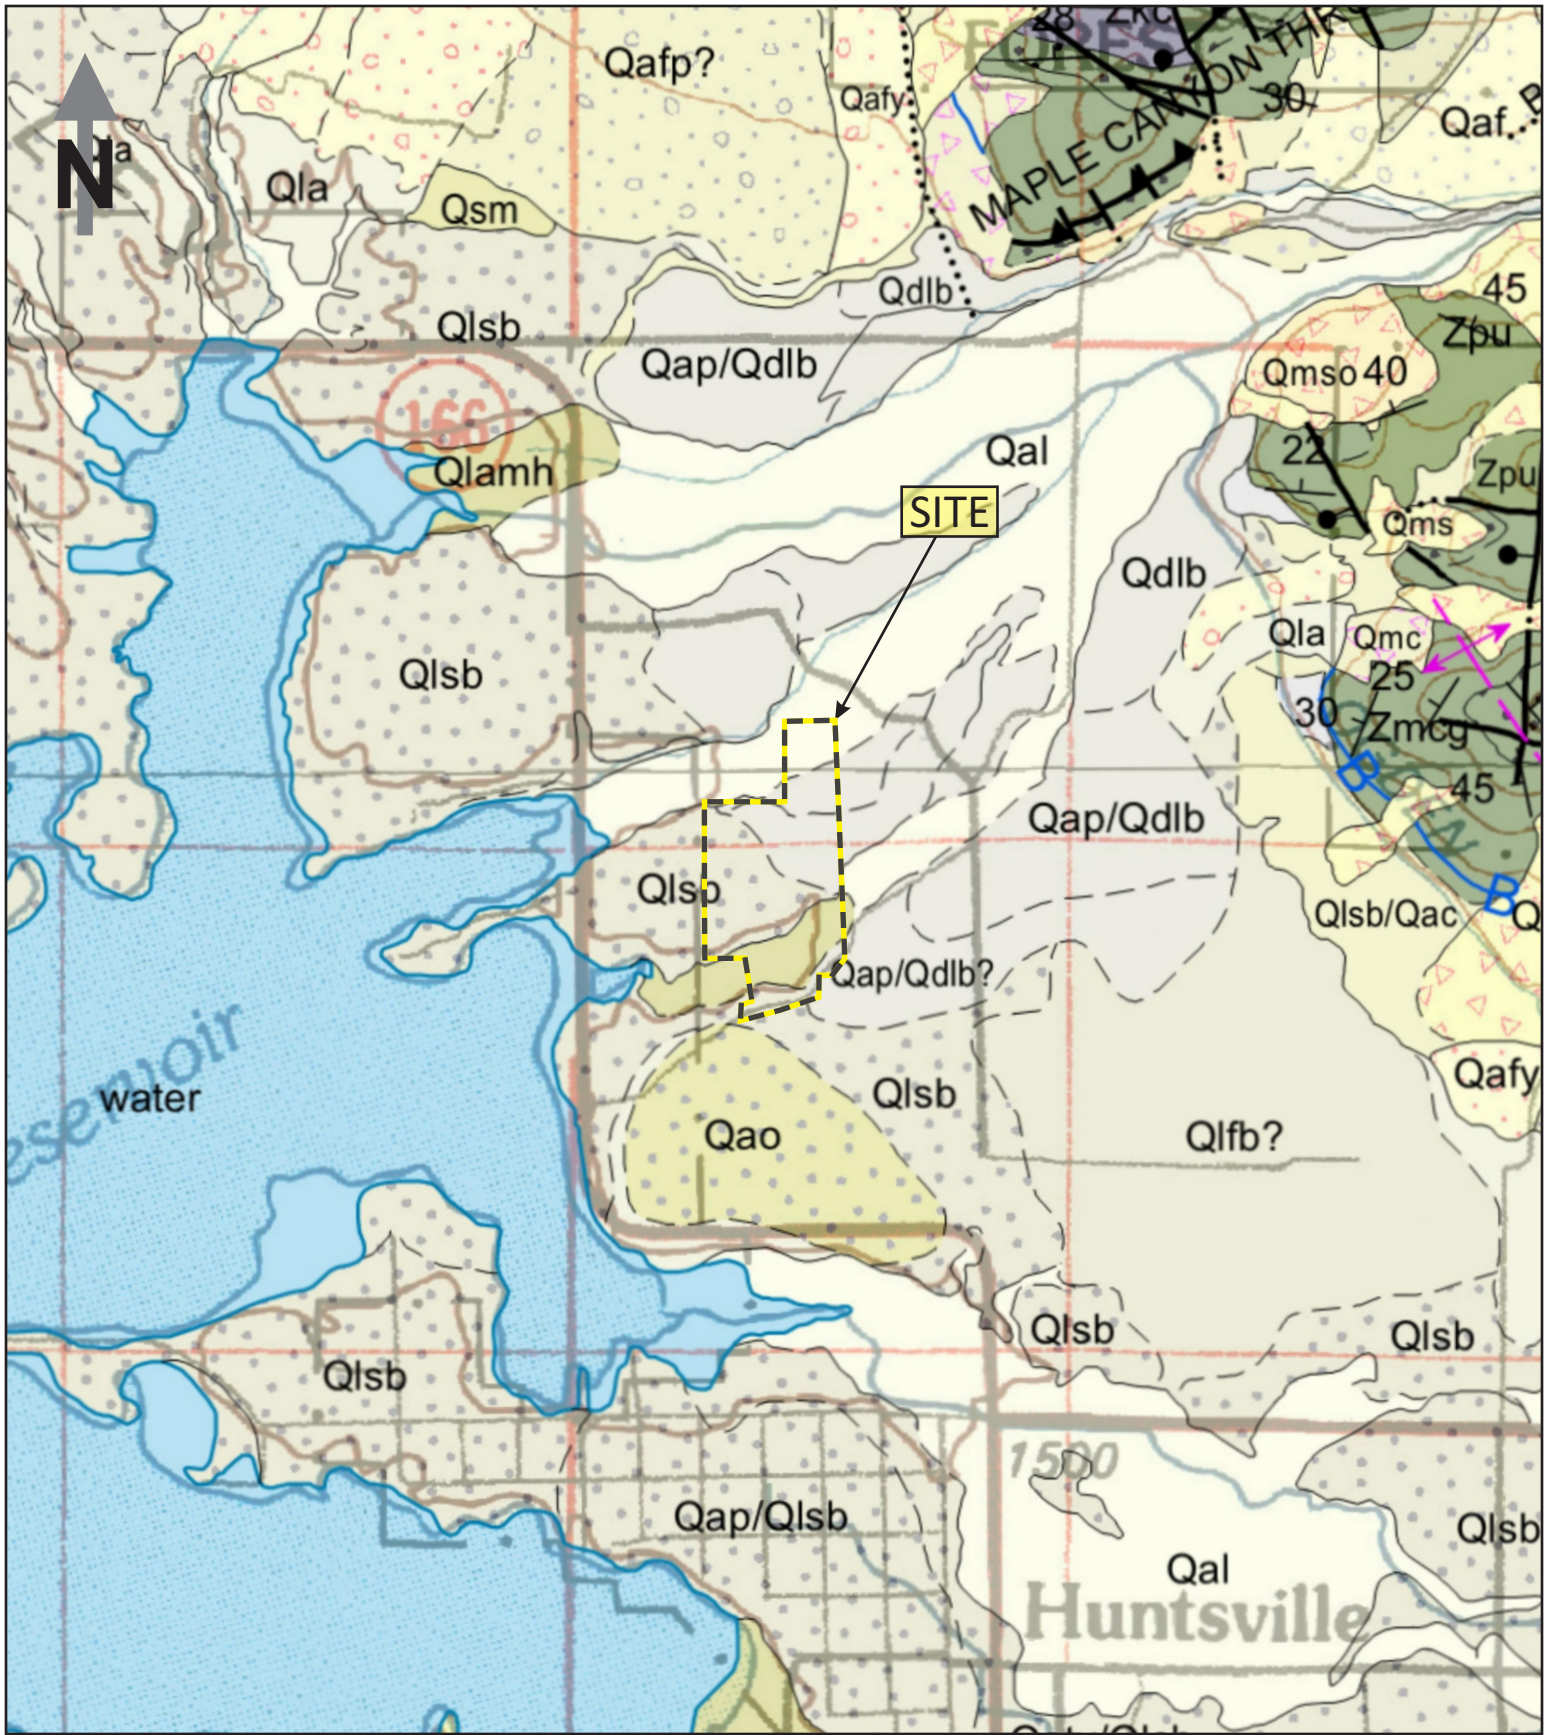
Figure

Base:
 Interim Geologic Map of the Ogden 30' x 60'
 Quadrangle (Coogan and King, 2016).

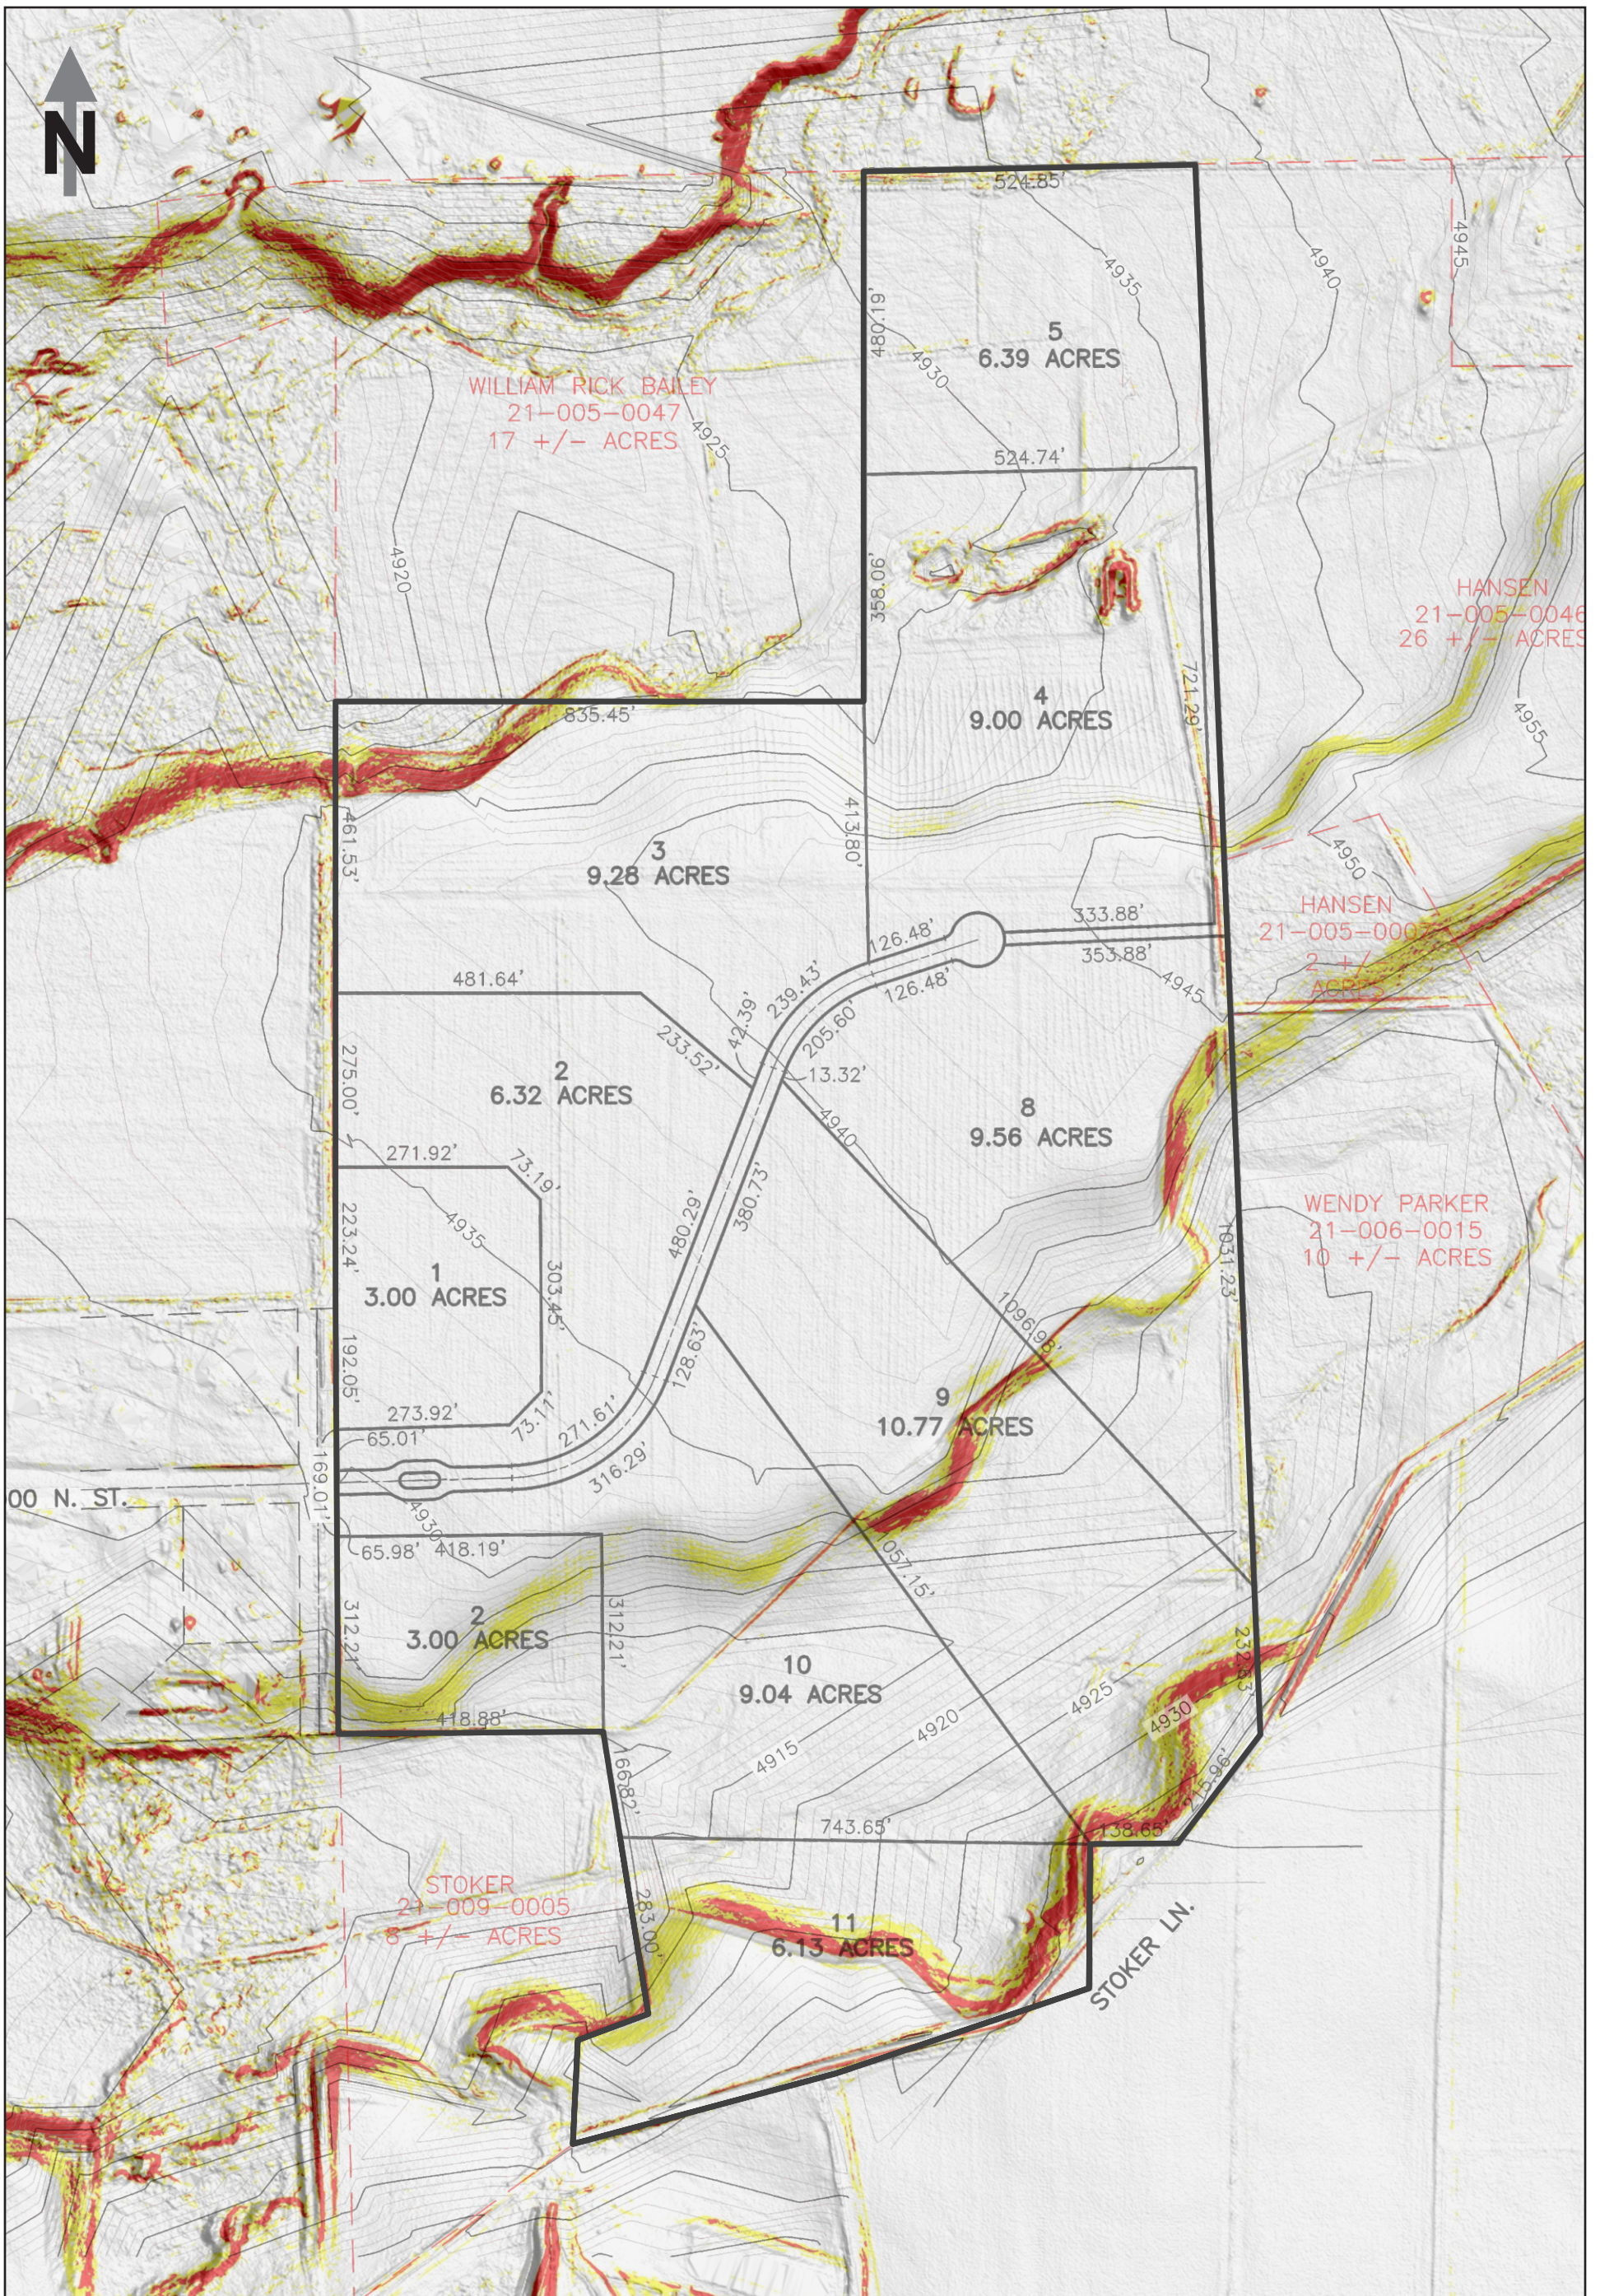
Figure
3

Base: 2016 LIDAR imagery available from Utah AGRC, 0.5 m resolution; slope steepness <15% shaded in green, 15-25% in yellow, and >25% in red.

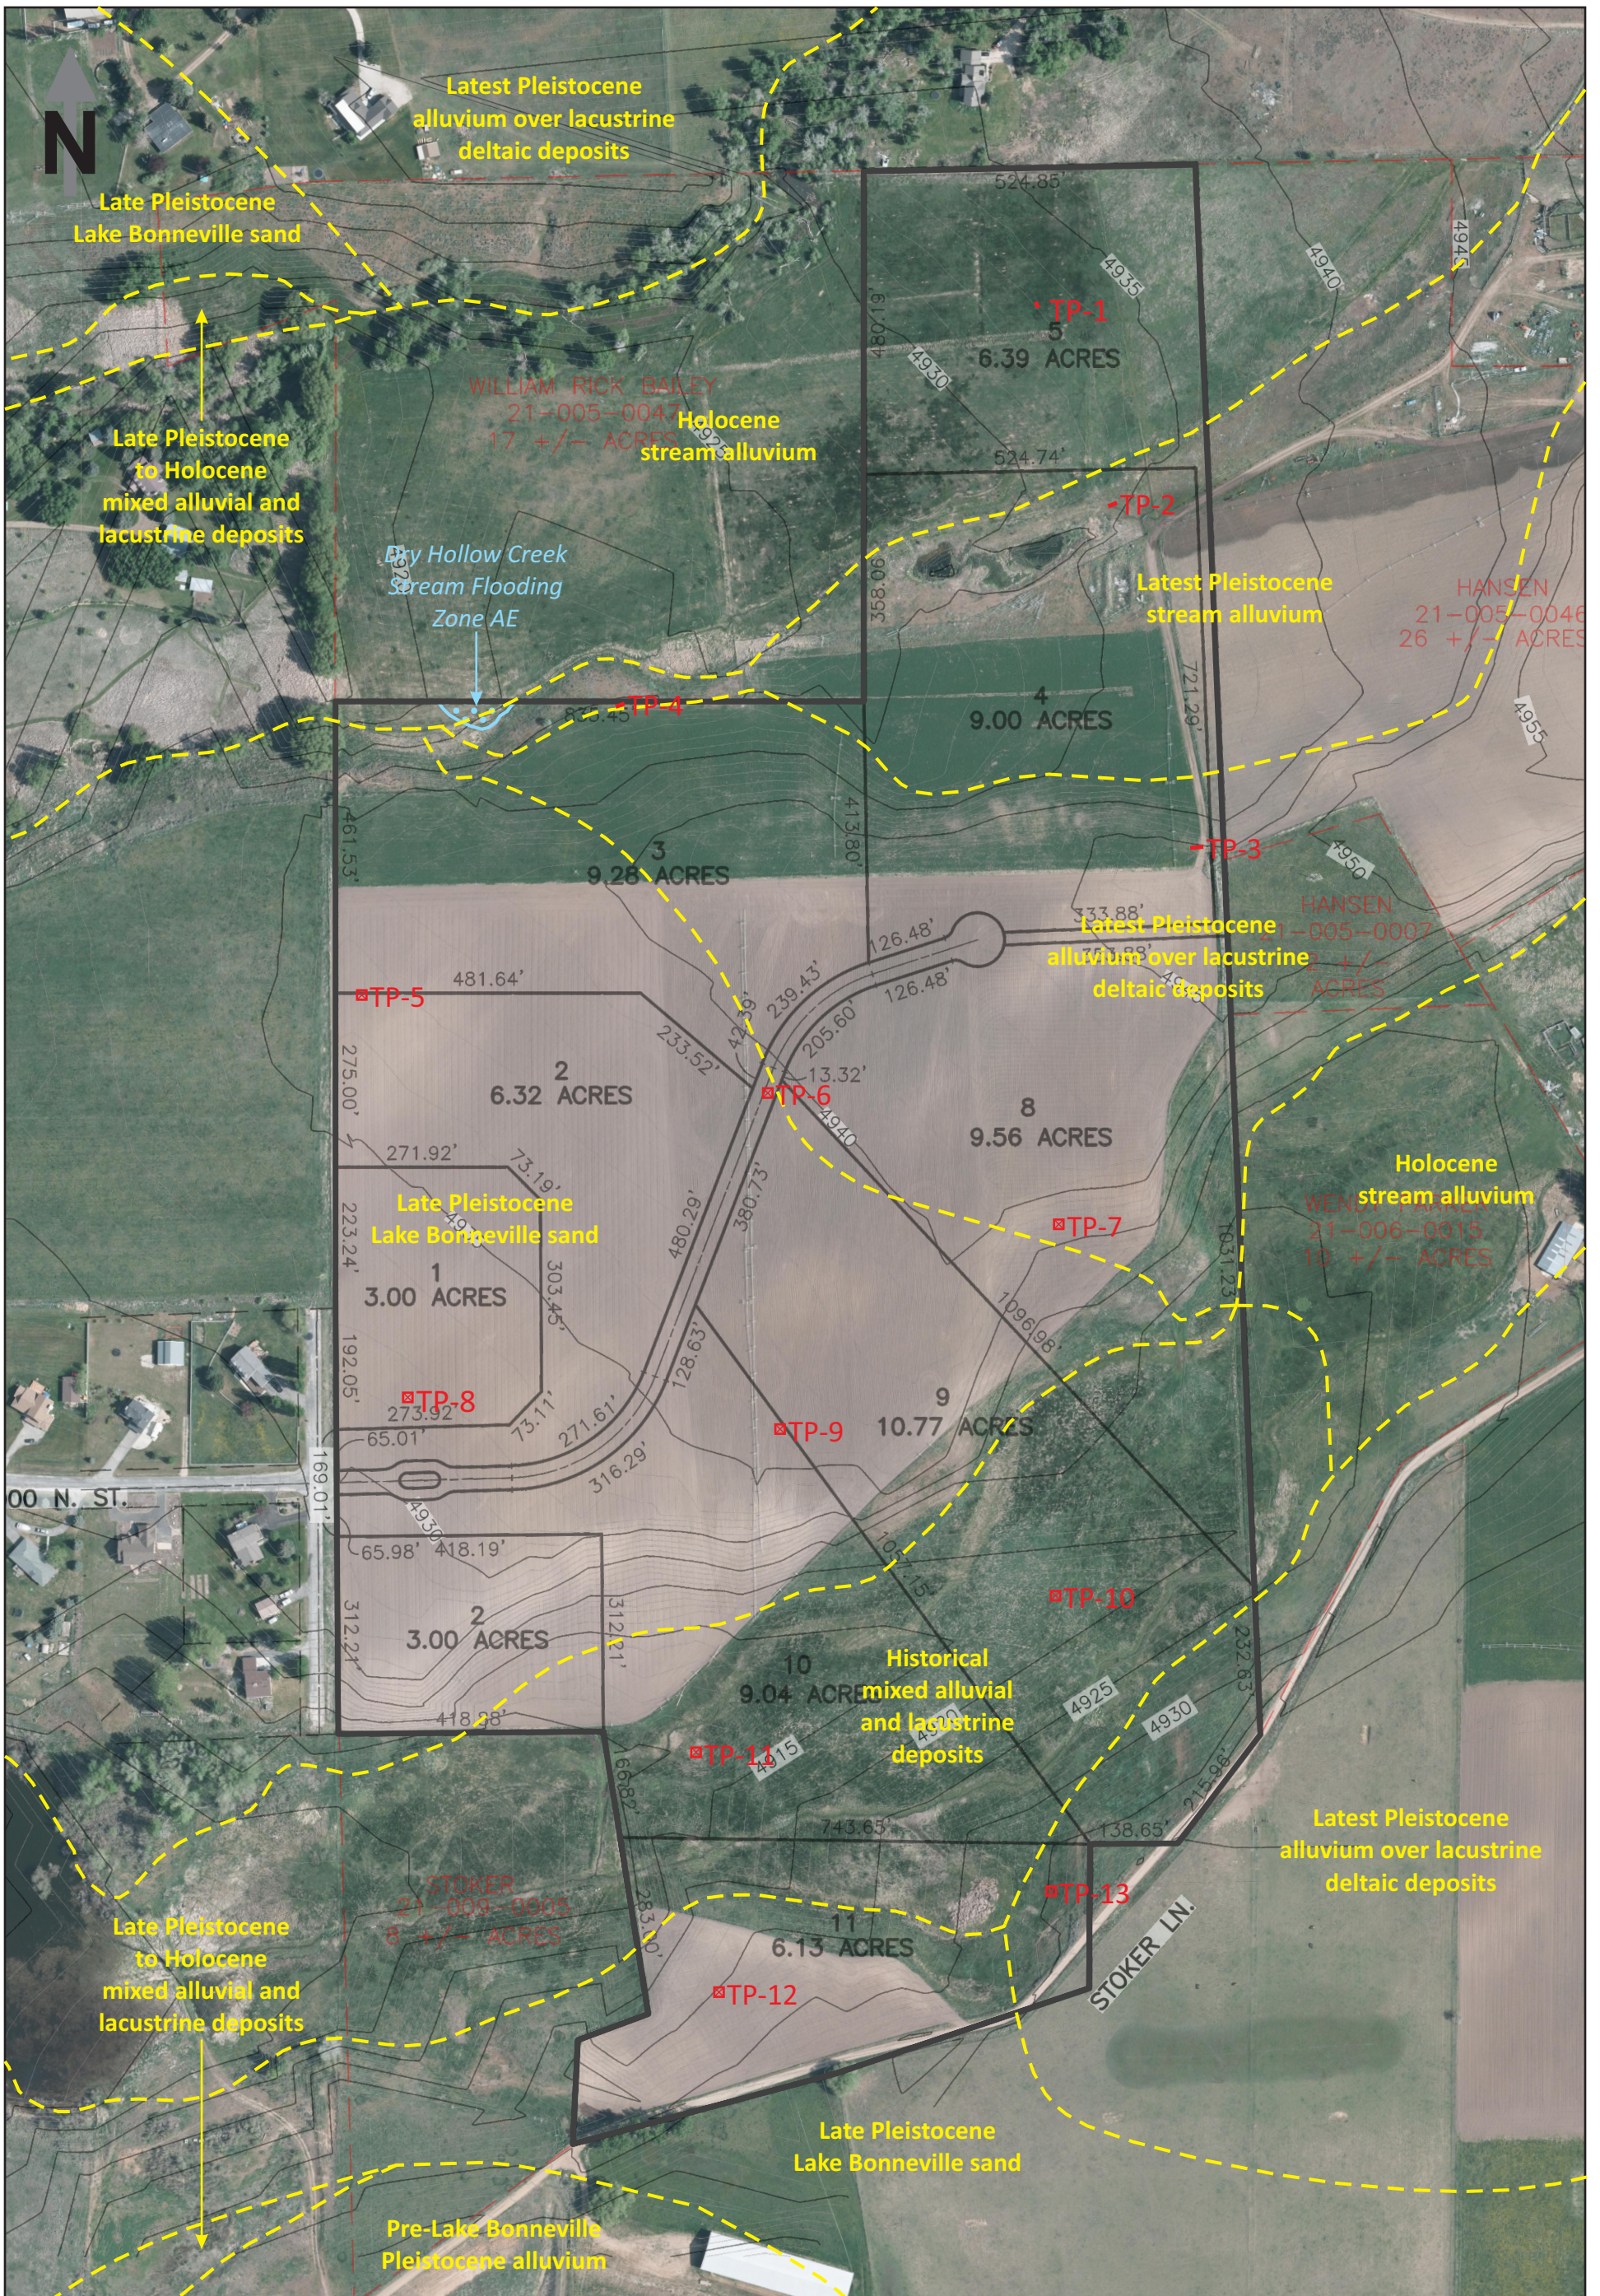
Figure
4

Base: 2012 high-resolution orthophoto available from Utah AGRC, 12.5 cm resolution; site plan from Reeve & Associates, February 22, 2021.

Subsurface soil conditions at the site were explored by excavating 13 test pits located as shown on **Figure 4**. The test pits were excavated using a track-mounted excavator to depths of 7.7 to 15.0 feet bgs for geologic/geotechnical logging and sampling. The excavation locations were measured using a handheld GPS unit and by trend and distance methods. During the course of the excavation operations, a continuous log of the subsurface conditions encountered was maintained. Disturbed bulk samples of representative soils encountered in the test pits were obtained for subsequent laboratory testing and examination. The representative soil samples were placed in sealed plastic bags and containers prior to transport to the laboratory.

Thirteen test pits were excavated at the site to evaluate subsurface soil conditions, as located on **Figure 4**. Test pits TP-1 through TP-4 (**Figures 5A-D**) were logged for geologic and geotechnical conditions, whereas test pits TP-5 through TP-13 (**Figures 6-14**) were logged and sampled for geotechnical conditions. The test pits mainly exposed sandy to gravelly alluvium with cobbles, and lacustrine sand with thin clay interbeds. Detailed stratigraphic unit descriptions are shown on the logs. Groundwater was encountered in test pit TP-13 at a depth of 12.0 feet bgs, but was not encountered in any of the other excavations to their explored depths of 7.7 to 15 feet bgs.

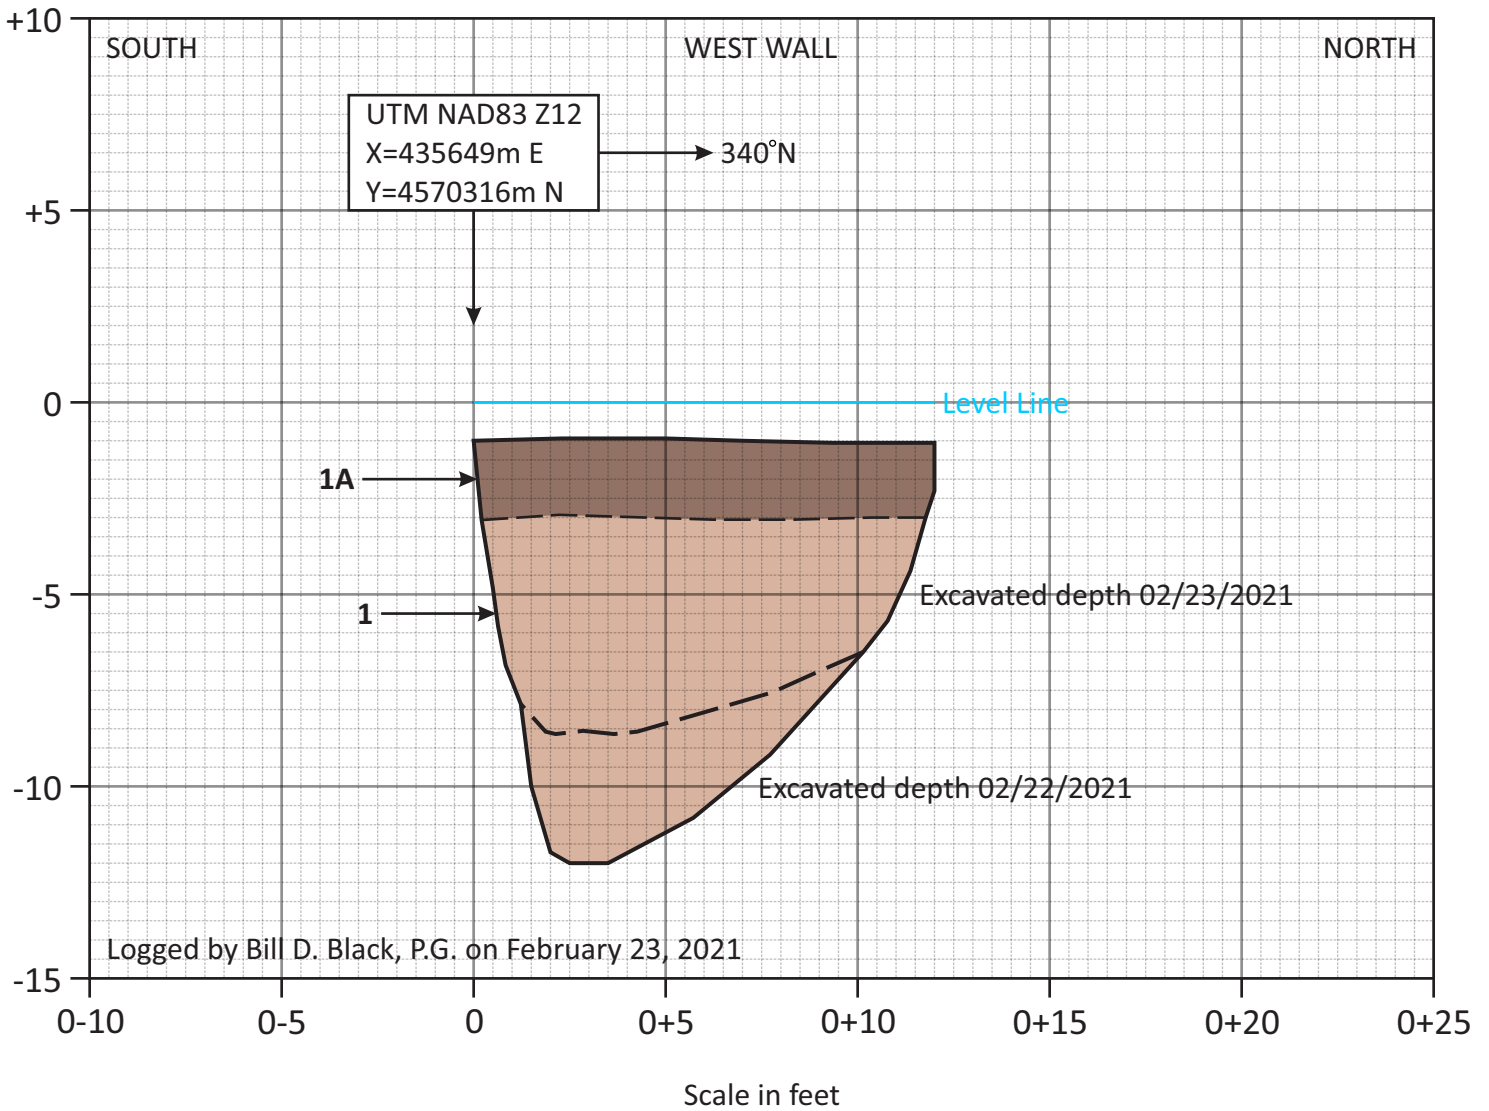
TEST PIT 1

Logged by Bill D. Black, P.G. on February 23, 2021

Scale 1 inch equals 5 feet (1:60) with no vertical exaggeration.

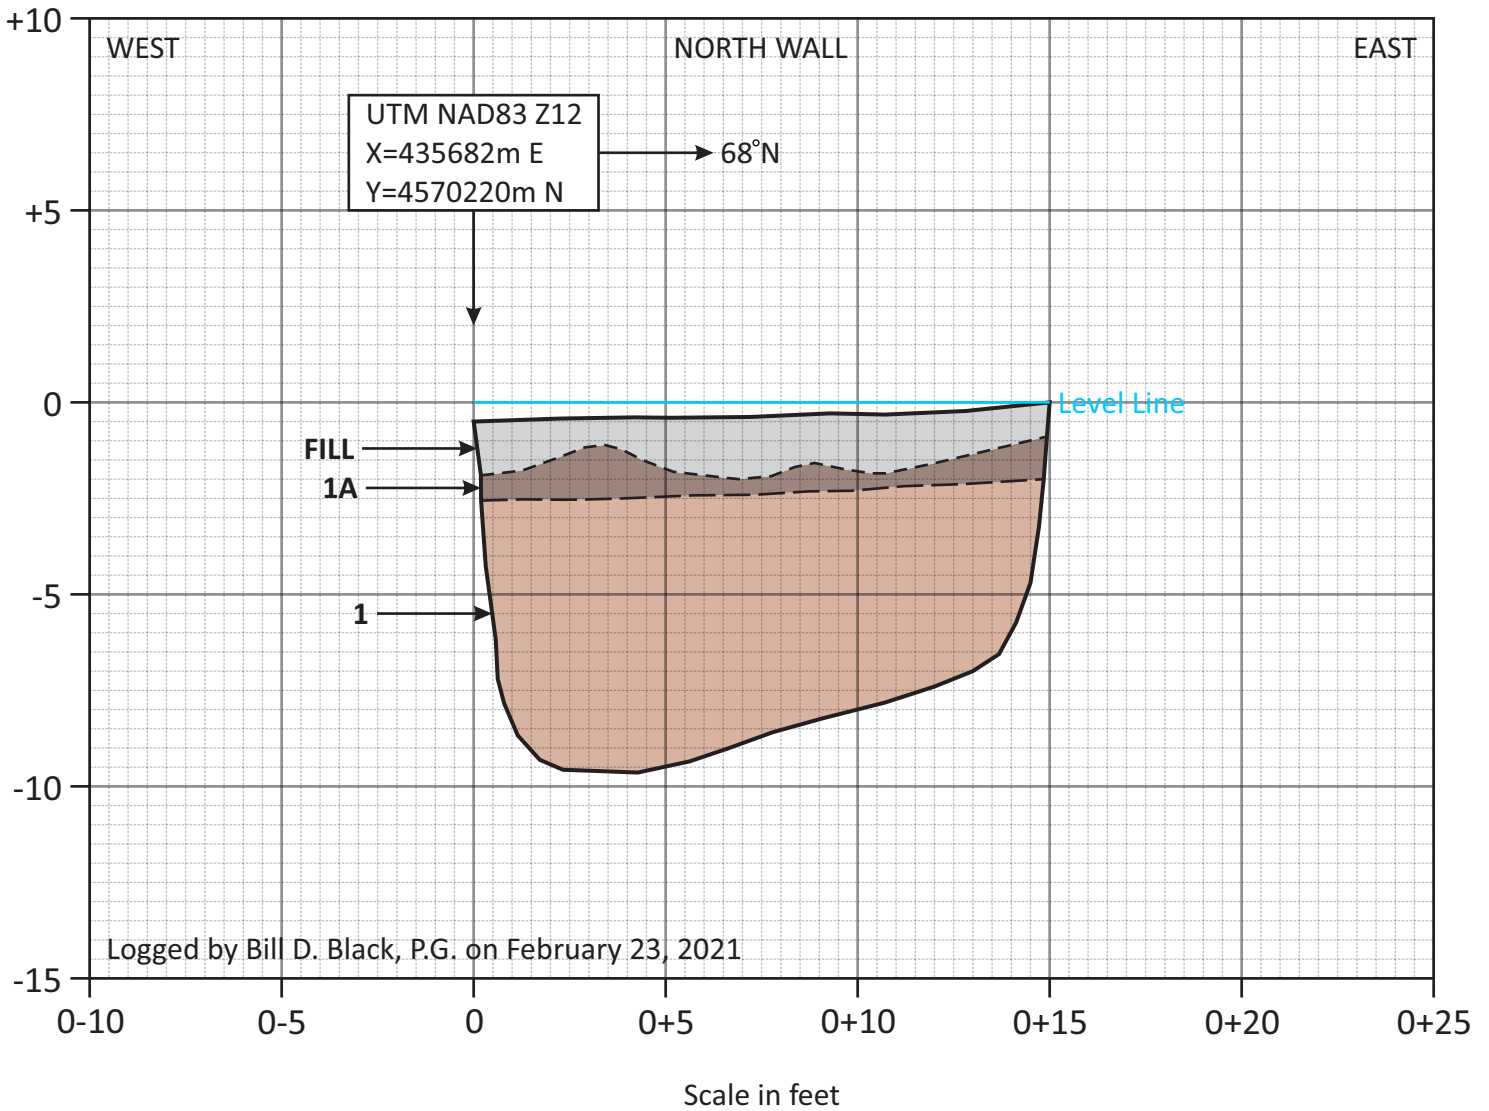
TEST PIT 2

Logged by Bill D. Black, P.G. on February 23, 2021

Scale 1 inch equals 5 feet (1:60) with no vertical exaggeration.

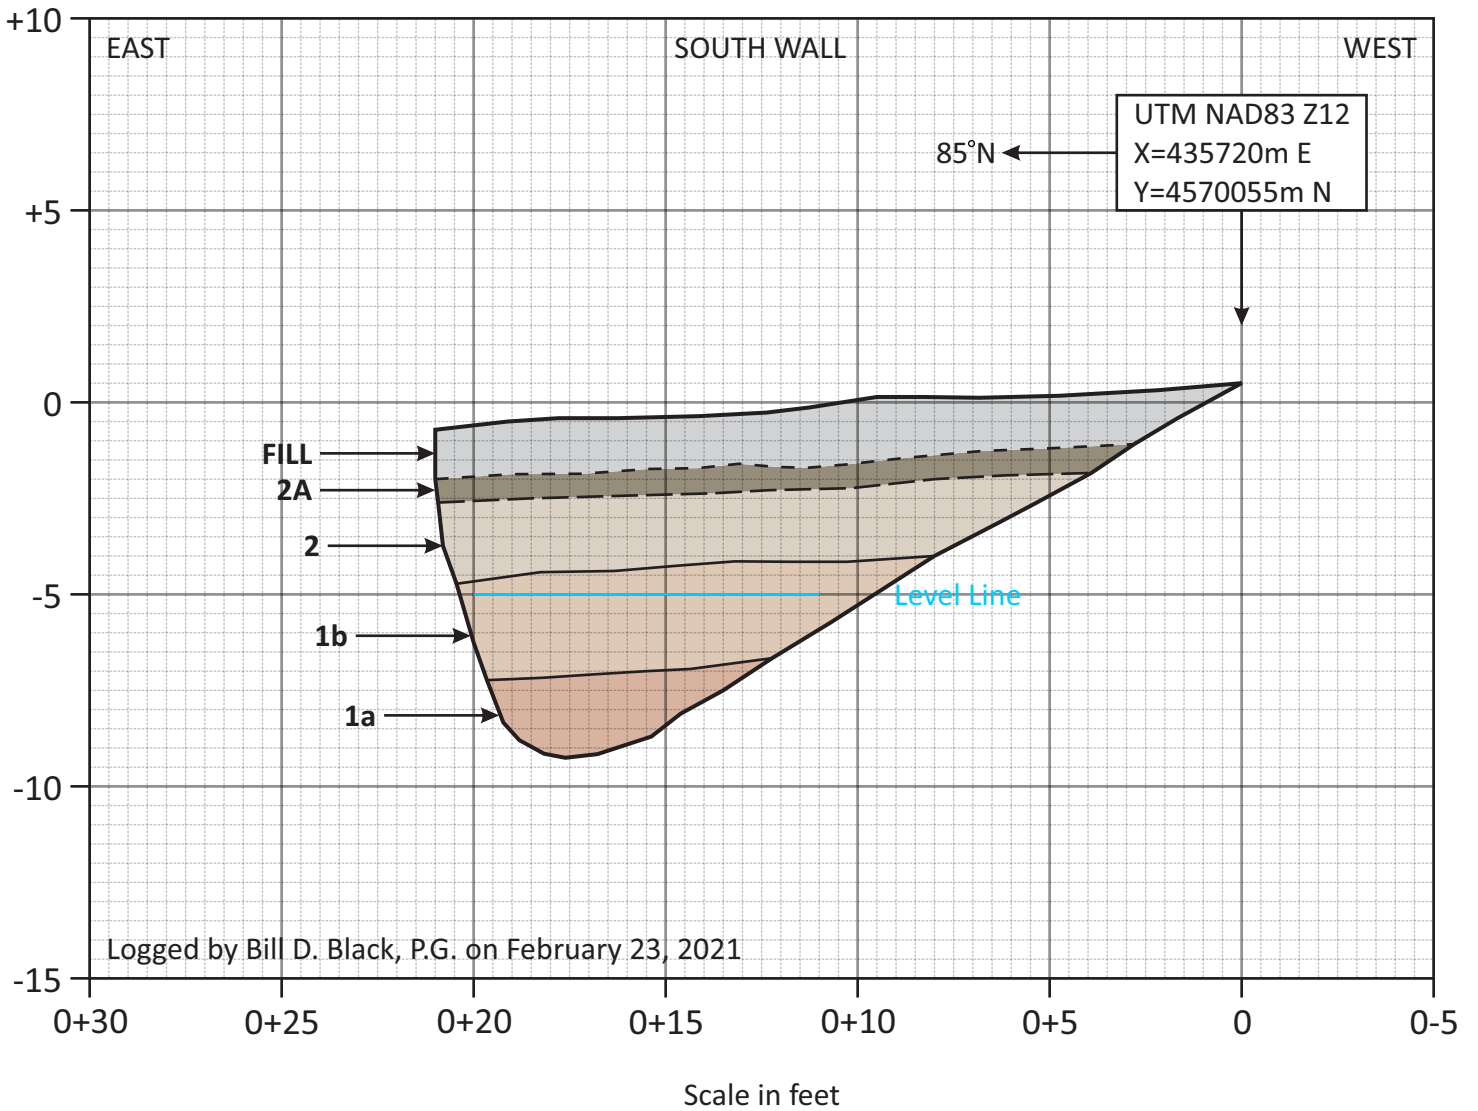
TEST PIT 3

Logged by Bill D. Black, P.G. on February 23, 2021

Scale 1 inch equals 5 feet (1:60) with no vertical exaggeration.

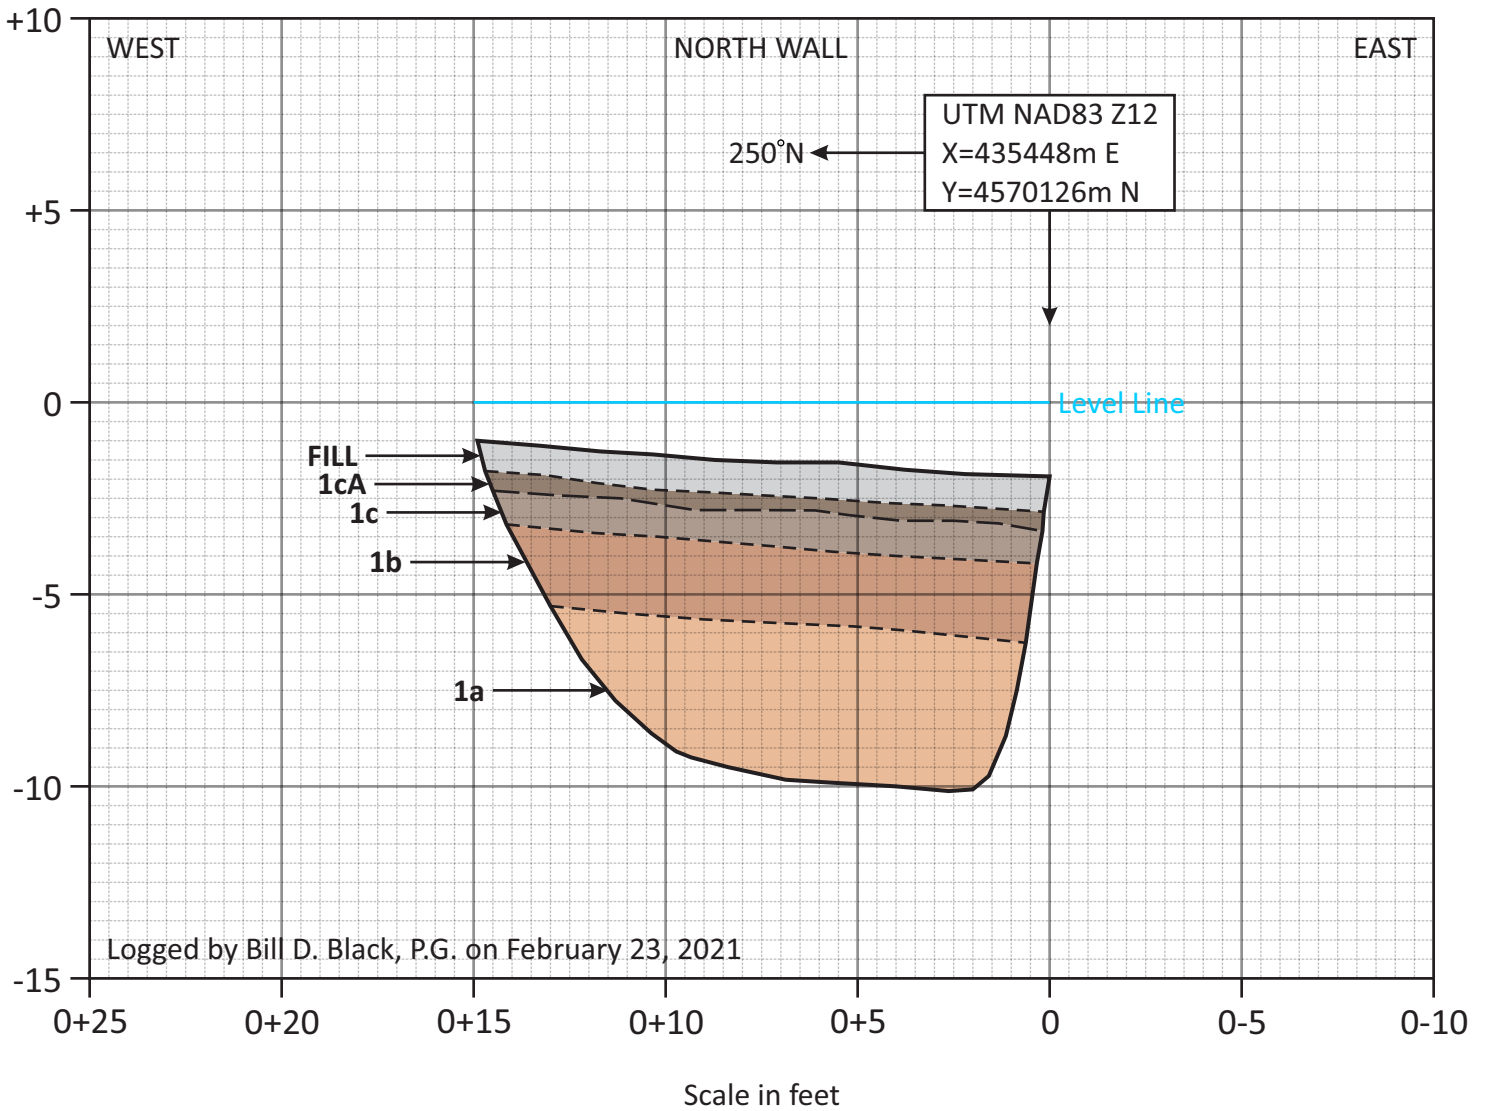
TEST PIT 4

Unit 1. *Post-Lake Bonneville alluvium* - sequence of pale-orange-brown, reddish-brown, and grayish-brown, poorly bedded, loose, sand to gravel comprised of a lower (1a) sandy gravel to gravelly sand (GW/SW) with round to subround cobbles and a topset carbonate-enriched layer; a middle (1b) sand (SW) with trace gravel; and an upper (1c) sandy gravel (GW) with trace subround cobbles; disturbed modern A-horizon soil formed in unit 1c (1cA), overlain by fill with barbed wire.
