**Geotechnical Investigation
Parkside PRUD Phases 3 & 4
Eden, Utah**

September 12, 2022

**Geotechnical Investigation
Parkside PRUD Phases 3 & 4
Approximately 4475 East Howe Drive
Eden, Utah
CG Project No.: 133-016**

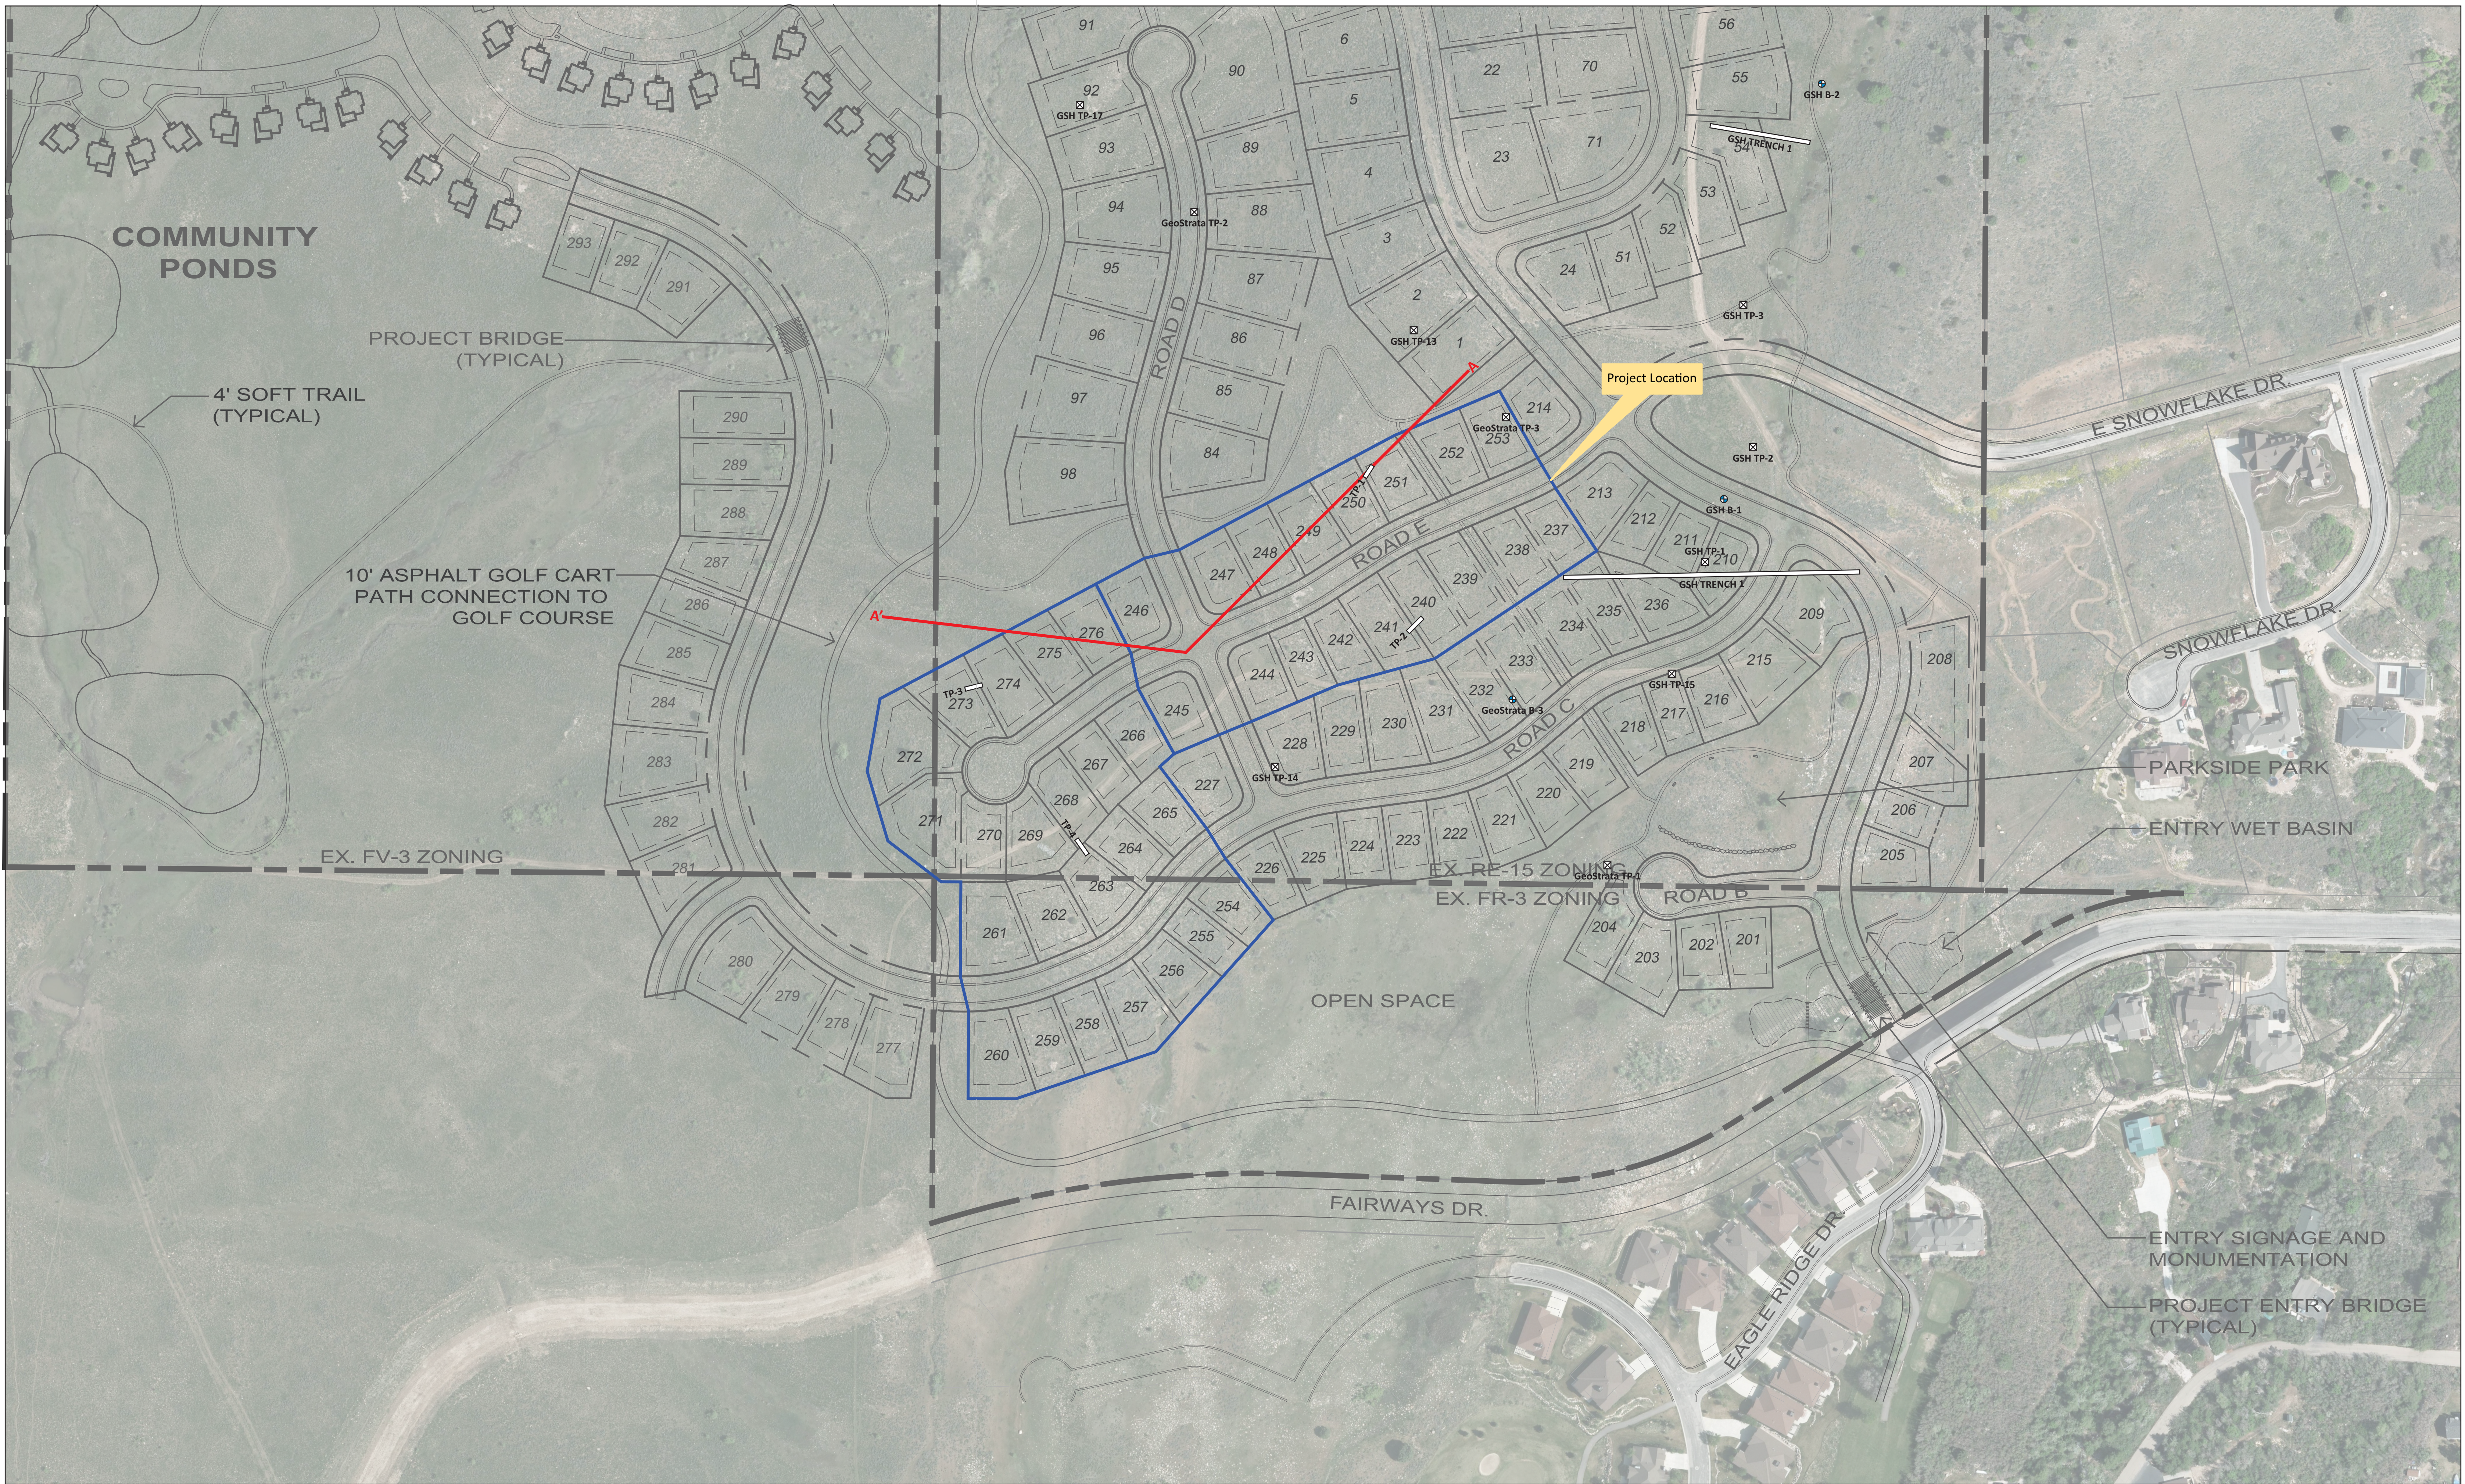
Base: Utah Geographic Resource Center high resolution orthophoto. Site plan modified from Langvardt Design Group overall site plan sheet P1.2 dated June 2019.

The subsurface conditions at the site were explored by excavating four test pits to depths of 7½ to 9 feet below the existing site grade. The approximate test pit locations are shown on the Exploration Location Map, Plate 2. The subsurface conditions as encountered in the test pits were recorded at the time of excavation and are presented on the attached Test Pit Logs, Plates 3 to 6. A key to the symbols and terms used on the Test Pit Logs may be found on Plate 7.

As recommended in the Geologic Hazards Evaluation by Western Geologic, a slope stability assessment was performed using the Slide computer program and the modified Bishop's method of slices. The location of the profile assessed is shown on Plate 2 and is based on the cross section presented in The Western Geologic report for the development. The strength of the bedrock used in our analyses was assumed to consist of a cohesion of 10,000 psf. The alluvial fan deposits were assumed to have a strength consisting of an angle of internal friction of 33 degrees and a cohesion of 50 psf.

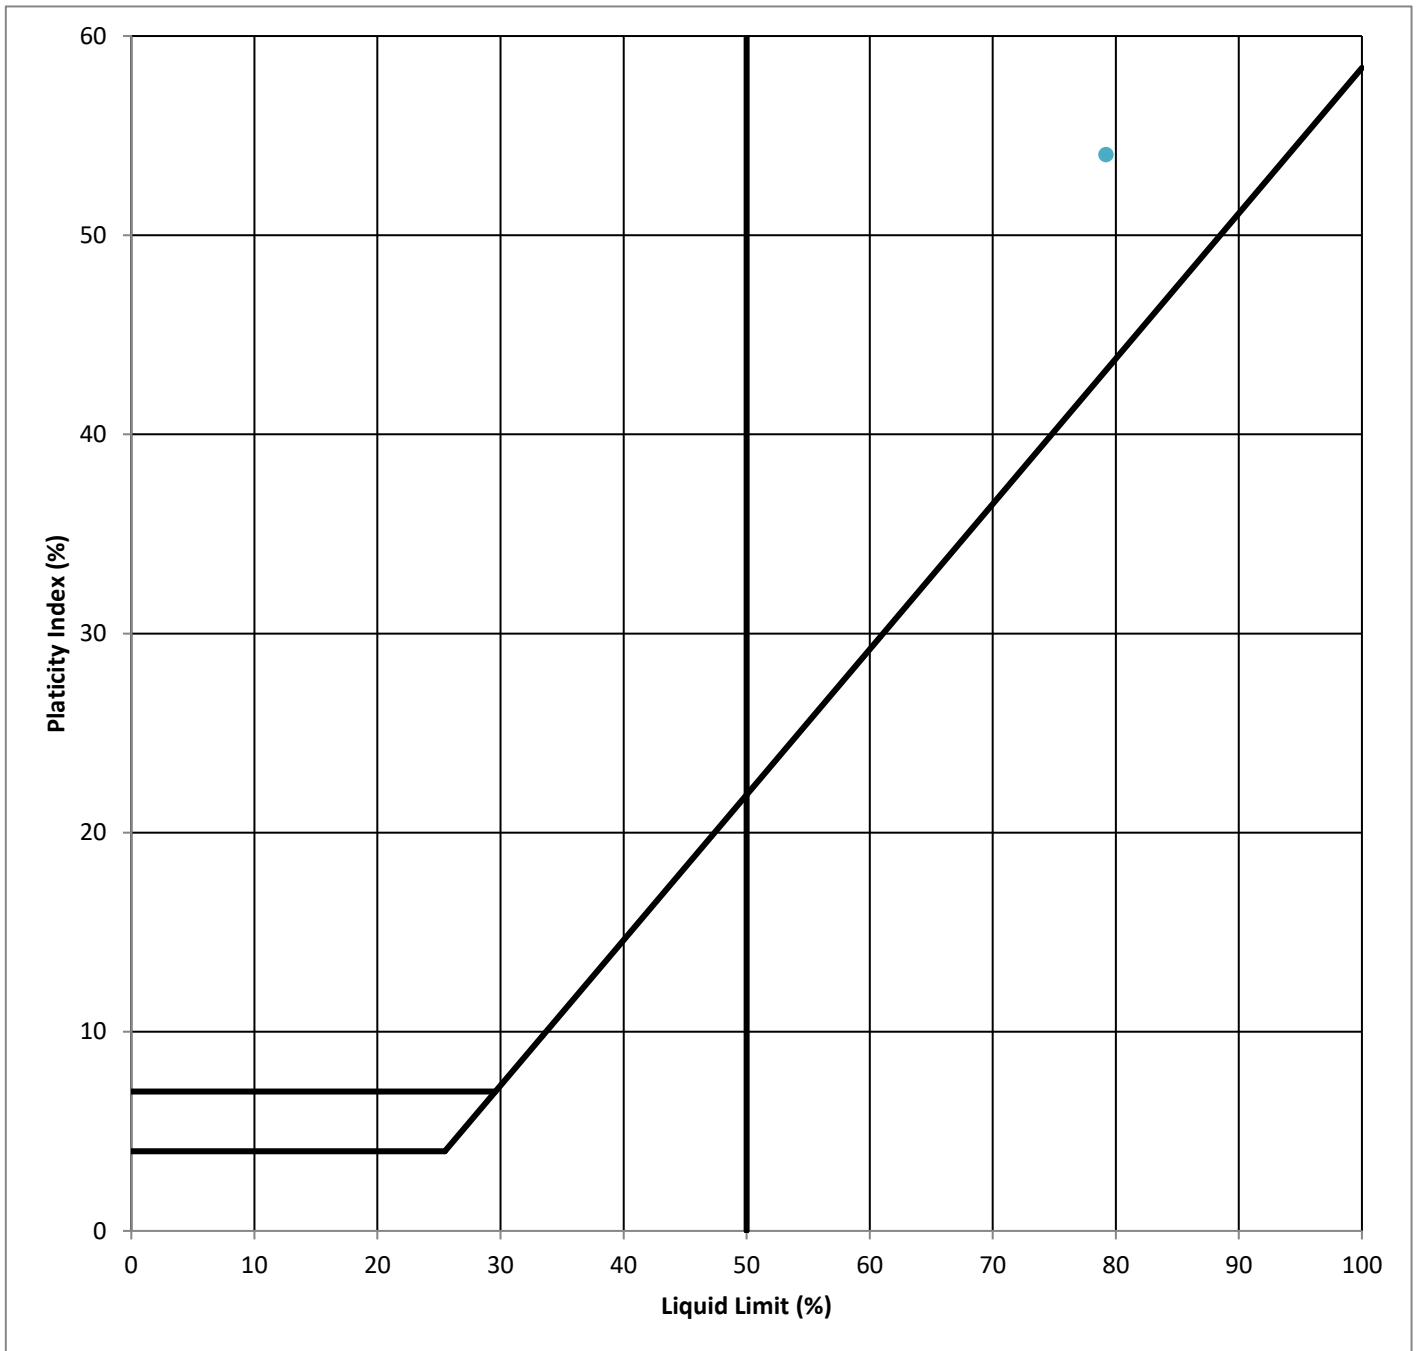
<p>Lewis Homes Parkside PRUD Phases 3 & 4 Eden, Utah Project No.: 133-016</p>	<p>Plate 8</p>
---	---	---------------------------

Atterberg Limits

Location	Depth (ft)		Classification	Liquid Limit	PI
TP-3	3	●	Fat CLAY with sand	79	54

TEST HOLE NO.	DEPTH (ft.)	NATURAL DRY DENSITY (pcf)	NATURAL MOISTURE (%)	ATTERBERG LIMITS		GRAIN SIZE DISTRIBUTION (%)			SOIL TYPE
				LIQUID LIMIT	PLASTICITY INDEX	GRAVEL (+ #4)	SAND	SILT/CLAY (- #200)	
TP-1	8		8.9			61.5	16.0	22.6	GC
TP-2	8		12.5			39.4	10.7	49.9	GC
TP-3	3	92.0	25.2	79	54			74.1	CH
TP-4	6		7.1			61.7	17.2	21.1	GC

The results of our laboratory tests are also presented on the Test Pit Logs, Plates 3 through 6, and more detailed laboratory results are presented on the laboratory testing plates, Plates 8 through 10.

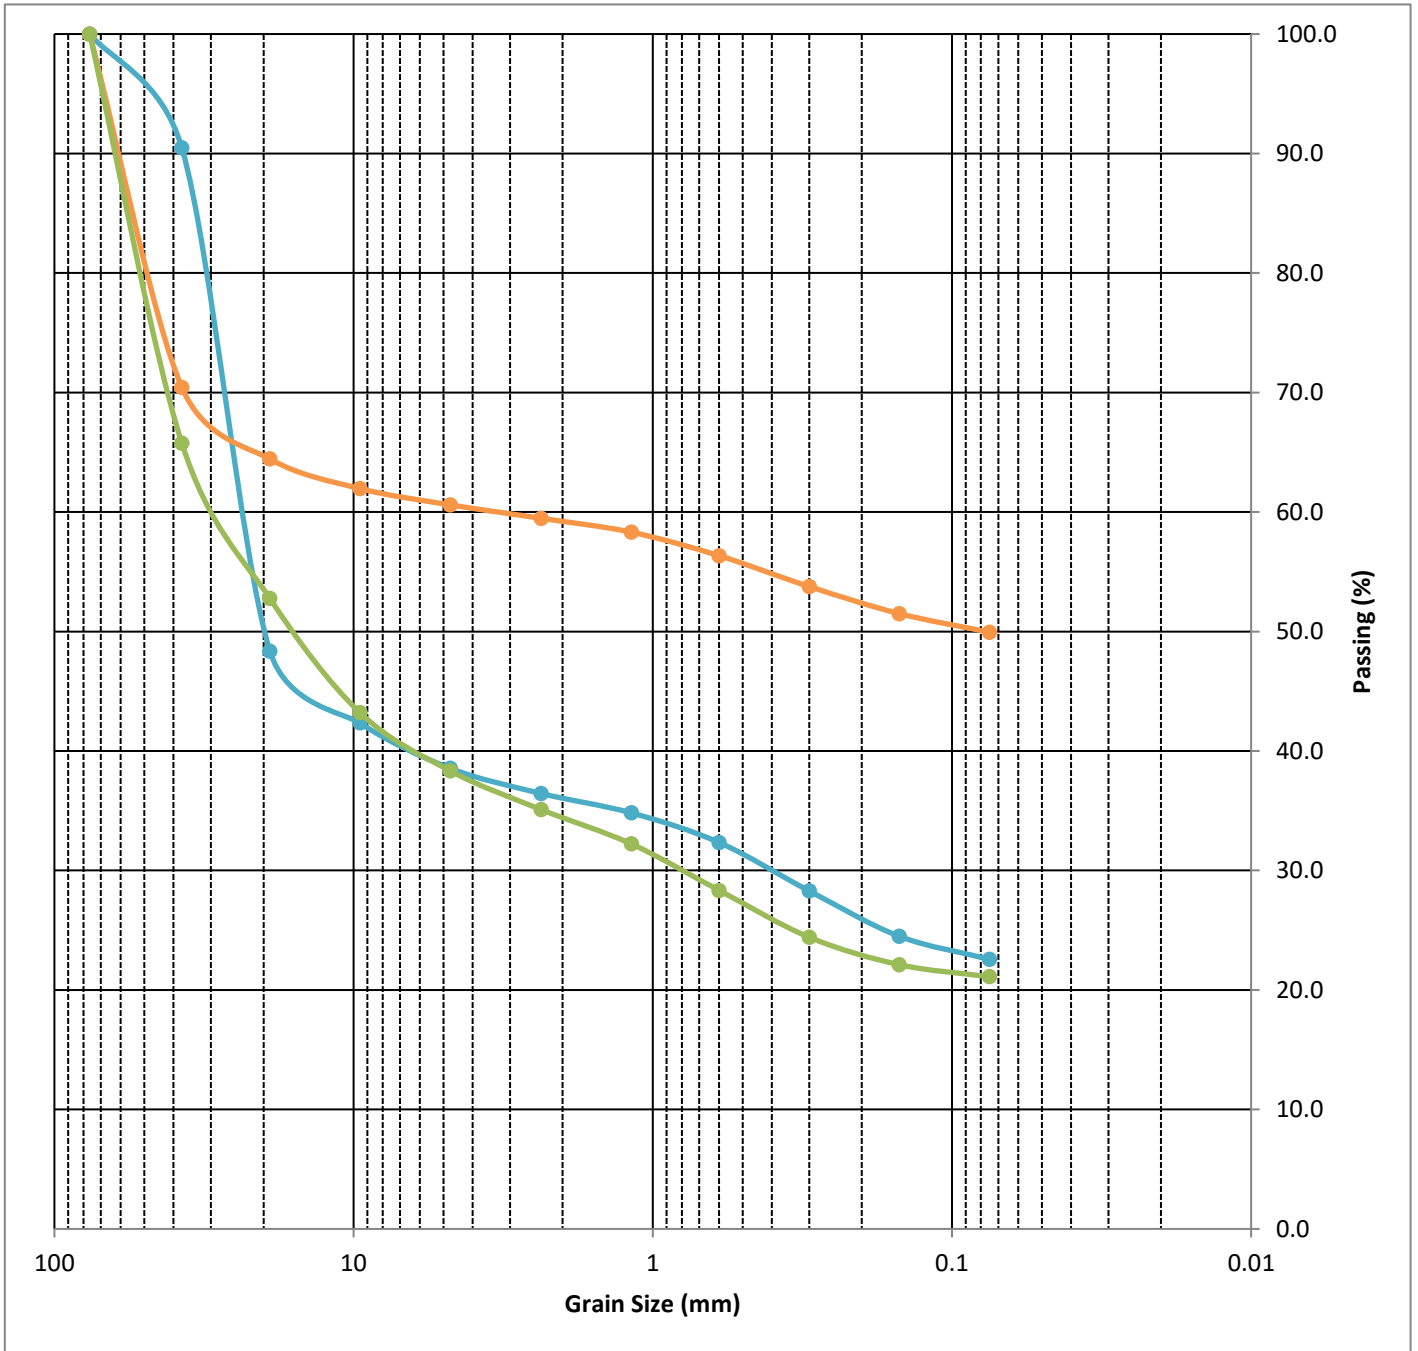
<p>Lewis Homes Parkside PRUD Phases 3 & 4 Eden, Utah Project No.: 133-016</p>	<p>Plate</p> <p style="font-size: 2em;">9</p>
---	--	---

Grain Size Distribution

Location	Depth		Classification	% Gravel	% Sand	% Silt and Clay
TP-1	8	●	Clayey GRAVEL with sand	61.5	16.0	22.6
TP-2	8	●	Clayey GRAVEL	39.4	10.7	49.9
TP-4	6	●	Clayey GRAVEL with sand	61.7	17.2	21.1

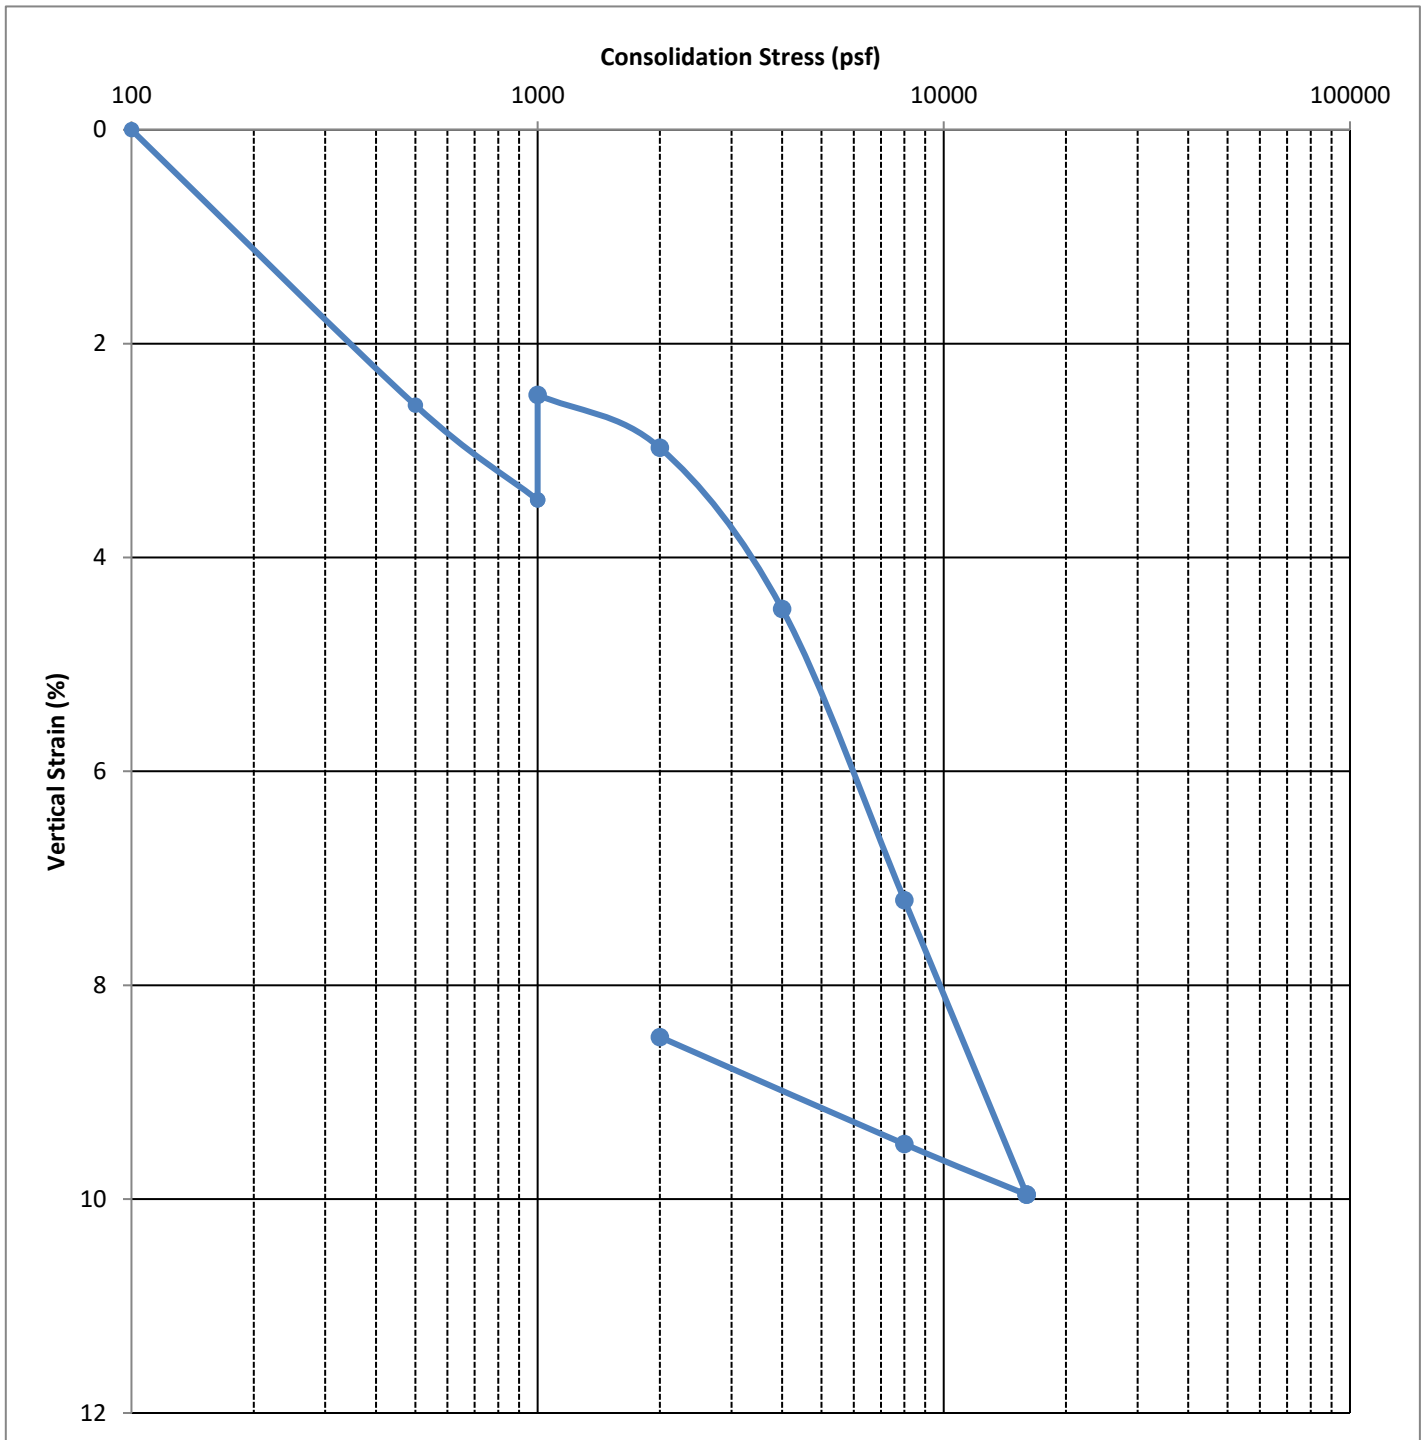
Lewis Homes Parkside PRUD Phases 3 & 4 Eden, Utah Project No.: 133-016	Plate 10
---	---	--------------------

1-D Consolidation

Location	Depth (ft)	Dry Density (pcf)	Moisture Content (%)	σ_o (psf)	σ_p (psf)	C_c	C_r	OCR
TP-3	3	92.0	25.2	300	2,600	0.091	0.016	8.7

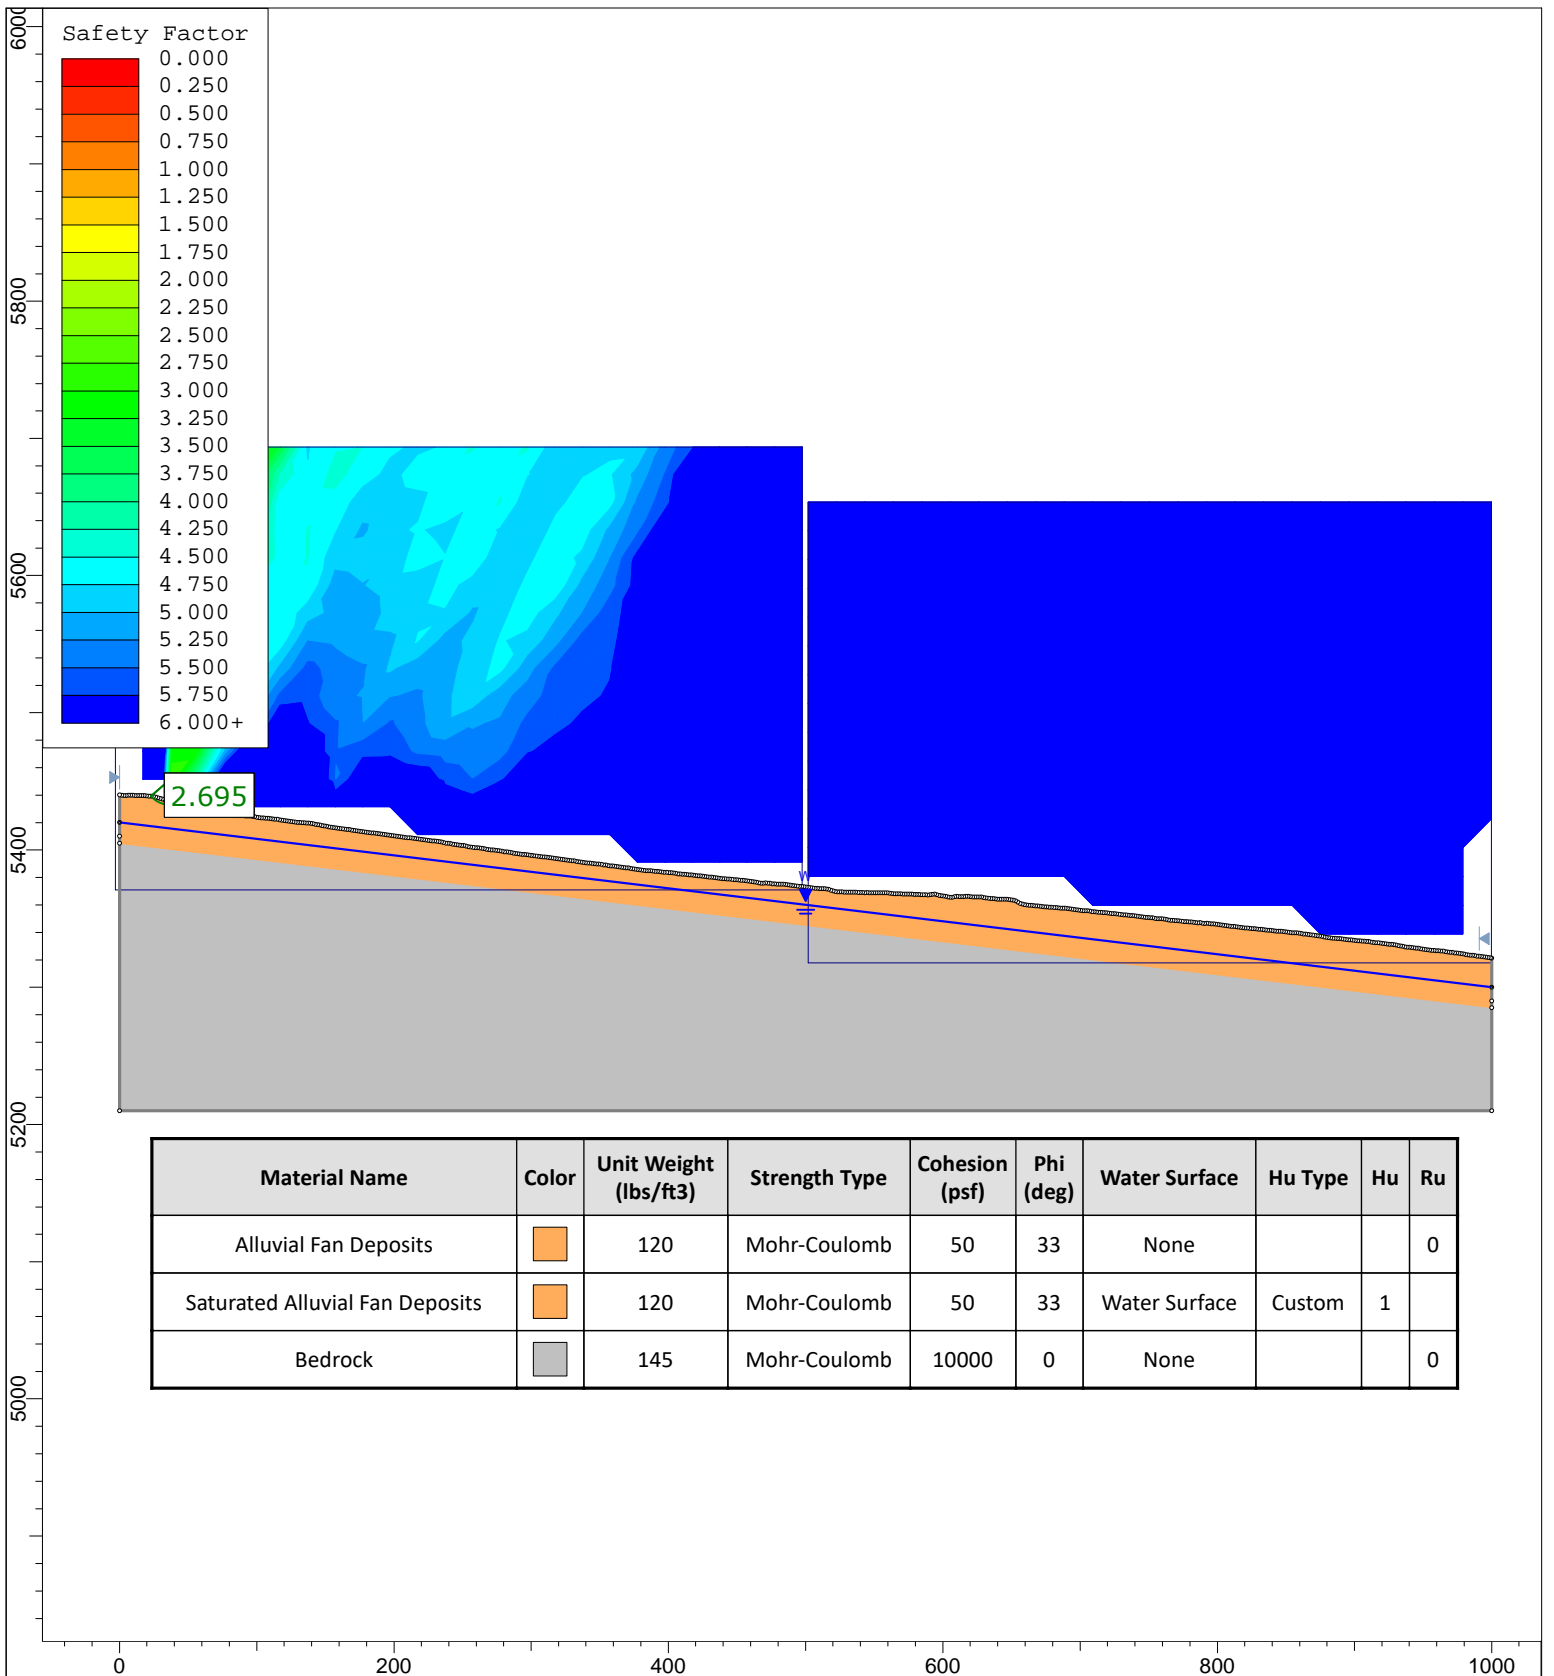
Plate
11

Global Stability - Static

The profile was assessed under static and pseudo static conditions. The pseudo static condition is used to assess the slope during a seismic event. As indicated in Section 4.1, the peak ground acceleration at this site is estimated to be 0.501g. As is common practice, half of this value was used in our pseudo static assessments. Minimum factors of safety of 1.5 and 1.0 for static and seismic conditions, respectively, were considered acceptable. Our analyses indicate that the profile has safety factors greater than 1.5 and 1.0 for the static and pseudo static conditions and is therefore considered suitable for residential construction.

increase the risk of slope failures. If cuts or fills over 15 feet are planned, additional slope stability assessments may be necessary and Christensen Geotechnical should be contacted to provide the additional assessments. The results of our slope stability assessments may be found on Plates 11 through 12.

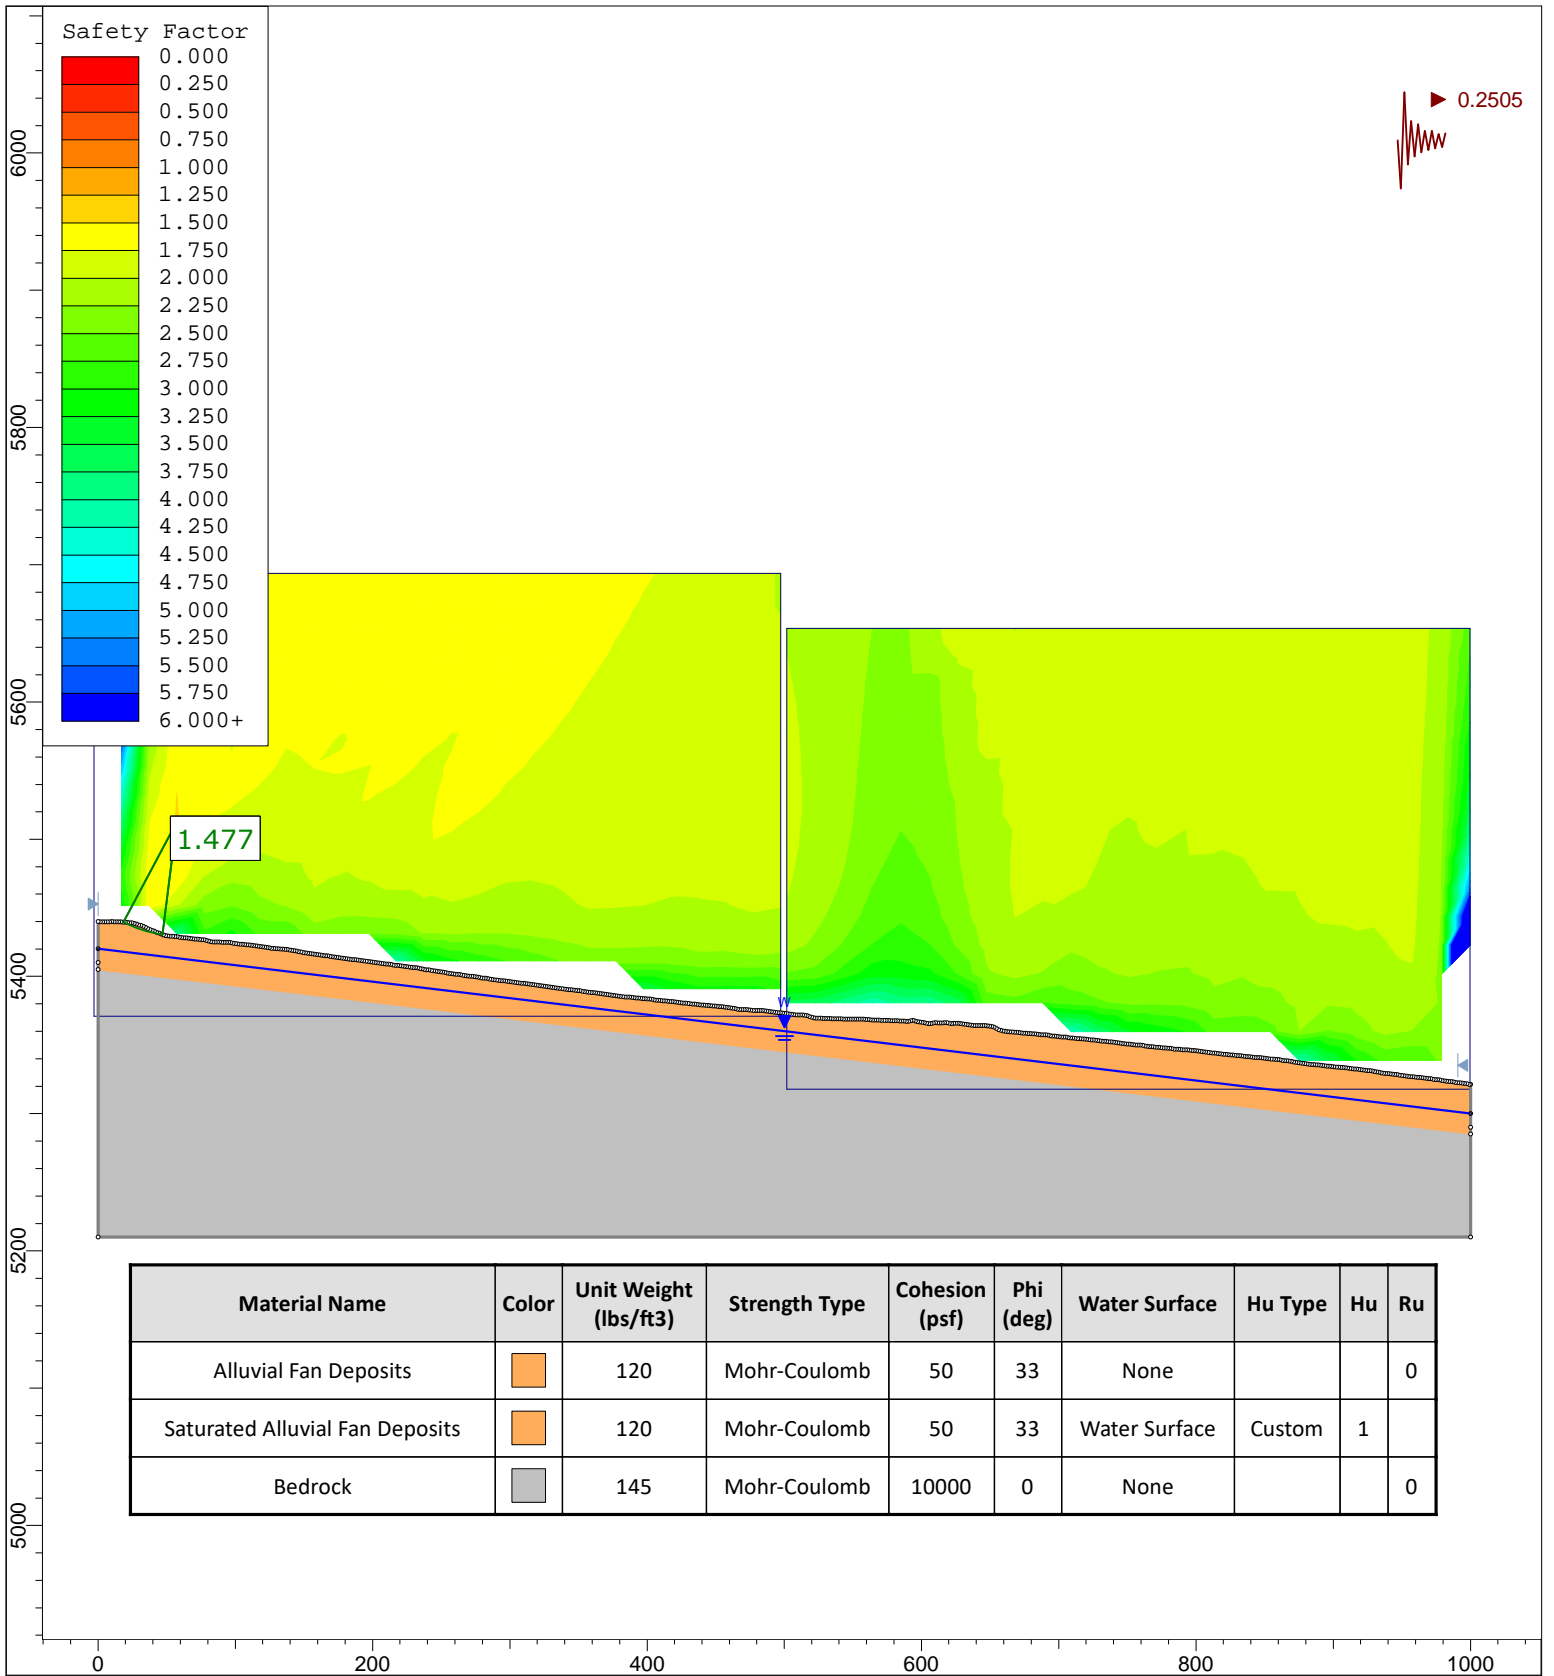
Plate
12

Global Stability - Pseudo Static
