Staff Report for Administrative Subdivision Approval

Application Request: Consideration and action for the final plat approval of Cedar Cove Estates Amendment 4 Subdivision including the concurrent consideration and action of the Cedar Cove Estates Amendment 4 Hillside Review and access via a private right of way requests for Lot 34.

SURFACE FAULT RUPTURE HAZARD EVALUATION

SUBJECT: Surface Fault Rupture Hazard Evaluation
Cedar Cove Subdivision Lot 28-A
6696 South 2850 East
Weber County, Utah

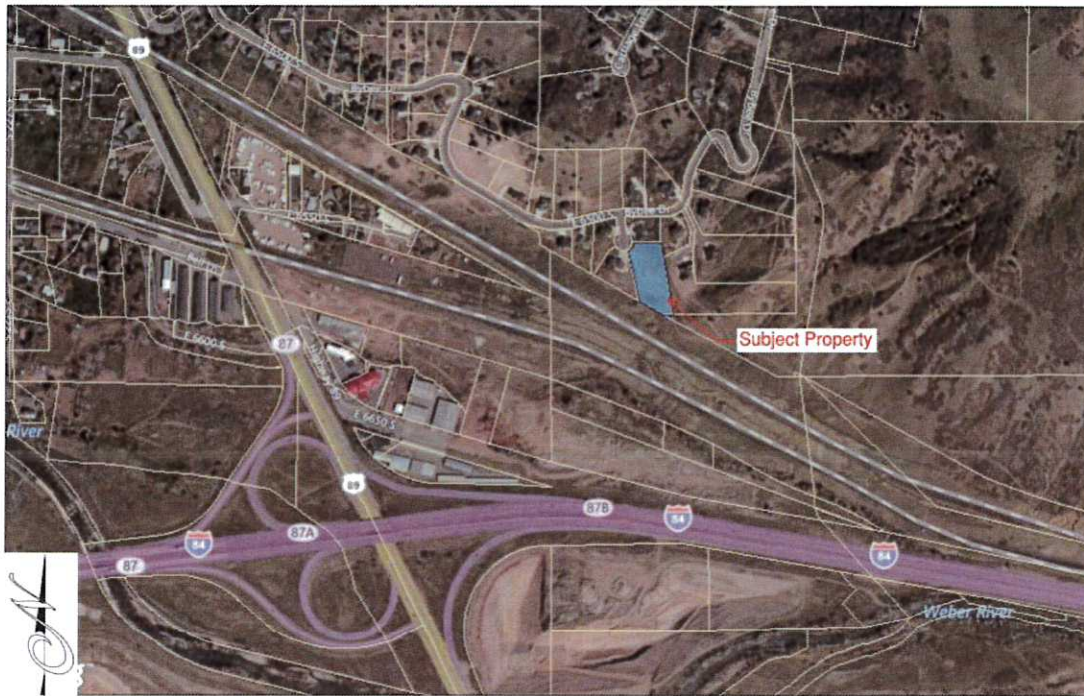
Map 1

Cedar Cove Estates Amendment 4

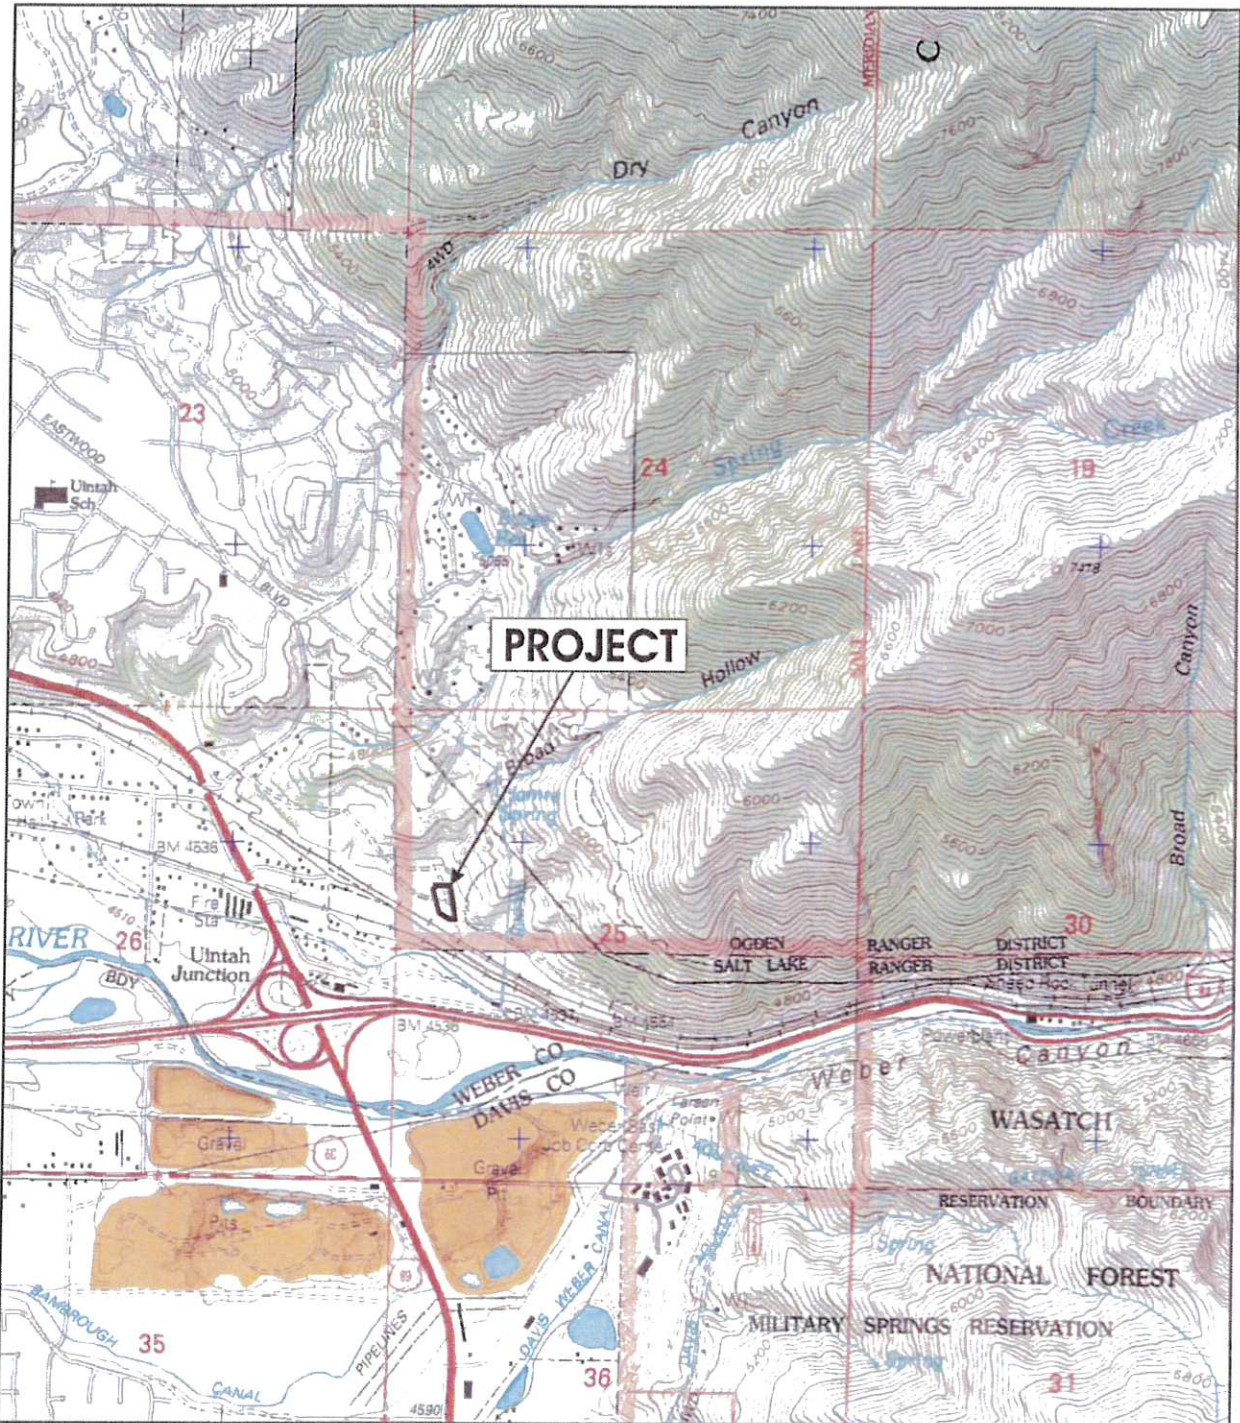
FIGURE 1

Source: U.S. Geological Survey Topographic Quadrangle, Ogden, UT, 1998.

This report presents results of a surface fault rupture hazard evaluation conducted by Western GeoLogic, LLC (Western GeoLogic) for Cedar Cove Subdivision Lot 28-A at 6696 South 2850 East in unincorporated Weber County, Utah (Figure 1 – Project Location). The site is on generally southwest-facing slopes overlooking the Weber River about 0.4 miles southwest of Broad Hollow at the western base of the Wasatch Range, and is in the NW¼ Section 25, Township 5 North, Range 1 West (Salt Lake Base Line and Meridian). Elevation of the site ranges between about 4,635 and 4,670 feet above sea level. It is our understanding that the existing parcel is planned for subdivision and future development of two single-family residences.

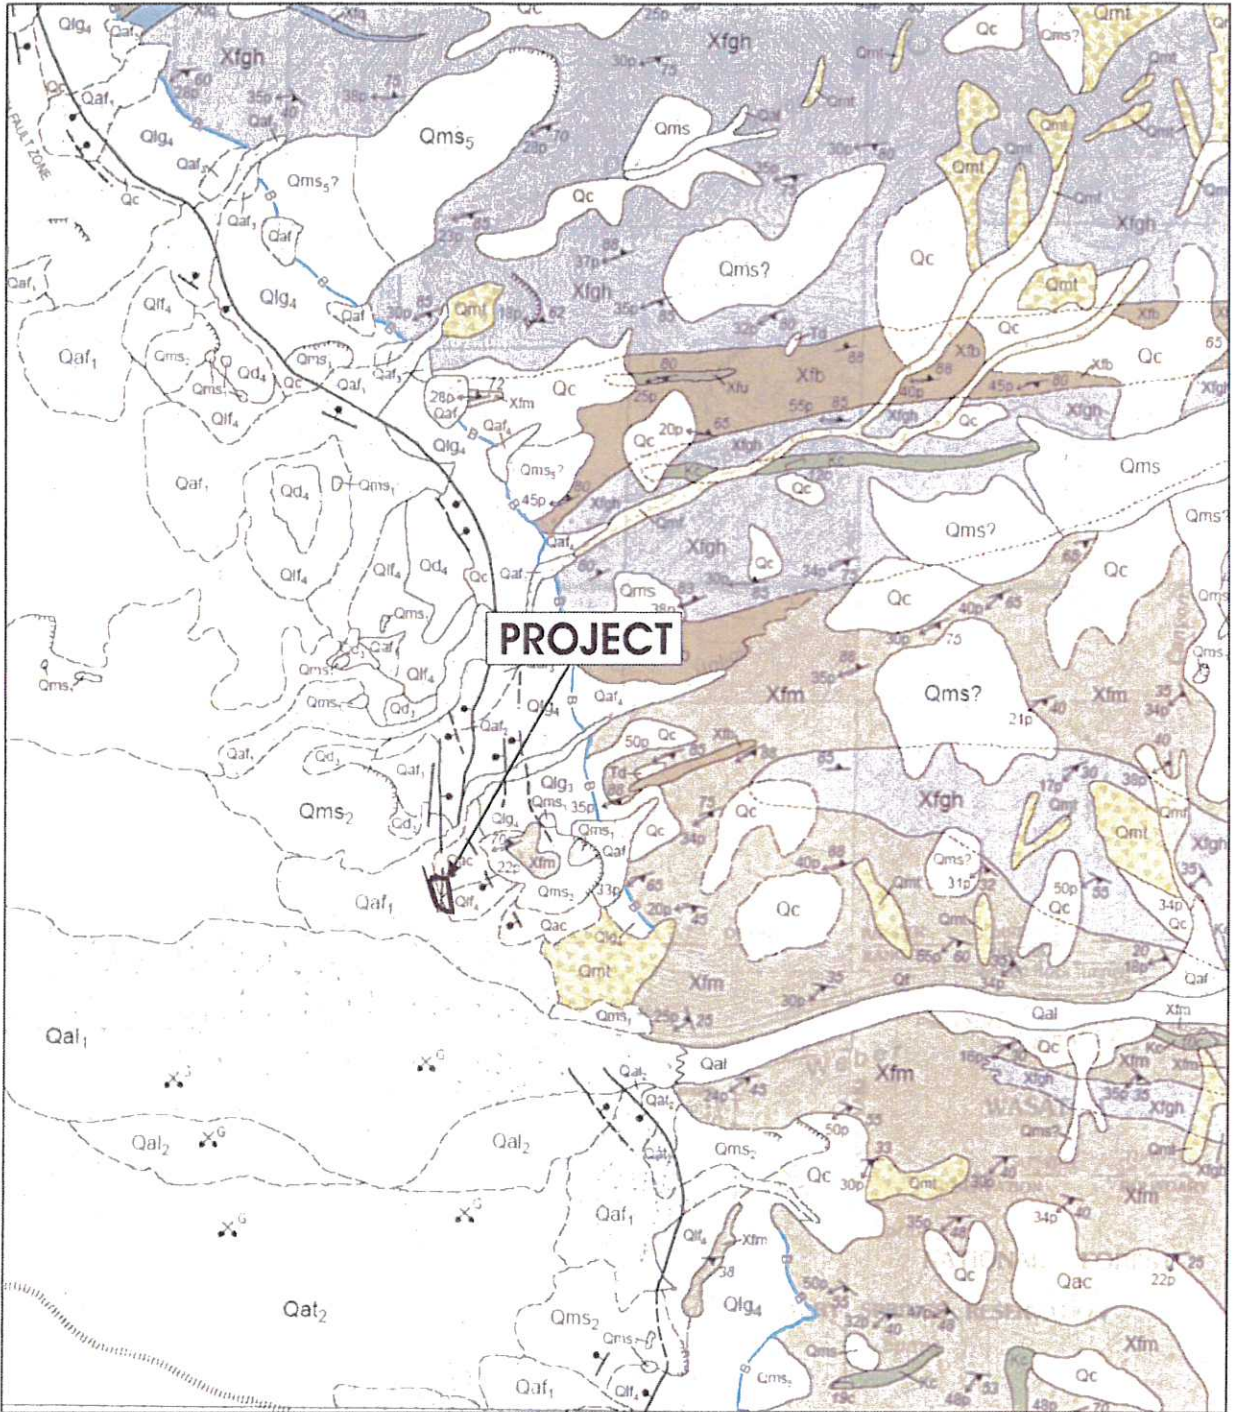
FIGURE 2

Source: Yankee and Lowe (2004); see text for descriptions of nearby surficial geologic units.

A main, west-dipping trace, and an east-dipping, antithetic trace of the Weber segment of the WFZ are shown crossing the eastern and western parts of the site on Weber County hazard maps. Yonkee and Lowe (2004; Figure 2) similarly show two faults crossing the site, although they incorrectly label the eastern trace as dipping to the east rather than to the

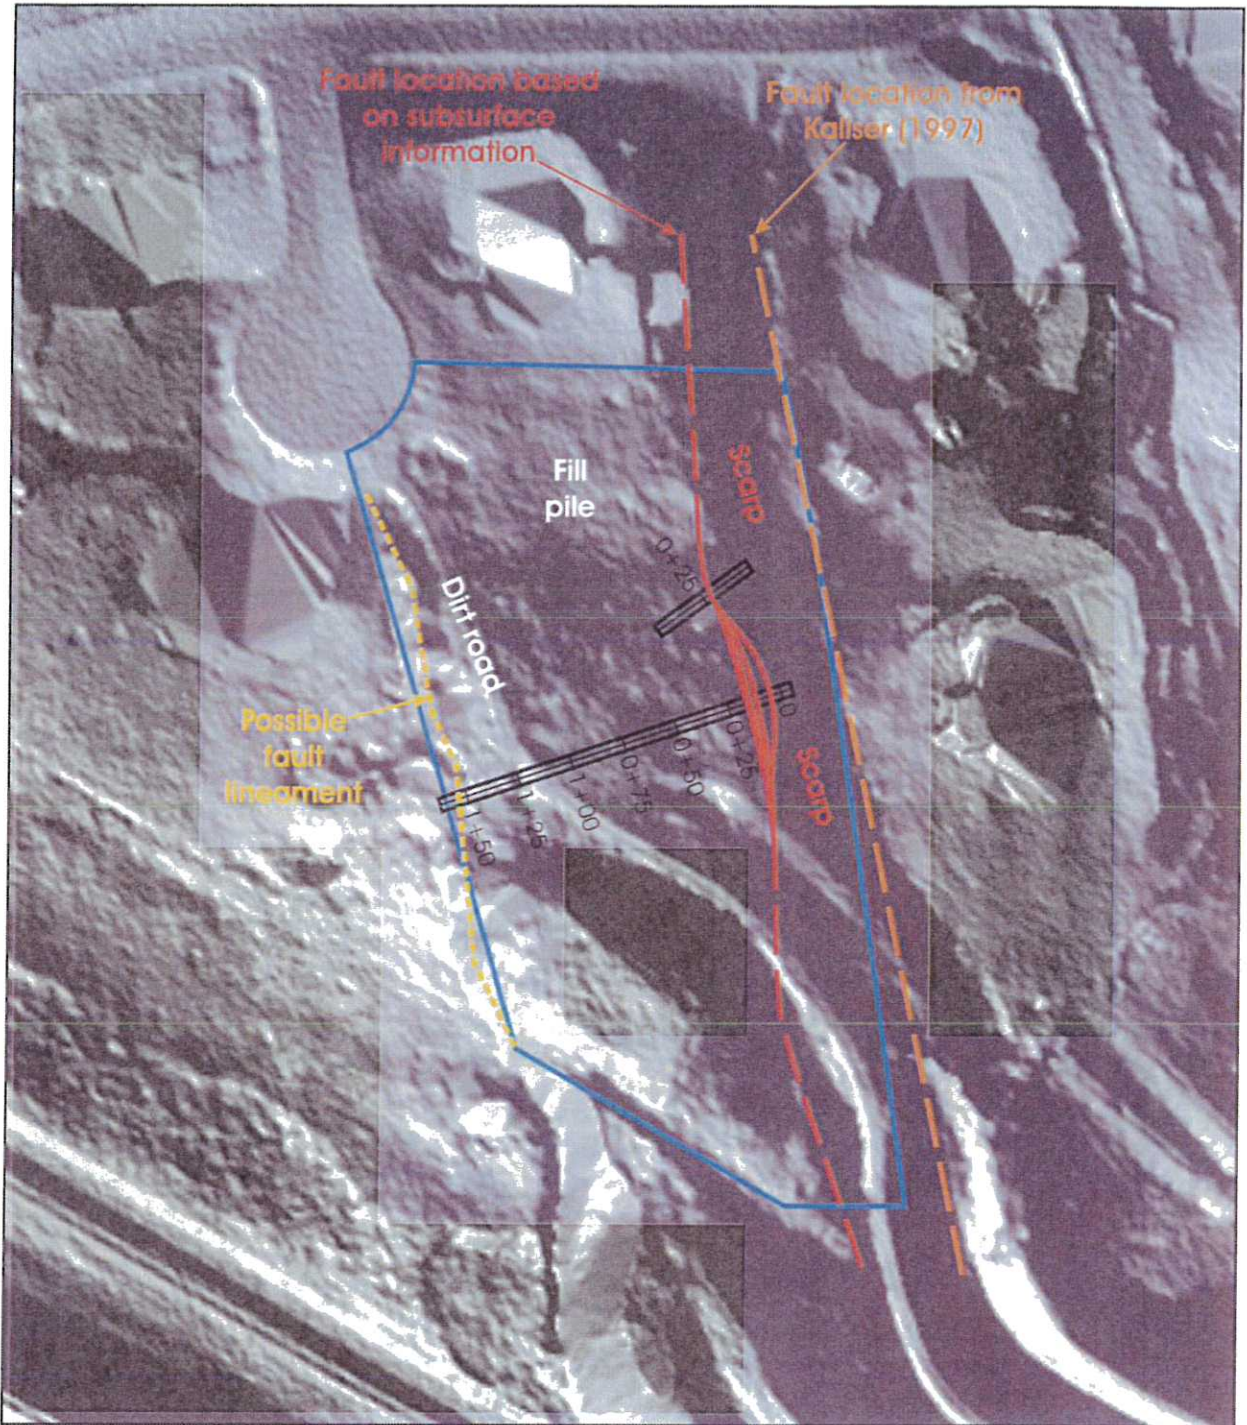
FIGURE 3A

Base from 2014 Utah AGRC 0.5-meter LIDAR Bare Earth DEM.

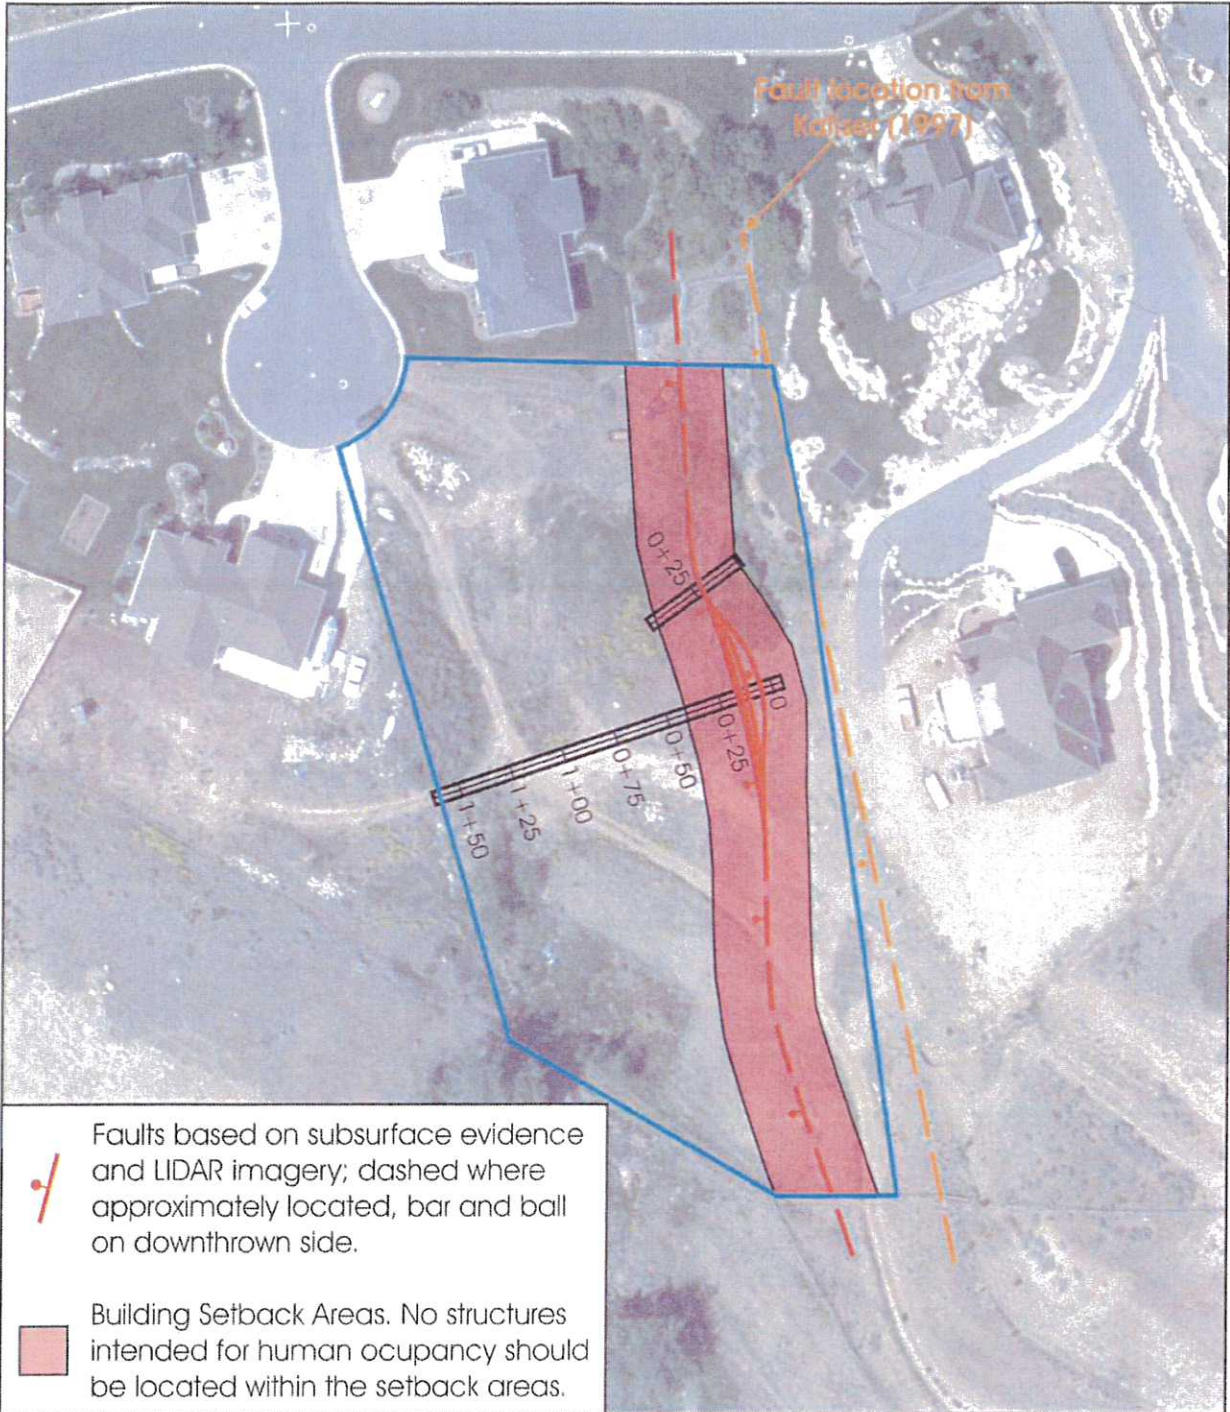
FIGURE 3B

Base from 2012 Utah AGRC High-Resolution Orthophoto

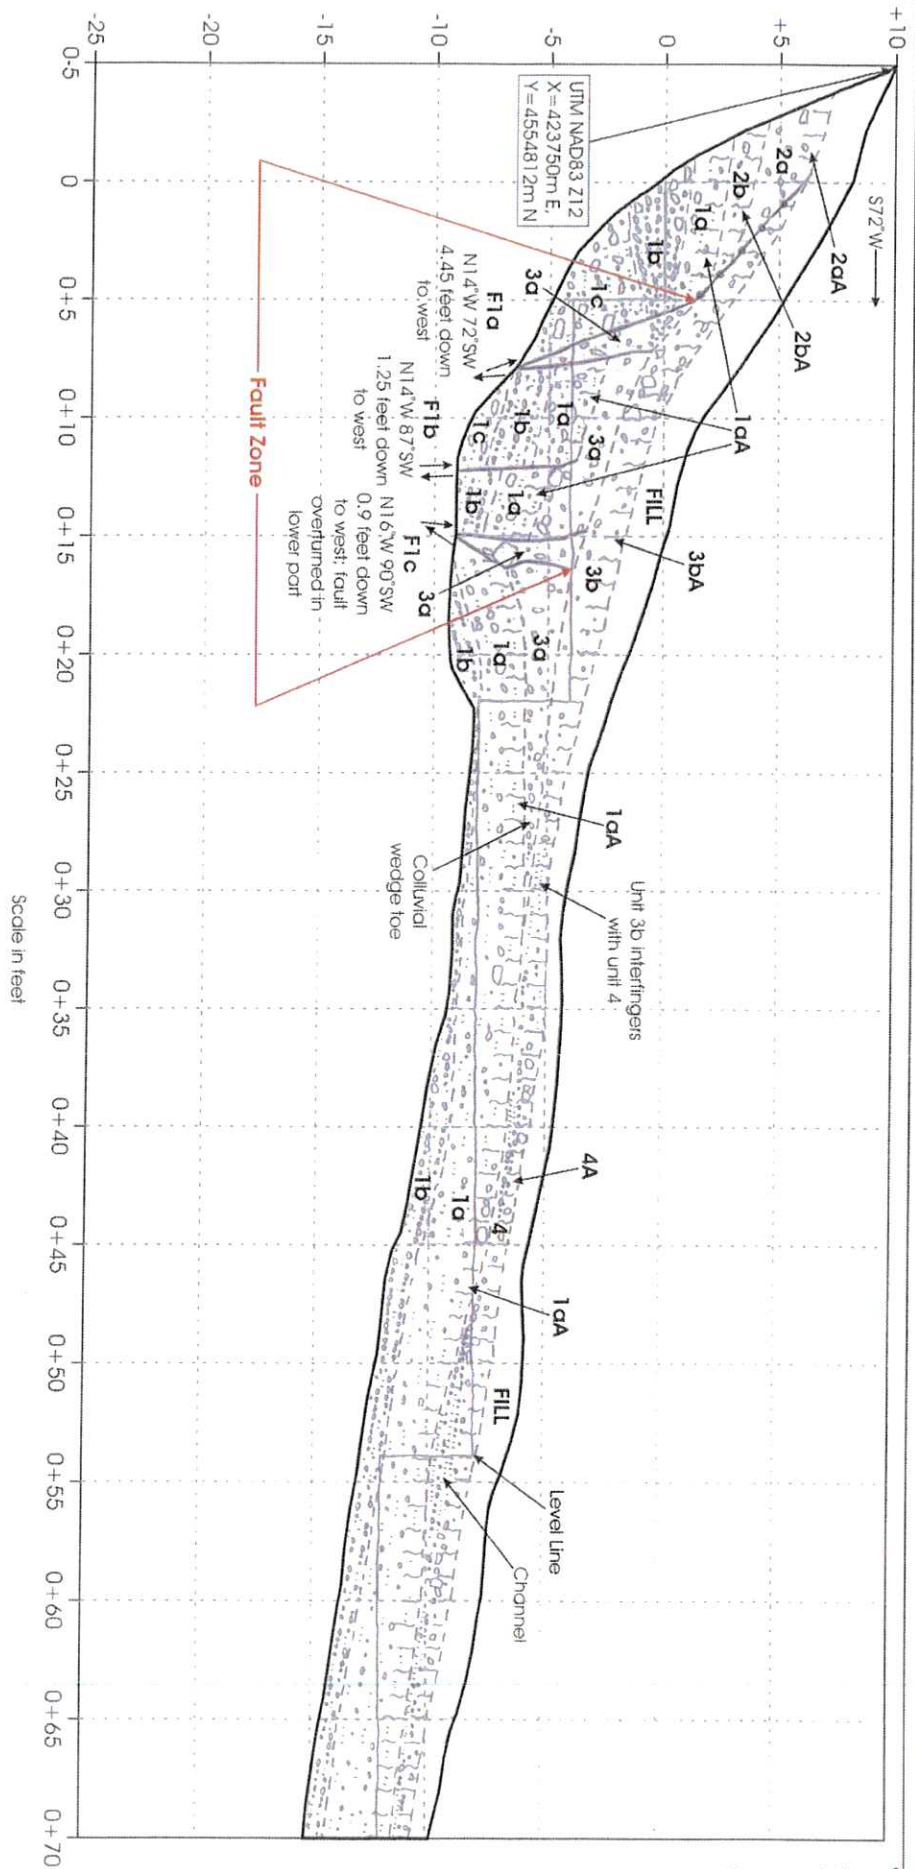
TRENCH 1 LOG, SHEET 1
SURFACE FAULT RUPTURE
HAZARD EVALUATION
 Cedar Cove Subdivision Lot 28-A
 6696 South 2850 East
 Weber County, Utah
FIGURE 4A

Both trenches at the site exposed a sequence of poorly bedded, sandy to gravelly Pleistocene Lake Bonneville sediments (unit 1), overlain by what appeared to be a sequence of distal debris flood deposits (unit 2) that likely draped over the fault scarp and died out to the west. In Trench 1, this sequence is displaced 6.6 feet down to the west across a zone of three faults (F1a-F1c, Figure 4A) and buried by fault-zone colluvium and crack infill (unit 3). The upper part of unit 3 in Trench 1 (unit 3b), which appeared to be a slope-wash facies from fault scarp degradation, interfingers with younger Holocene alluvium (unit 4) to the west, which overlies the lacustrine sequence. The Holocene alluvium exposed in Trench 1 (unit 4) was observed to contain several gravel and sand channels suggestive of stream deposition (Figure 4B). No evidence for a second fault trace at the location of the lineament on Figure 3A was observed in Trench 1. Given the above, we believe this feature is likely from stream cutting and not faulting. We believe the multiple faults in Trench 1 are from an eastward stepover toward the confluence of two drainages on Kaliser's (1997) Figure 2. Such a confluence would be an area of weakness from stream downcutting and cause shearing to embay upslope into the weakened area.

SCALE: 1 inch = 5 feet
 (no vertical exaggeration)
 South Wall Logged, East to West
 Trench logged by Bill D Block, PG,
 on March 10-11, 2016
 Reviewed by Craig V Nelson, PG.

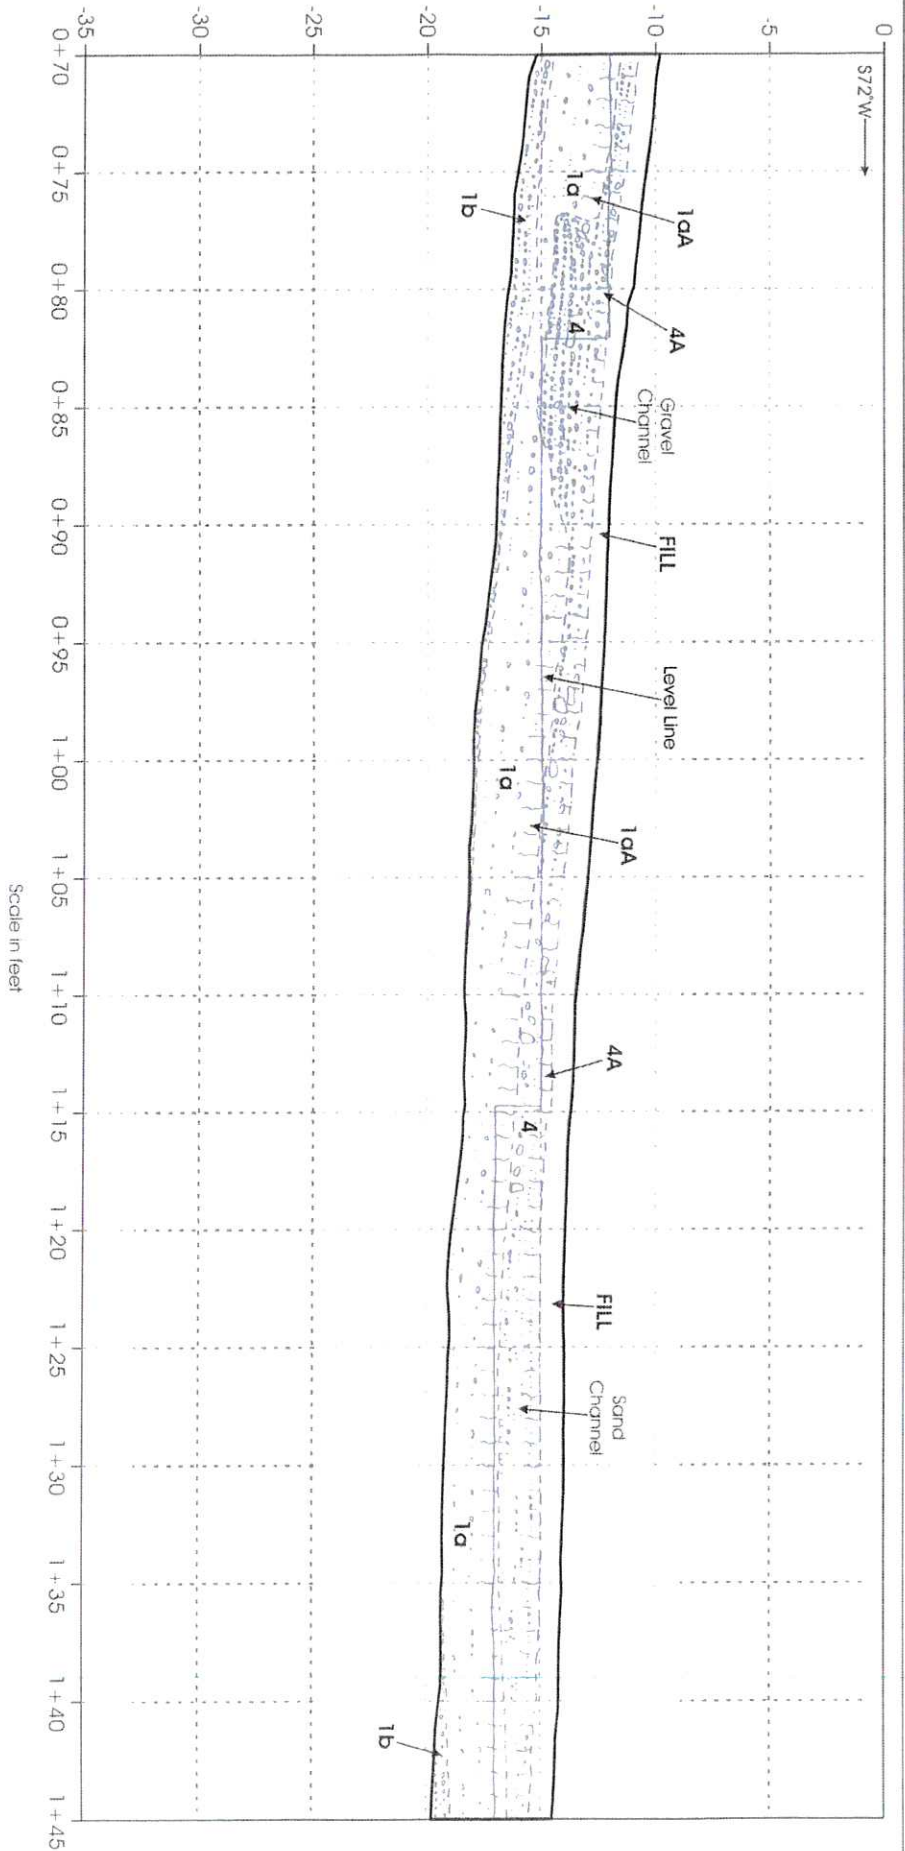
TRENCH 1 LOG, SHEET 2
SURFACE FAULT RUPTURE
HAZARD EVALUATION
 Cedar Cove Subdivision Lot 28-A
 6696 South 2850 East
 Weber County, Utah
FIGURE 4B

SCALE: 1 inch = 5 feet
 (no vertical exaggeration)
 South Well Logged, East to West
 Trench logged by Bill D Block, P.G.
 on March 10-11, 2016
 Reviewed by Craig V Nelson, P.G.

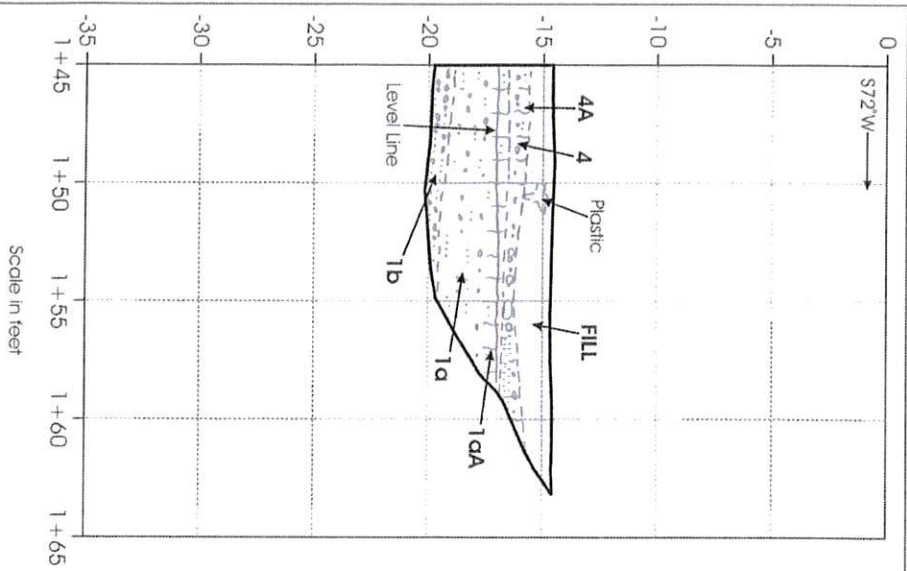
<p>TRENCH 1 LOG, SHEET 3</p> <p>SURFACE FAULT RUPTURE HAZARD EVALUATION</p> <p>Cedar Cove Subdivision Lot 28-A 6696 South 2850 East Weber County, Utah</p> <p>FIGURE 4C</p>
--

TRENCH 1 UNIT DESCRIPTIONS

- Unit 1.** *Loesslike sediments related to the regressive stage of Late Pleistocene Lake Bonneville* - sequence of generally poorly bedded, low to moderate density, gravelly sand to sandy gravel with round to subangular cobbles; clasts with stage II carbonate coatings.

- Unit 3.** *Fault-zone and scarp-derived colluvium* - colluvium from faulting and fault-scarp degradation from the most-recent surface faulting earthquake on the Weber segment of the Wasatch fault zone.

- 3a. Crack fill and colluvial wedge; brown to reddish-brown, massive, low density, gravelly sand (SW) with cobbles.
 - 3b. Upper slope-wash facies of colluvial wedge; generally similar to unit 3a but finer grained; interfingers with unit 4 to west.

SCALE: 1 inch = 5 feet
 (no vertical exaggeration)
 South Wall logged. East to West
 Trench logged by Bill D Black, PG,
 on March 10-11, 2016
 Reviewed by Craig V Nelson, RG.

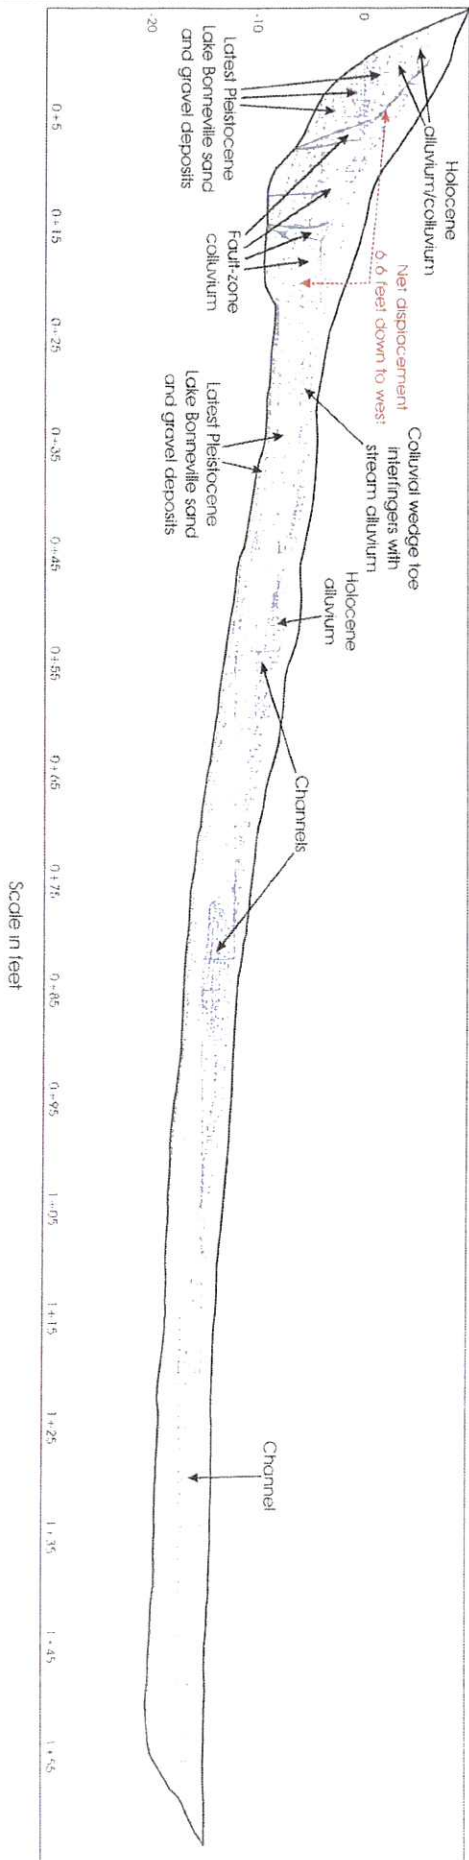
<p>TRENCH 1 OVERVIEW</p> <p>SURFACE FAULT RUPTURE HAZARD EVALUATION</p> <p>Cedar Cove Subdivision Lot 28-A 6676 South 2850 East Weber County, Utah</p> <p>FIGURE 4D</p>

Two generally southwest-trending trenches were excavated at the site to evaluate subsurface geologic conditions and assess the potential hazard from surface faulting. Trench 1 extended S72°W for a total distance of 168 feet from about 20 feet west of the eastern site boundary. Trench 2 is about 50 feet northwest of Trench 1, and extends S55°W for a total distance of 50 feet. Figure 3B shows locations of the trenches at the site at a scale of 1 inch equals 80 feet (1:960). The trench locations were measured using trend and distance methods from known points, and verified by measurements from two handheld GPS units accurate to within 1 meter. We consider the locations to be accurate to within 1 foot. No surveying was conducted or considered necessary given there was good reference point availability to combine with the GPS measurements. The trenches extended to a depth sufficient to expose sediments capable of displaying evidence for any active

excavated at the site to evaluate the hazard from surface faulting. The trenches exposed a main fault trace with 6.6 feet of down-to-the-west displacement about 35 feet west of Kaliser's (1997) inferred location. No evidence for the western fault was also observed in Trench 1, which extended past the western site boundary.

SCALE: 1 inch = 5 feet
 (no vertical exaggeration)
 South Wall Logged, East to West
 trench logged by Bill D Block, P.G.
 on March 10-11, 2016
 Reviewed by Craig V. Nelson, P.G.

Given the above, the risk from surface faulting is high at the site. Based on the results of this investigation and our current understanding that surface fault rupture and deformation tend to follow past patterns, we recommend a non-buildable (setback) zone around the fault traces as shown on Figure 3B (shaded in red). Setback distances are based on guidelines in Christenson and others (2003).

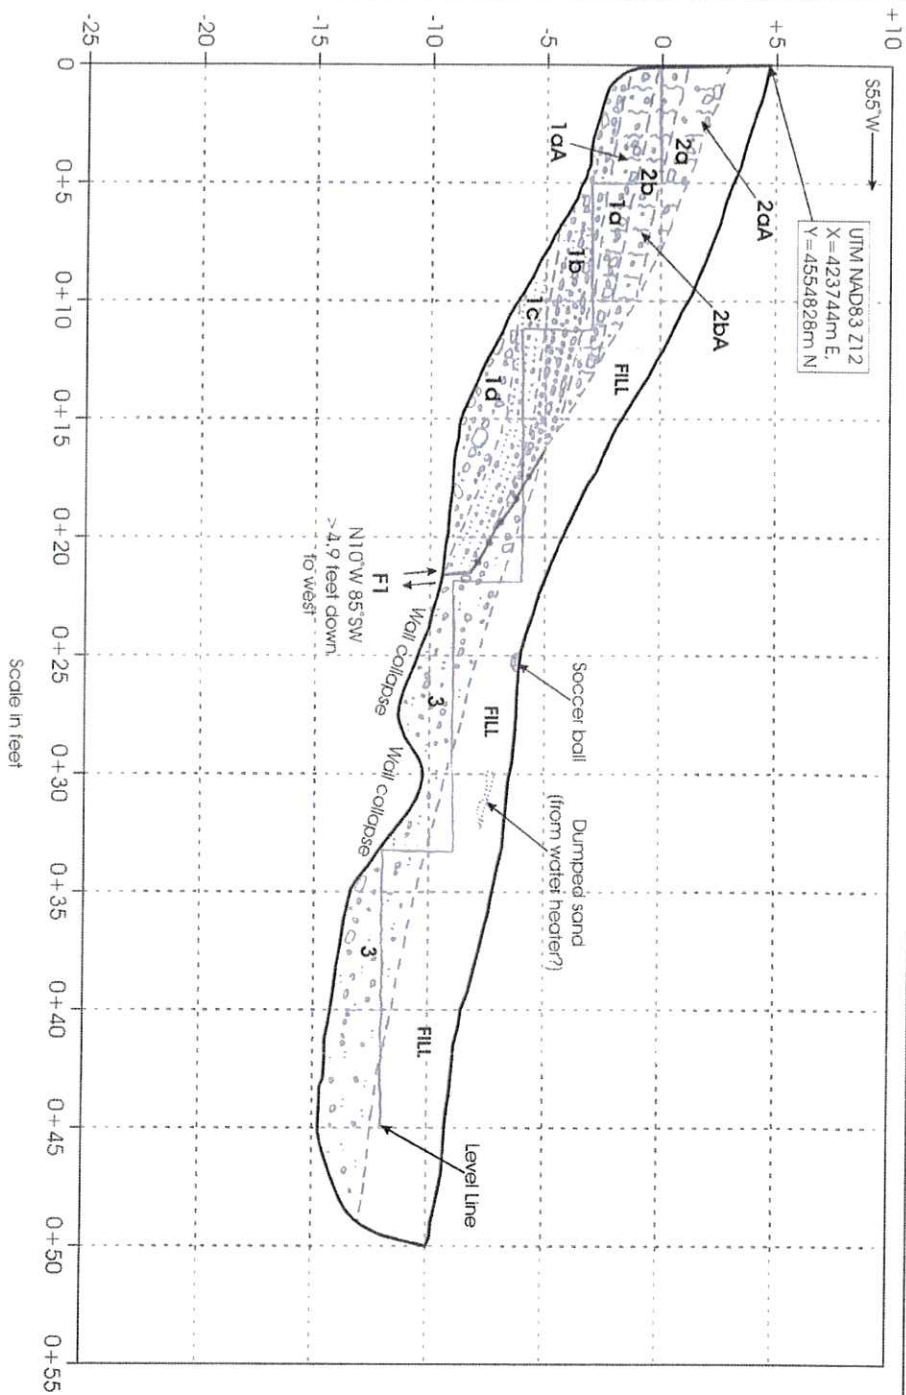
TRENCH 2
SURFACE FAULT RUPTURE HAZARD EVALUATION
Cedar Cove Subdivision Lot 28-A 6696 South 2850 East Weber County, Utah
FIGURE 5

The lacustrine sequence in Trench 2 appeared similarly displaced as Trench 1 across the main fault, but only one trace was evident (Figure 5). No additional faults were observed west of this trace in Trench 2 during the time the exposure was visible prior to wall collapse. Correlative stratigraphy across the fault could not be exposed to the west in trench 2, but the displacement is more than 4.9 feet down to the west (Figure 5). Yonkee and Lowe (2004) indicate that lacustrine fines (unit Q1f4) should be at the site beneath Holocene alluvium and colluvium (Figure 2). However, the lacustrine sequence in both trench exposures was coarser grained and more likely correlative to their Q1g3 or Qd3 units (described above). The trenches otherwise exposed sediments correlating well with the surficial geologic mapping.

UNIT DESCRIPTIONS

Unit 1. Lacustrine sediments related to the regressive stage of Late Pleistocene Lake Bonneville - sequence of generally poorly bedded, low to moderate density, gravelly sand to sandy gravel with round to subangular cobbles; clasts with stage II carbonate coatings.

Unit 3. Mixed Holocene alluvium and fault-zone/scarp-derived colluvium - brown, massive, sand (SM) with gravel and trace cobbles; upper part organic rich and root penetrated; very loose and caving in areas close to fault; wall instability prevented deeper excavation.
