Staff Report for Administrative Subdivision Approval

Application Request: Consideration and action for the final plat approval of Cedar Cove Estates Amendment 4 Subdivision including the concurrent consideration and action of the Cedar Cove Estates Amendment 4 Hillside Review and access via a private right of way requests for Lot 34.

SURFACE FAULT RUPTURE HAZARD EVALUATION

SUBJECT: Surface Fault Rupture Hazard Evaluation
Cedar Cove Subdivision Lot 28-A
6696 South 2850 East
Weber County, Utah

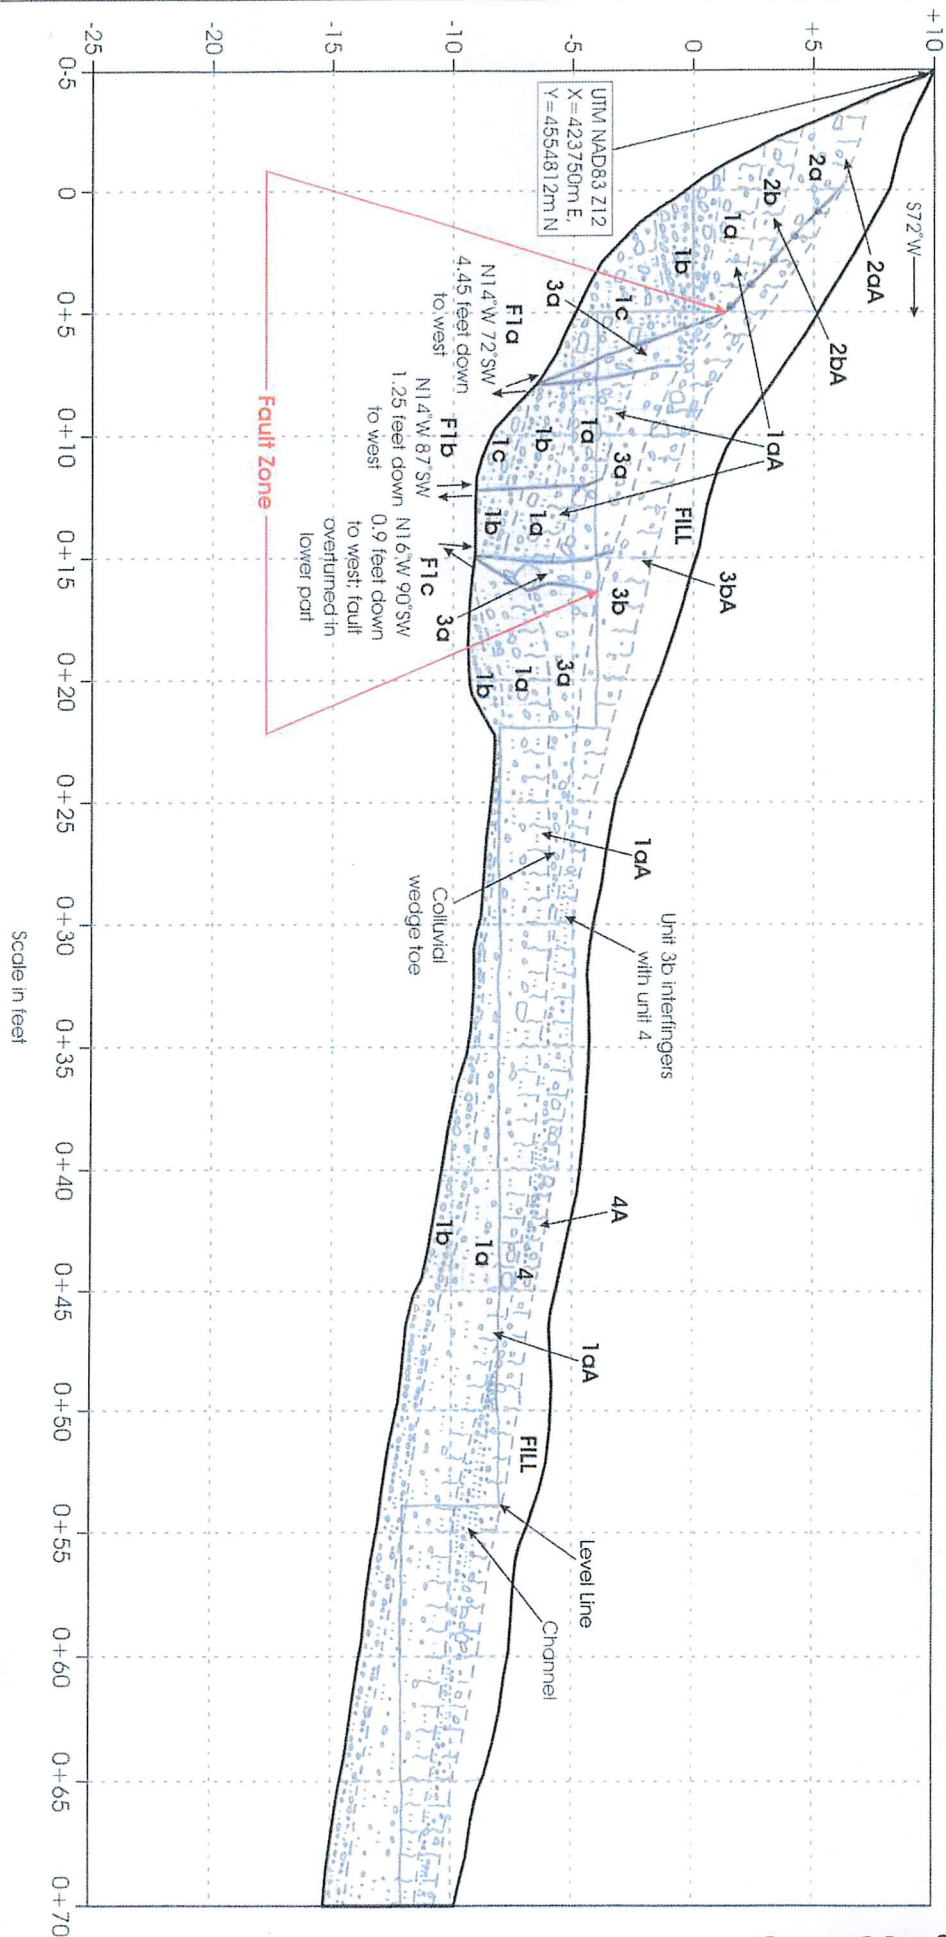
SCALE: 1 inch = 5 feet
(no vertical exaggeration)
South Wall Logged, East to West
Trench logged by Bill D Black, PG,
on March 10-11, 2016
Reviewed by Craig V Nelson, PG.

TRENCH 1 LOG, SHEET 1
SURFACE FAULT RUPTURE
HAZARD EVALUATION
Cedar Cove Subdivision Lot 28-A
6696 South 2850 East
Weber County, Utah
FIGURE 4A

Both trenches at the site exposed a sequence of poorly bedded, sandy to gravelly Pleistocene Lake Bonneville sediments (unit 1), overlain by what appeared to be a sequence of distal debris flood deposits (unit 2) that likely draped over the fault scarp and died out to the west. In Trench 1, this sequence is displaced 6.6 feet down to the west across a zone of three faults (F1a-F1c, Figure 4A) and buried by fault-zone colluvium and crack infill (unit 3). The upper part of unit 3 in Trench 1 (unit 3b), which appeared to be a slope-wash facies from fault scarp degradation, interfingers with younger Holocene alluvium (unit 4) to the west, which overlies the lacustrine sequence. The Holocene alluvium exposed in Trench 1 (unit 4) was observed to contain several gravel and sand channels suggestive of stream deposition (Figure 4B). No evidence for a second fault trace at the location of the lineament on Figure 3A was observed in Trench 1. Given the above, we believe this feature is likely from stream cutting and not faulting. We believe the multiple faults in Trench 1 are from an eastward stepover toward the confluence of two drainages on Kaliser's (1997) Figure 2. Such a confluence would be an area of weakness from stream downcutting and cause shearing to embay upslope into the weakened area.

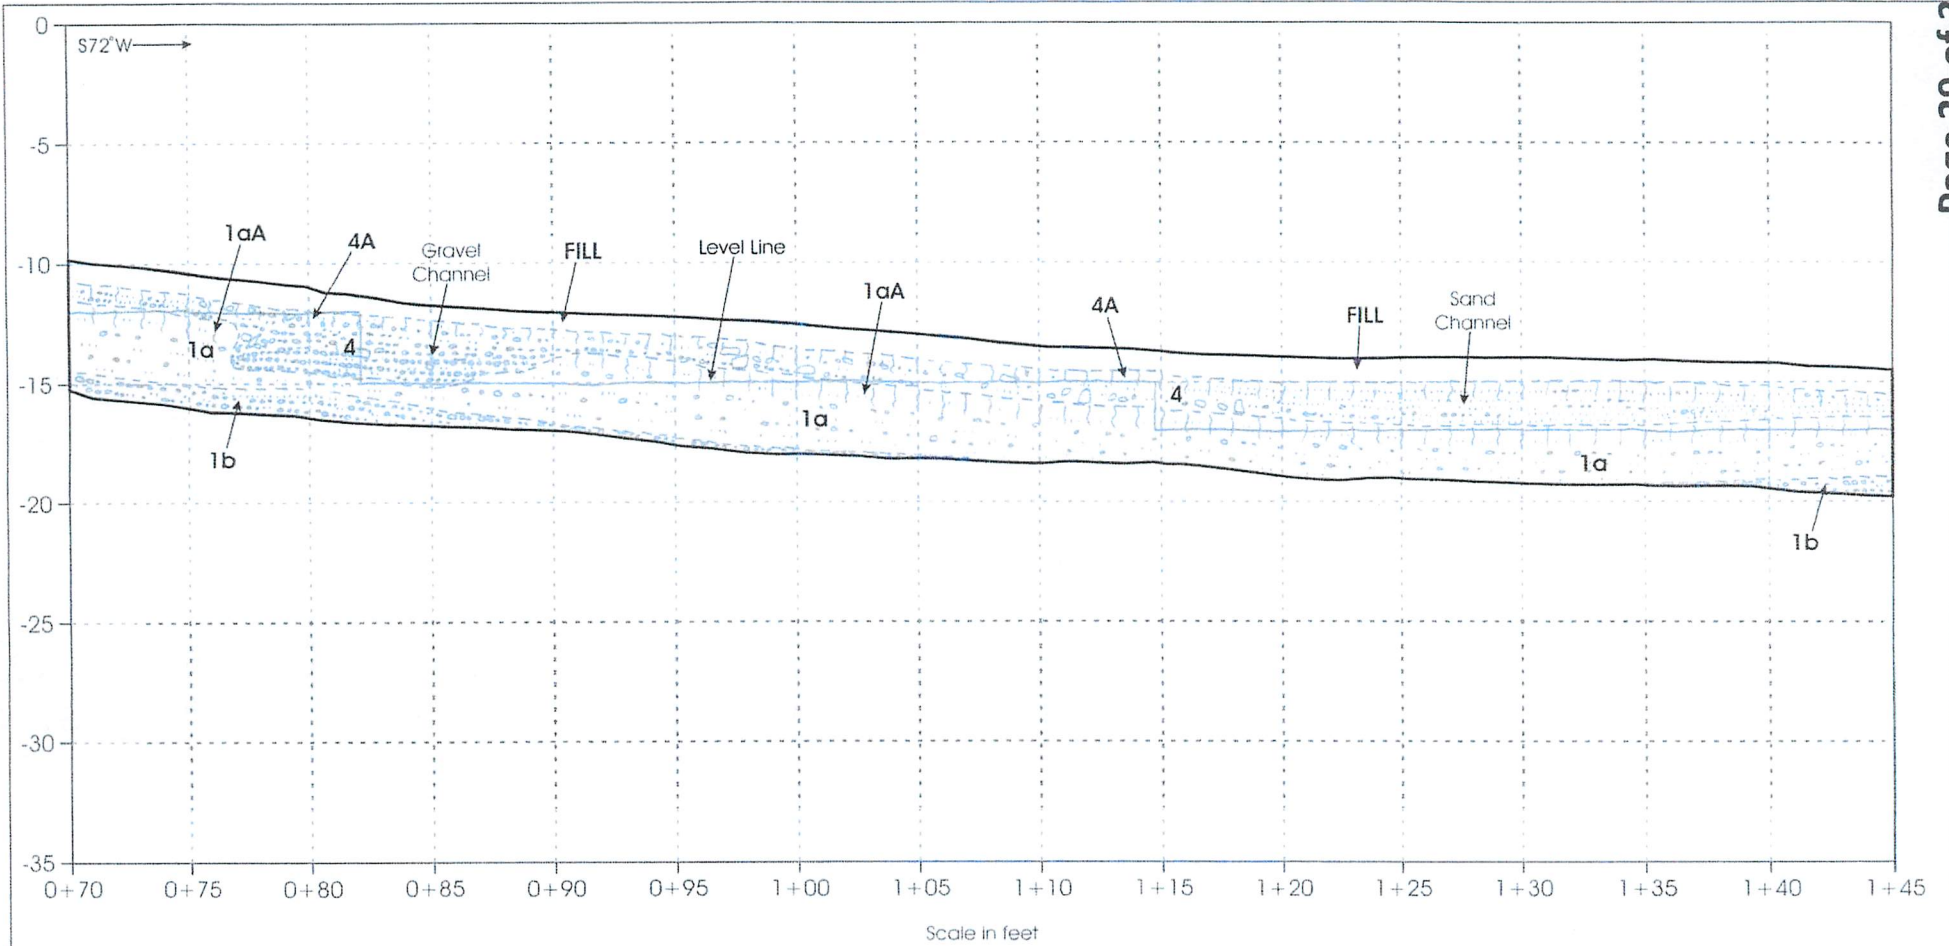
TRENCH 1 LOG, SHEET 2

Trench logged by Bill D Black, P.G.
on March 10-11, 2016
Reviewed by Craig V Nelson, P.G.

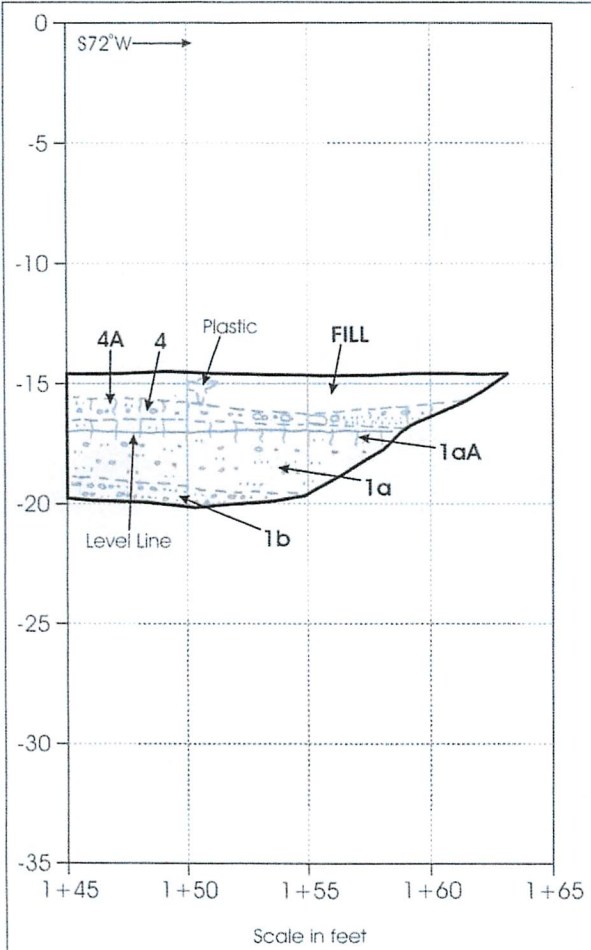
TRENCH 1 UNIT DESCRIPTIONS

Unit 1. Lacustrine sediments related to the regressive stage of Late Pleistocene Lake Bonneville - sequence of generally poorly bedded, low to moderate density, gravelly sand to sandy gravel with round to subangular cobbles; clasts with stage II carbonate coatings.

Unit 3. Fault-zone and scarp-derived colluvium - colluvium from faulting and fault-scarp degradation from the most-recent surface faulting earthquake on the Weber segment of the Wasatch fault zone.

- 3a. Crack fill and colluvial wedge; brown to reddish-brown, massive, low density, gravelly sand (SW) with cobbles.
- 3b. Upper slope-wash facies of colluvial wedge, generally similar to unit 3a but finer grained; interfingers with unit 4 to west.
- 3bA. Modern A-horizon soil formed in unit 3b; overlain by fill.

<p>TRENCH 1 LOG, SHEET 3</p> <p>SURFACE FAULT RUPTURE HAZARD EVALUATION</p> <p>Cedar Cove Subdivision Lot 28-A 6696 South 2850 East Weber County, Utah</p> <p style="text-align: right;">FIGURE 4C</p>
--

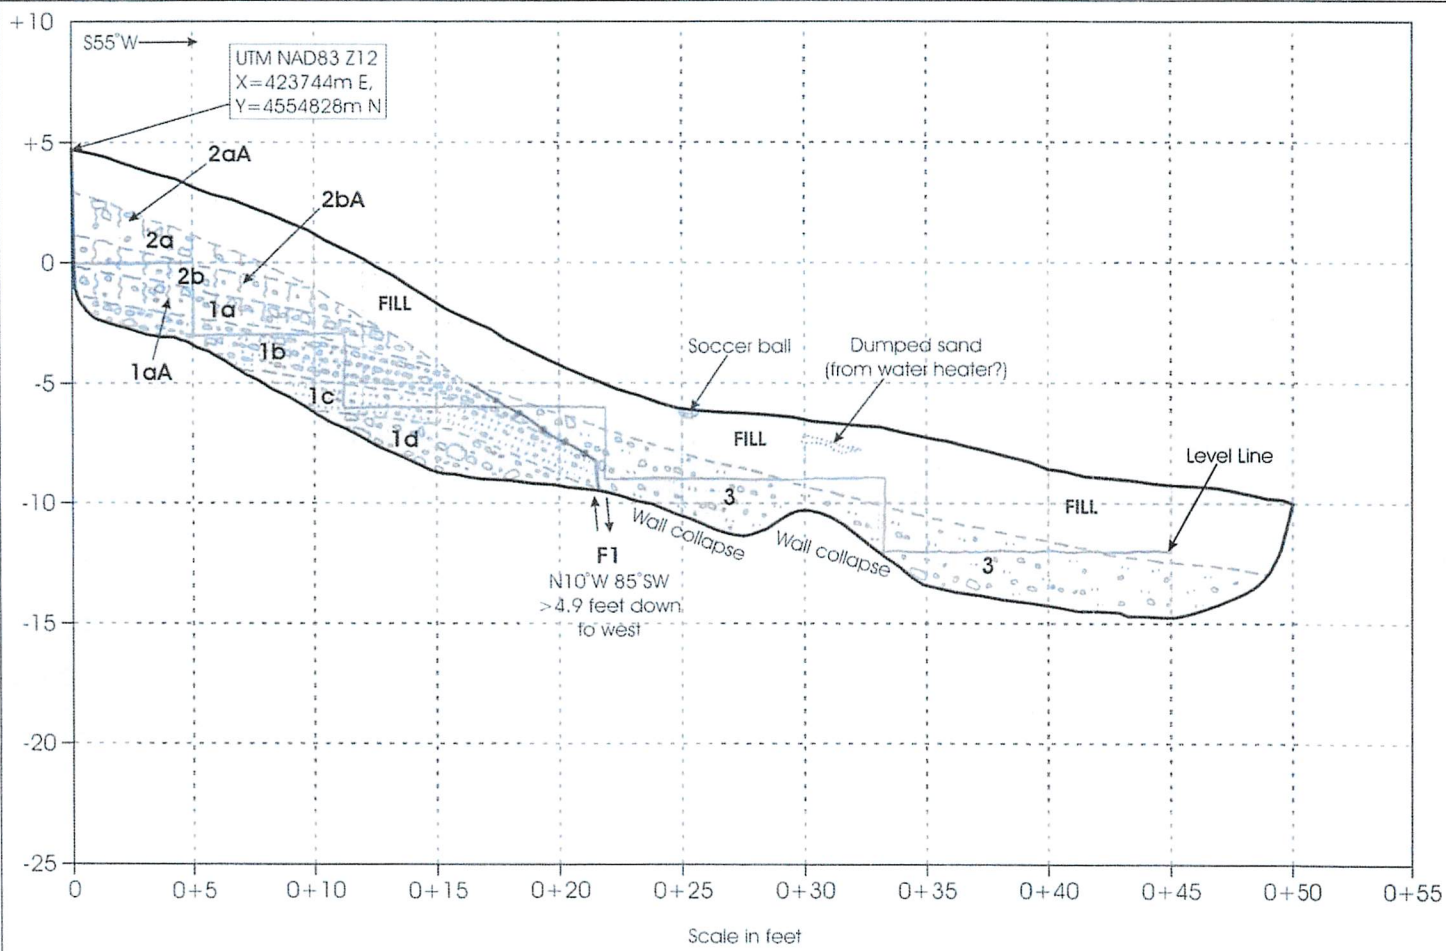
UNIT DESCRIPTIONS

Unit 1. Lacustrine sediments related to the regressive stage of Late Pleistocene Lake Bonneville - sequence of generally poorly bedded, low to moderate density, gravelly sand to sandy gravel with round to subangular cobbles; clasts with stage II carbonate coatings.

Unit 3. Mixed Holocene alluvium and fault-zone/ scarp-derived colluvium - brown, massive, sand (SW) with gravel and trace cobbles; upper part organic rich and root penetrated; very loose and caving in areas close to fault, wall instability prevented deeper excavation.

TRENCH 2
SURFACE FAULT RUPTURE HAZARD EVALUATION
Cedar Cove Subdivision Lot 28-A 6696 South 2850 East Weber County, Utah
FIGURE 5

The lacustrine sequence in Trench 2 appeared similarly displaced as Trench 1 across the main fault, but only one trace was evident (Figure 5). No additional faults were observed west of this trace in Trench 2 during the time the exposure was visible prior to wall collapse. Correlative stratigraphy across the fault could not be exposed to the west in trench 2, but the displacement is more than 4.9 feet down to the west (Figure 5). Yonkee and Lowe (2004) indicate that lacustrine fines (unit Q1f4) should be at the site beneath Holocene alluvium and colluvium (Figure 2). However, the lacustrine sequence in both trench exposures was coarser grained and more likely correlative to their Q1g3 or Qd3 units (described above). The trenches otherwise exposed sediments correlating well with the surficial geologic mapping.
