# Staff Report for Administrative Subdivision Approval

<b>Application Request:</b>	Consideration and action on an administrative application for final approval of Silver Bell Estates No 2, 2nd Amendment, a one lot subdivision.
<b>Type of Decision:</b>	Administrative
<b>Agenda Date:</b>	Wednesday, October 11, 2017
<b>Applicant:</b>	Travis Braden, owner
<b>File Number:</b>	UVS 061317

## GEOLOGIC HAZARDS RECONNAISSANCE

**SUBJECT:** Geologic Hazards Reconnaissance  
Silver Bell Estates Lot 63  
Nordic Valley Drive and Viking Drive  
Eden, Weber County, Utah

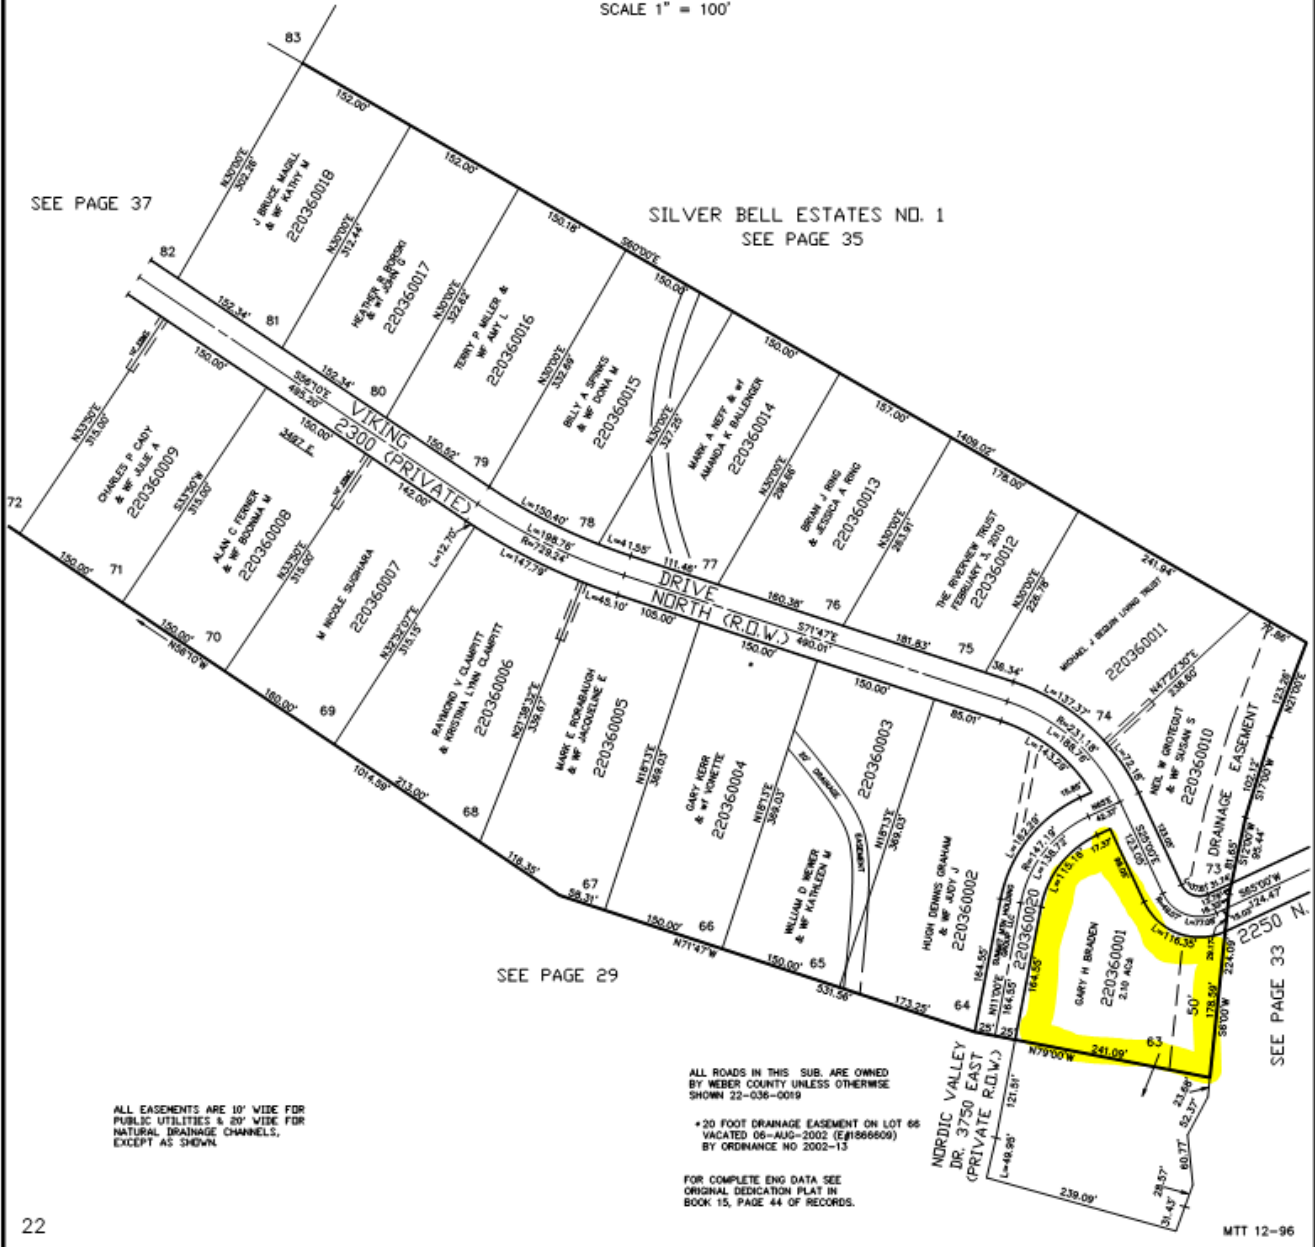
PART OF SECTION 29 & 32, T.7N., R.1E., S.L.B. & M.  
**SILVER BELL ESTATES NO. 2**

LOTS 63 - 71 & 73 - 81

ALL EASEMENTS ARE 10' WIDE FOR PUBLIC UTILITIES & 20' WIDE FOR NATURAL DRAINAGE CHANNELS, EXCEPT AS SHOWN.

ALL ROADS IN THIS SUB. ARE OWNED BY WEBER COUNTY UNLESS OTHERWISE SHOWN 22-036-0019

\* 20 FOOT DRAINAGE EASEMENT ON LOT 66 VACATED 08-AUG-2002 (E#1866609) BY ORDINANCE NO 2002-13

The applicant has submitted a proposal for a one lot subdivision. The proposed subdivision will expand the size of the recorded lot 63 of the Silver Bell Estates No 2. Currently, both parcels have been combined for tax purposes only. There are no structures on either lot 63 or the parcel to the south. Lot 63 is a corner lot that has access from Nordic Valley Drive, a private right of way, and a County Road called Viking Drive (see Exhibit A, B and C).
