Staff Report for Administrative Approval Hillside Review – Notice of Conditional Approval

Application Request: Consideration and action on a request to approve a Hillside Review for the Hollis Carter residence located on Lot 75R in the Summit Eden Phase 1C.
Applicant: Hollis Carter
Authorized Representative: Josh Arrington
File Number: HSR 2017-03

**RE: Geotechnical & Geologic Hazard Investigation Report (Rev 1)
Lot 75R of Summit Powder Mountain Resort
8452 E. Spring Park
Weber County, Utah**

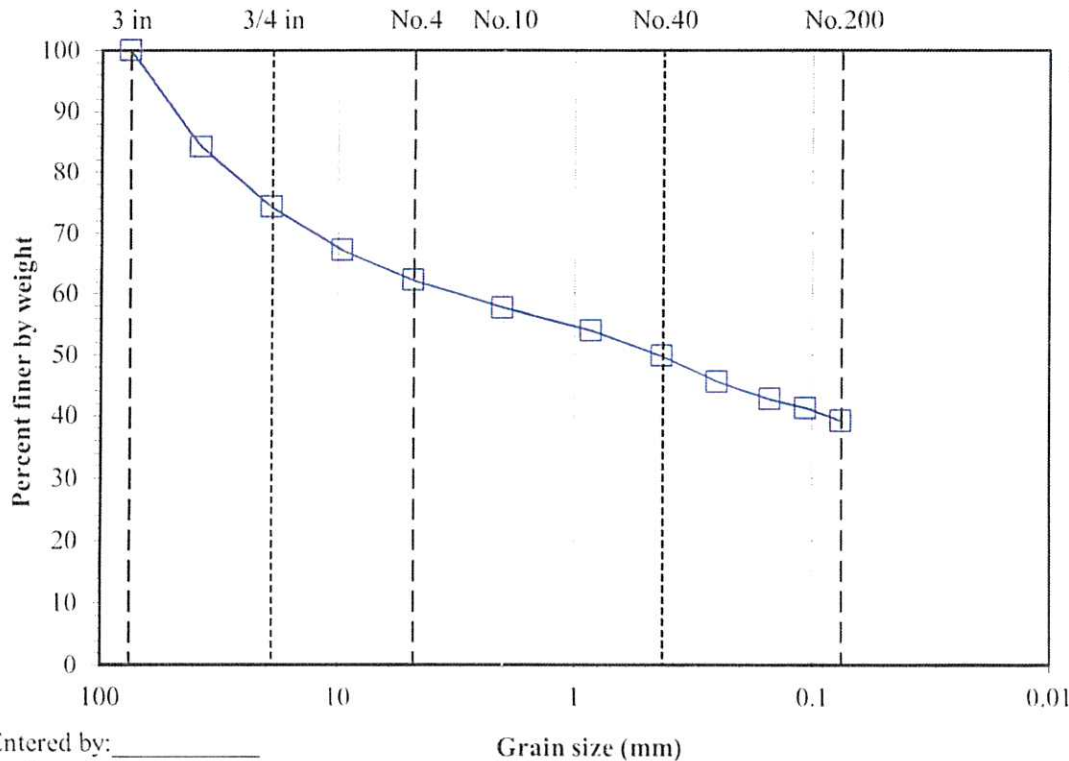
Sieve	Accum. Wt. Ret. (g)	Grain Size (mm)	Percent Finer
8"	-	200	-
6"	-	150	-
4"	-	100	-
3"	-	75	100.0
1.5"	2941.70	37.5	84.1
3/4"	4769.00	19	74.3
3/8"	6093.90	9.5	67.1
No.4	54.59	4.75	62.2
No.10	105.00	2	57.7
No.20	146.61	0.85	53.9
No.40	193.49	0.425	49.7
No.60	239.97	0.25	45.5
No.100	271.85	0.15	42.6
No.140	287.78	0.106	41.2
No.200	310.21	0.075	39.2

Gravel (%): 37.8
 Sand (%): 23.0
 Fines (%): 39.2
