**Geotechnical Investigation**  
**Lot 70R – Summit Eden Phase 1C Development**  
**8492 East Spring Park**  
**Weber County, Utah**

GeoStrata Job No. 594-004

July 11, 2018

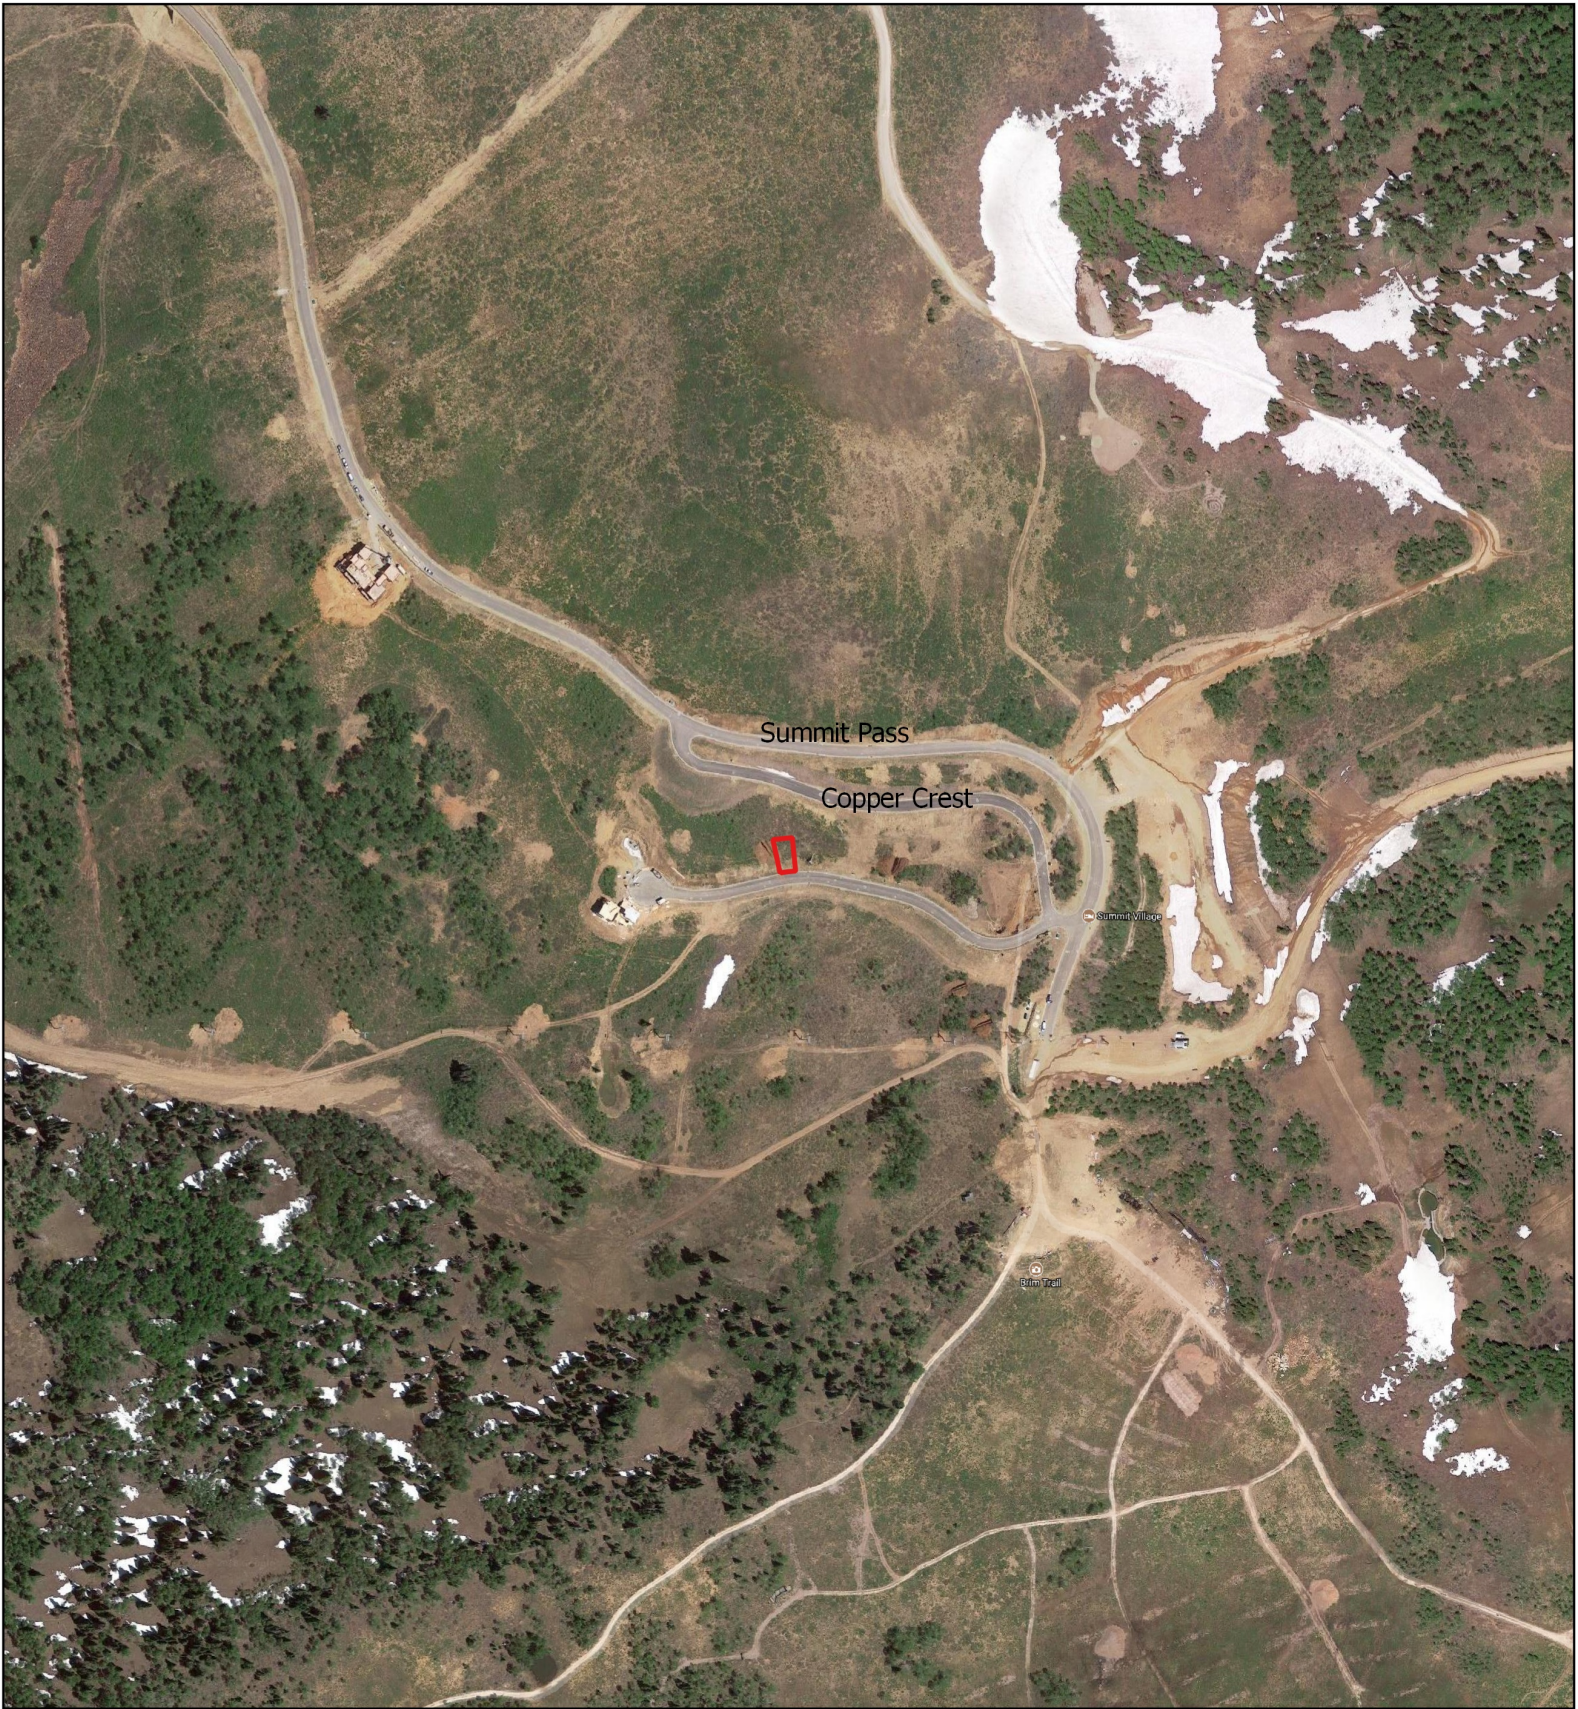
**Plate  
A-1**

**Exploration Location Map**

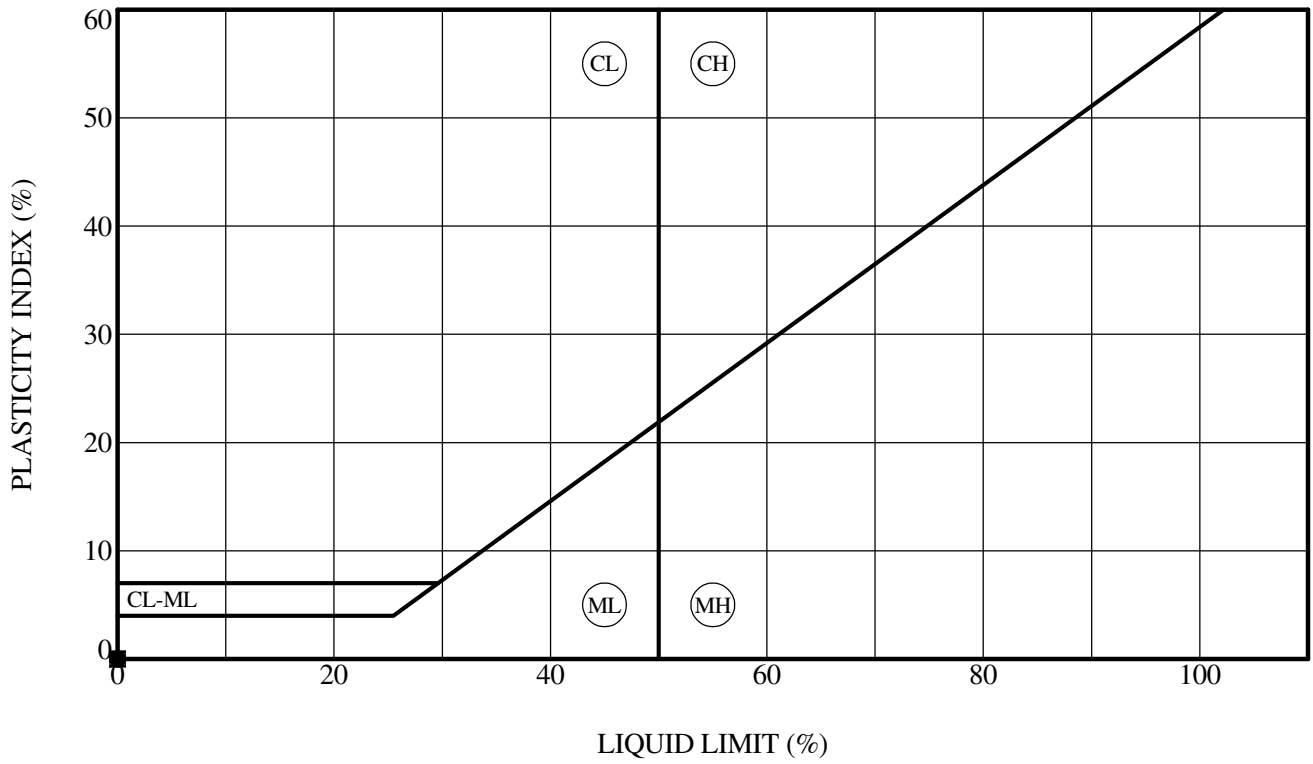
**Plate**  
**C - 2**

Sample Location	Depth (ft)	LL (%)	PL (%)	PI (%)	Fines (%)	Classification
● TP-1	4.5	NP	NP	NP	11.3	Poorly Graded GRAVEL with silt
☒ TP-2	6.0	NP	NP	NP	13.9	Poorly Graded GRAVEL with silt

**ATTERBERG LIMITS' RESULTS - ASTM D 4318**

Plate C-2.....Atterberg Limits Test Results

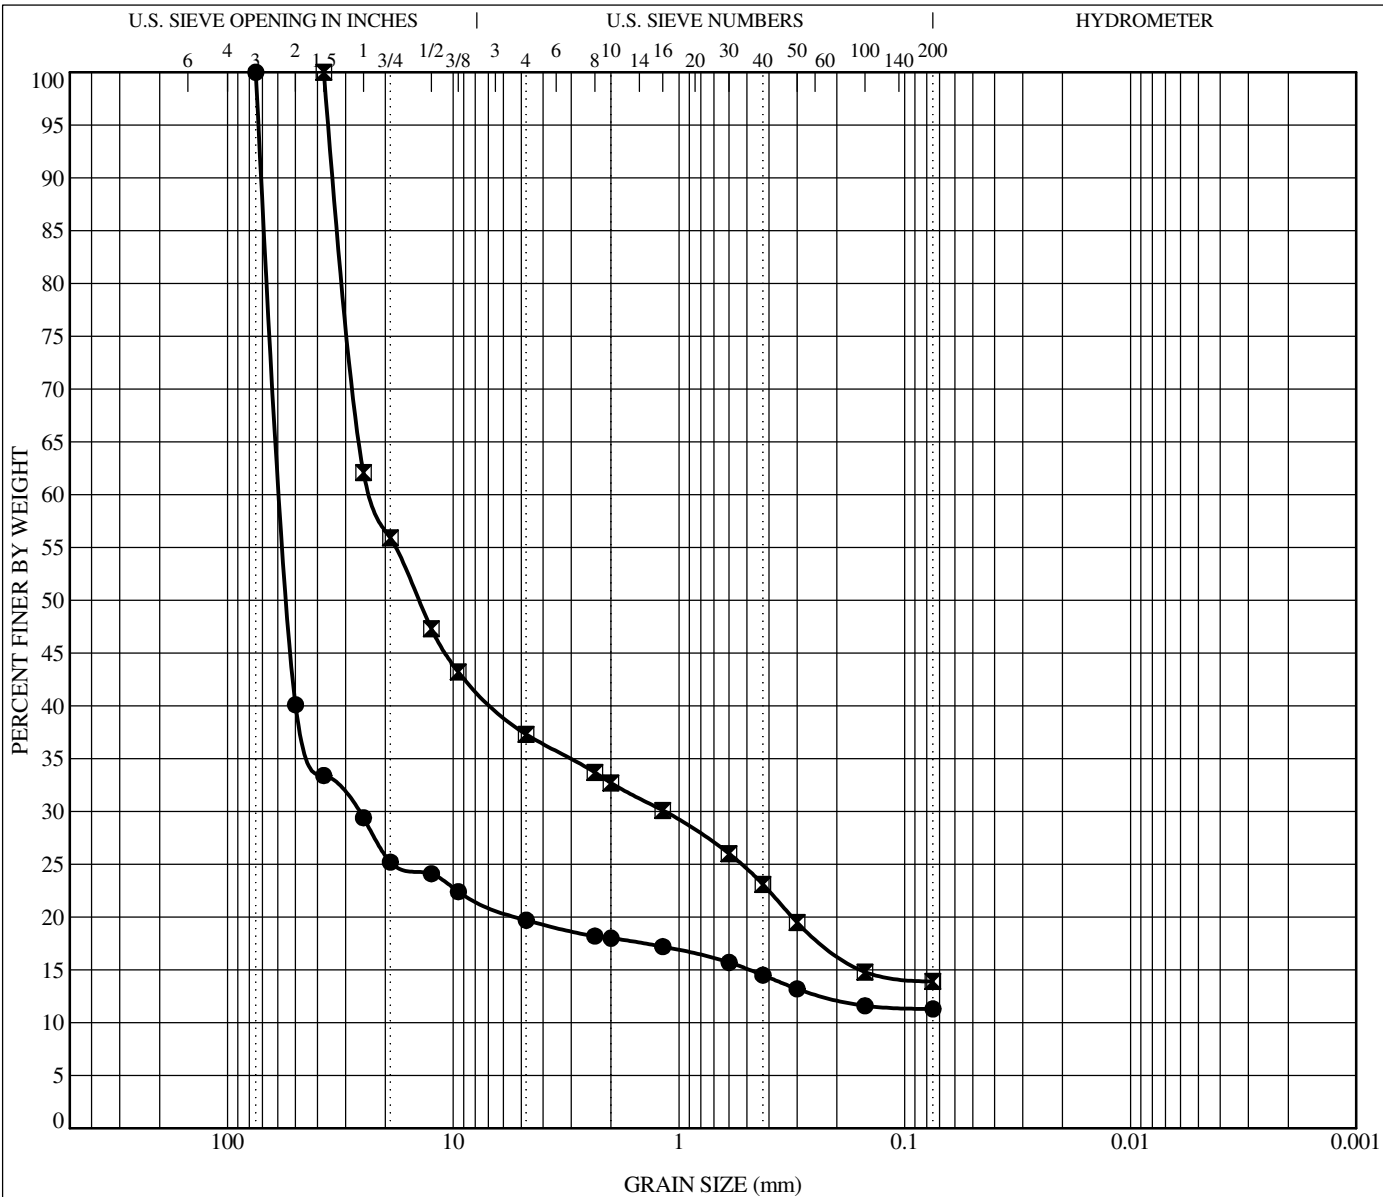
Sample Location	Depth	Classification	LL	PL	PI	Cc	Cu
● TP-1	4.5	Poorly Graded GRAVEL with silt	NP	NP	NP	3316.1	5377.03
■ TP-2	6.0	Poorly Graded GRAVEL with silt	NP	NP	NP

Plate C-3.....Grain-Size Distribution Test Results

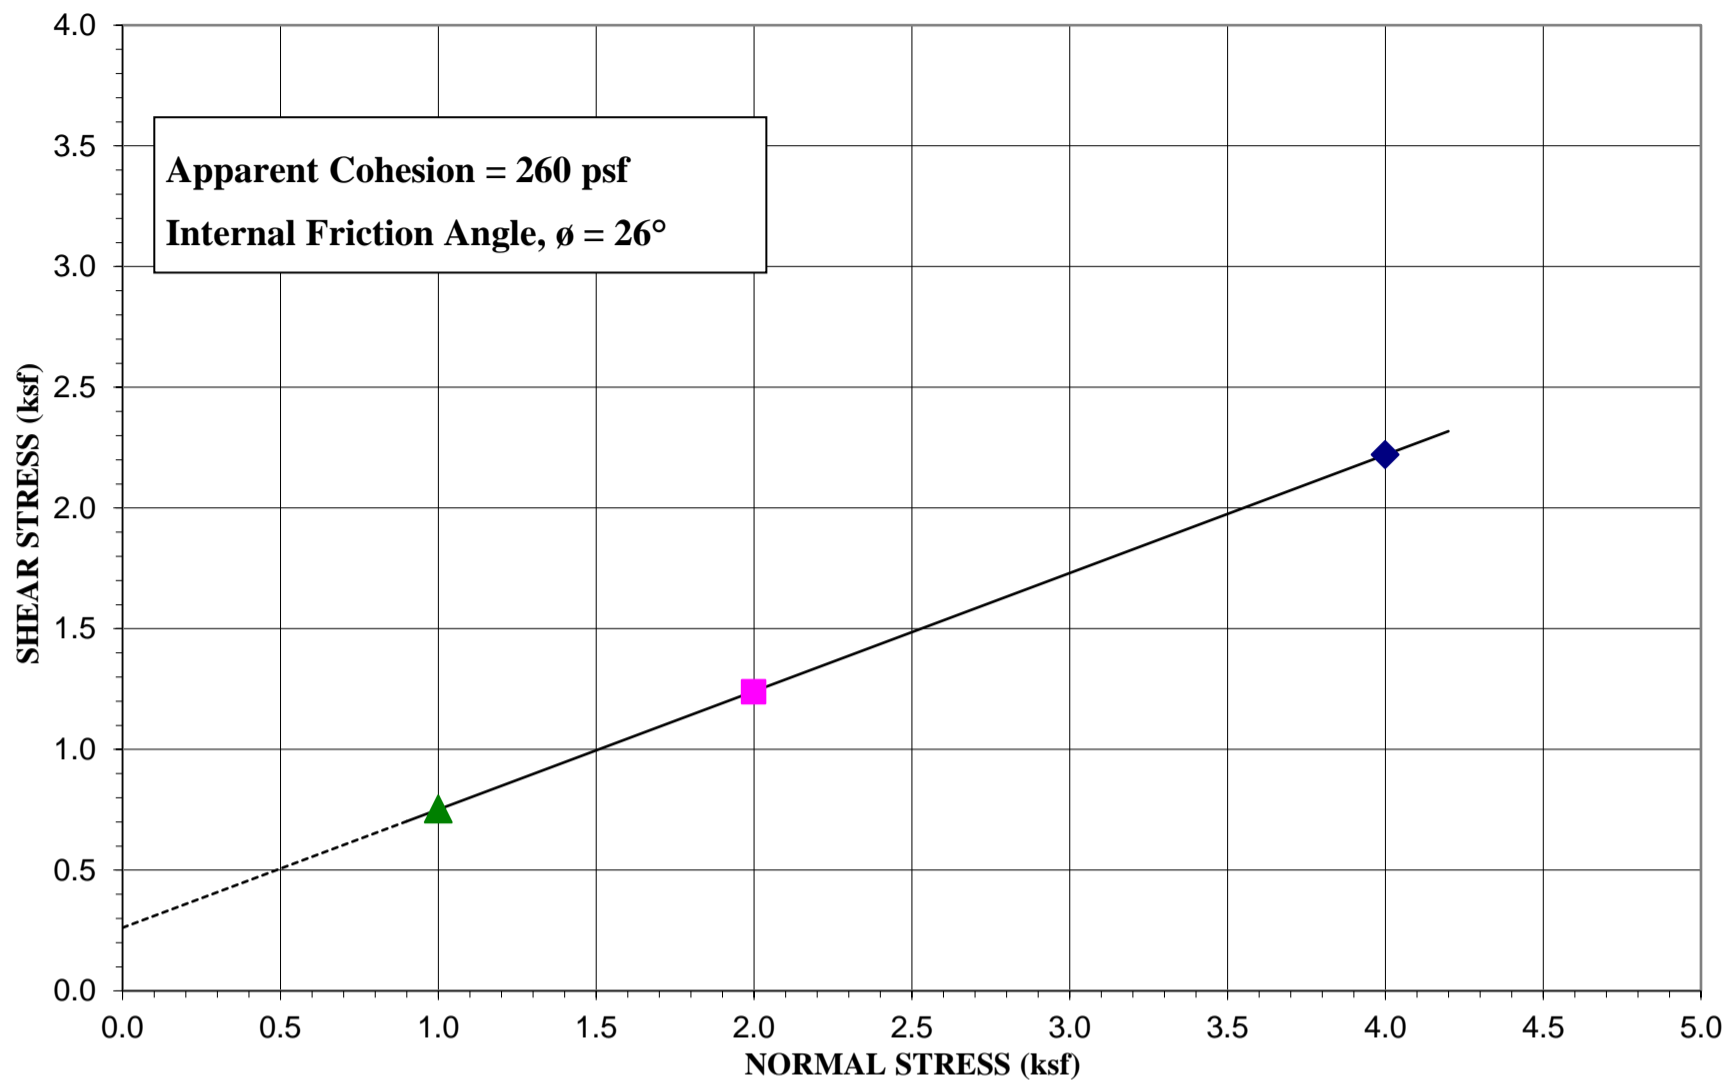
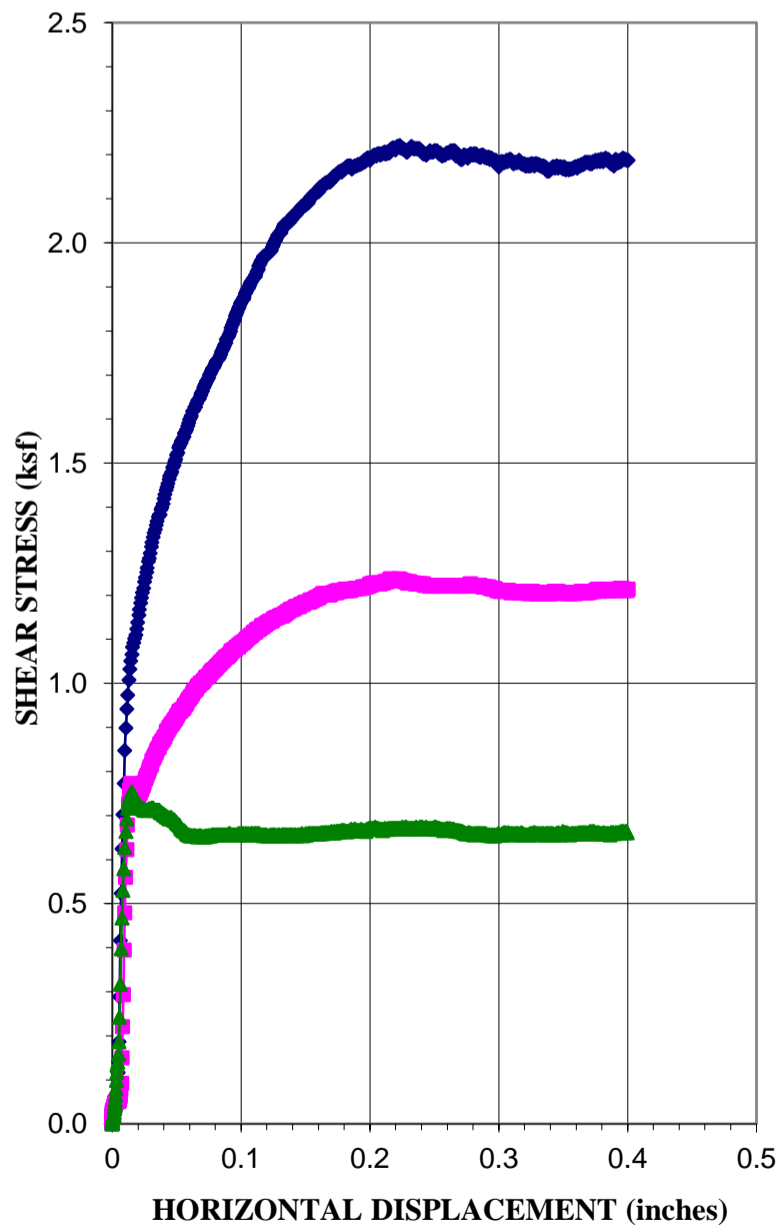
**Plate  
C-4**

# DIRECT SHEAR TEST

<b>Sample Location:</b>	TP-2 @ 9 ft
<b>Type of Test:</b>	Consolidated Drained/Saturated

Test No. (Symbol)	1 (◆)	2 (■)	3 (▲)
Sample Type	Remolded		
Initial Height, in.	0.984	0.982	0.989
Diameter, in.	2.5	2.5	2.5
Dry Density Before, pcf	115.7	115.2	113.4
Dry Density After, pcf	117.6	117.2	115.4
Moisture % Before	5.9	7.5	7.9
Moisture % After	13.9	14.4	14.7
Saturation, % Before	36.3	45.9	45.6
Saturation, % After	90.5	92.7	90.0
Normal Load, ksf	4.0	2.0	1.0
Shear Stress, ksf	2.22	1.24	0.75
Strain Rate	IN/MIN

Plate C-4.....Direct Shear Test Results

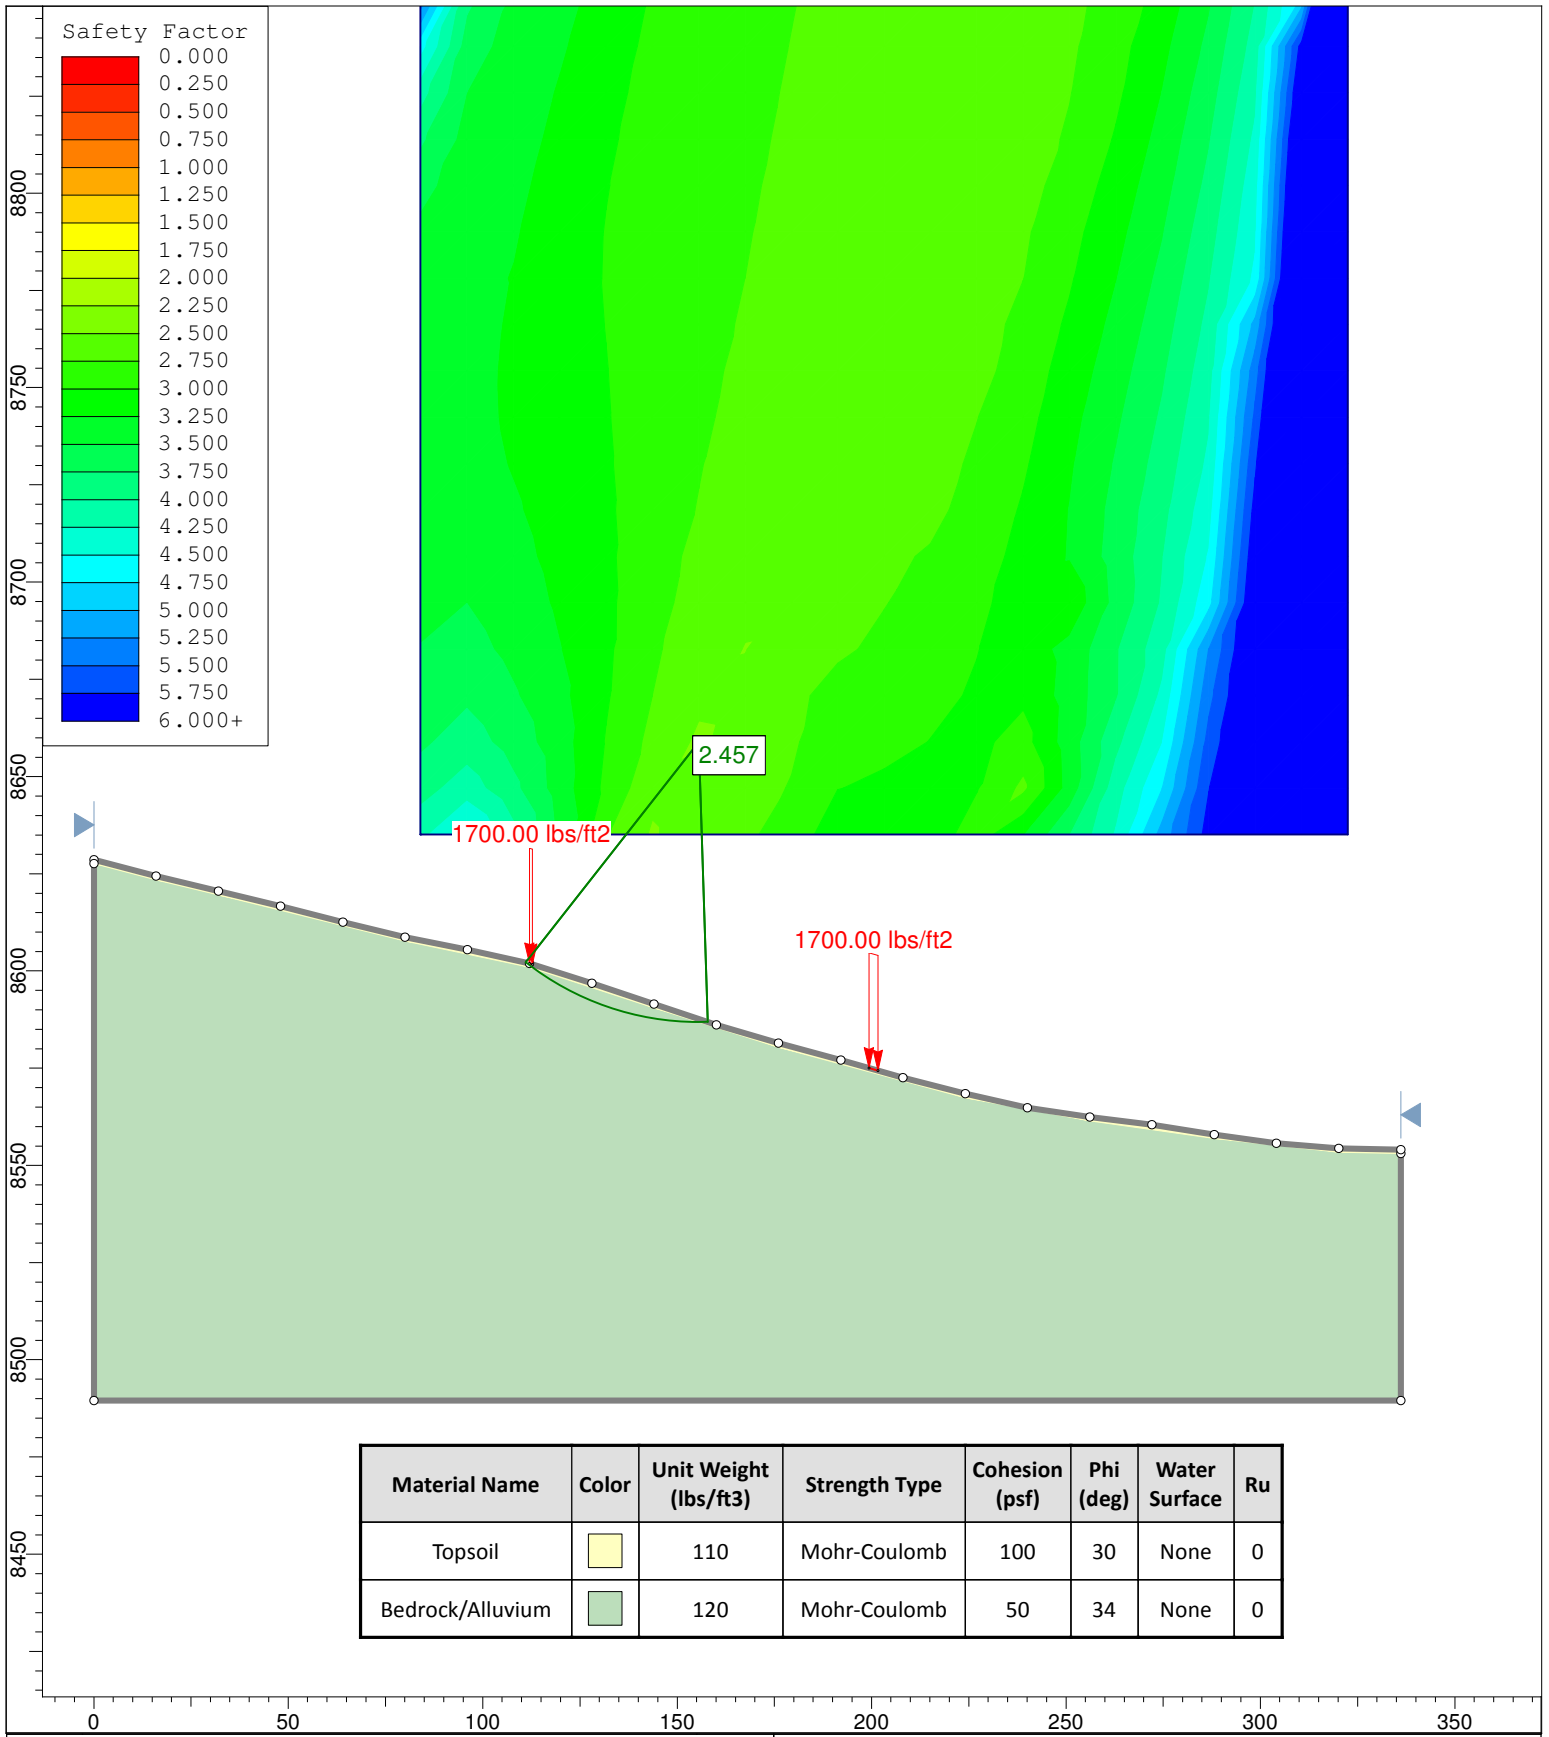
Material Name	Color	Unit Weight (lbs/ft3)	Strength Type	Cohesion (psf)	Phi (deg)	Water Surface	Ru
Topsoil	 	110	Mohr-Coulomb	100	30	None	0
Bedrock/Alluvium

120	Mohr-Coulomb	50	34	None	0

The global stability of Lot 70R was modeled using the SLIDE computer application and the Janbu’s Corrected Method of analysis. Calculations for stability were developed by searching for the minimum factor of safety for a circular-type and user-defined slope parallel failure surfaces. Homogenous earth materials and arcuate failure surfaces were assumed. The profile for the lot was obtained from ARC GIS data. A surcharge of approximately 1,700 psf was applied to our model within the anticipated vicinity of the residence. Slope stability was performed for the static and pseudo-static conditions. The pseudo-static assessment used one half of the peak ground acceleration of 0.35g as presented in Section 6.1 of our Geologic Hazards Assessment Report. Groundwater is presumed to be relatively deep and was not incorporated into the model.

1.0 for static and pseudo-static conditions, respectively, are considered stable. The analyses performed for this report indicated that the site has a static factor of safety of 2.5 and a pseudo static factor of safety of 1.56.
