**GEOTECHNICAL ENGINEERING AND
GEOLOGICAL RECONNAISSANCE STUDY**

Proposed Schlaf Residence

About 6886 East 1100 South
Huntsville, Weber County, Utah
CMT PROJECT NO. 13838

January 5, 2019

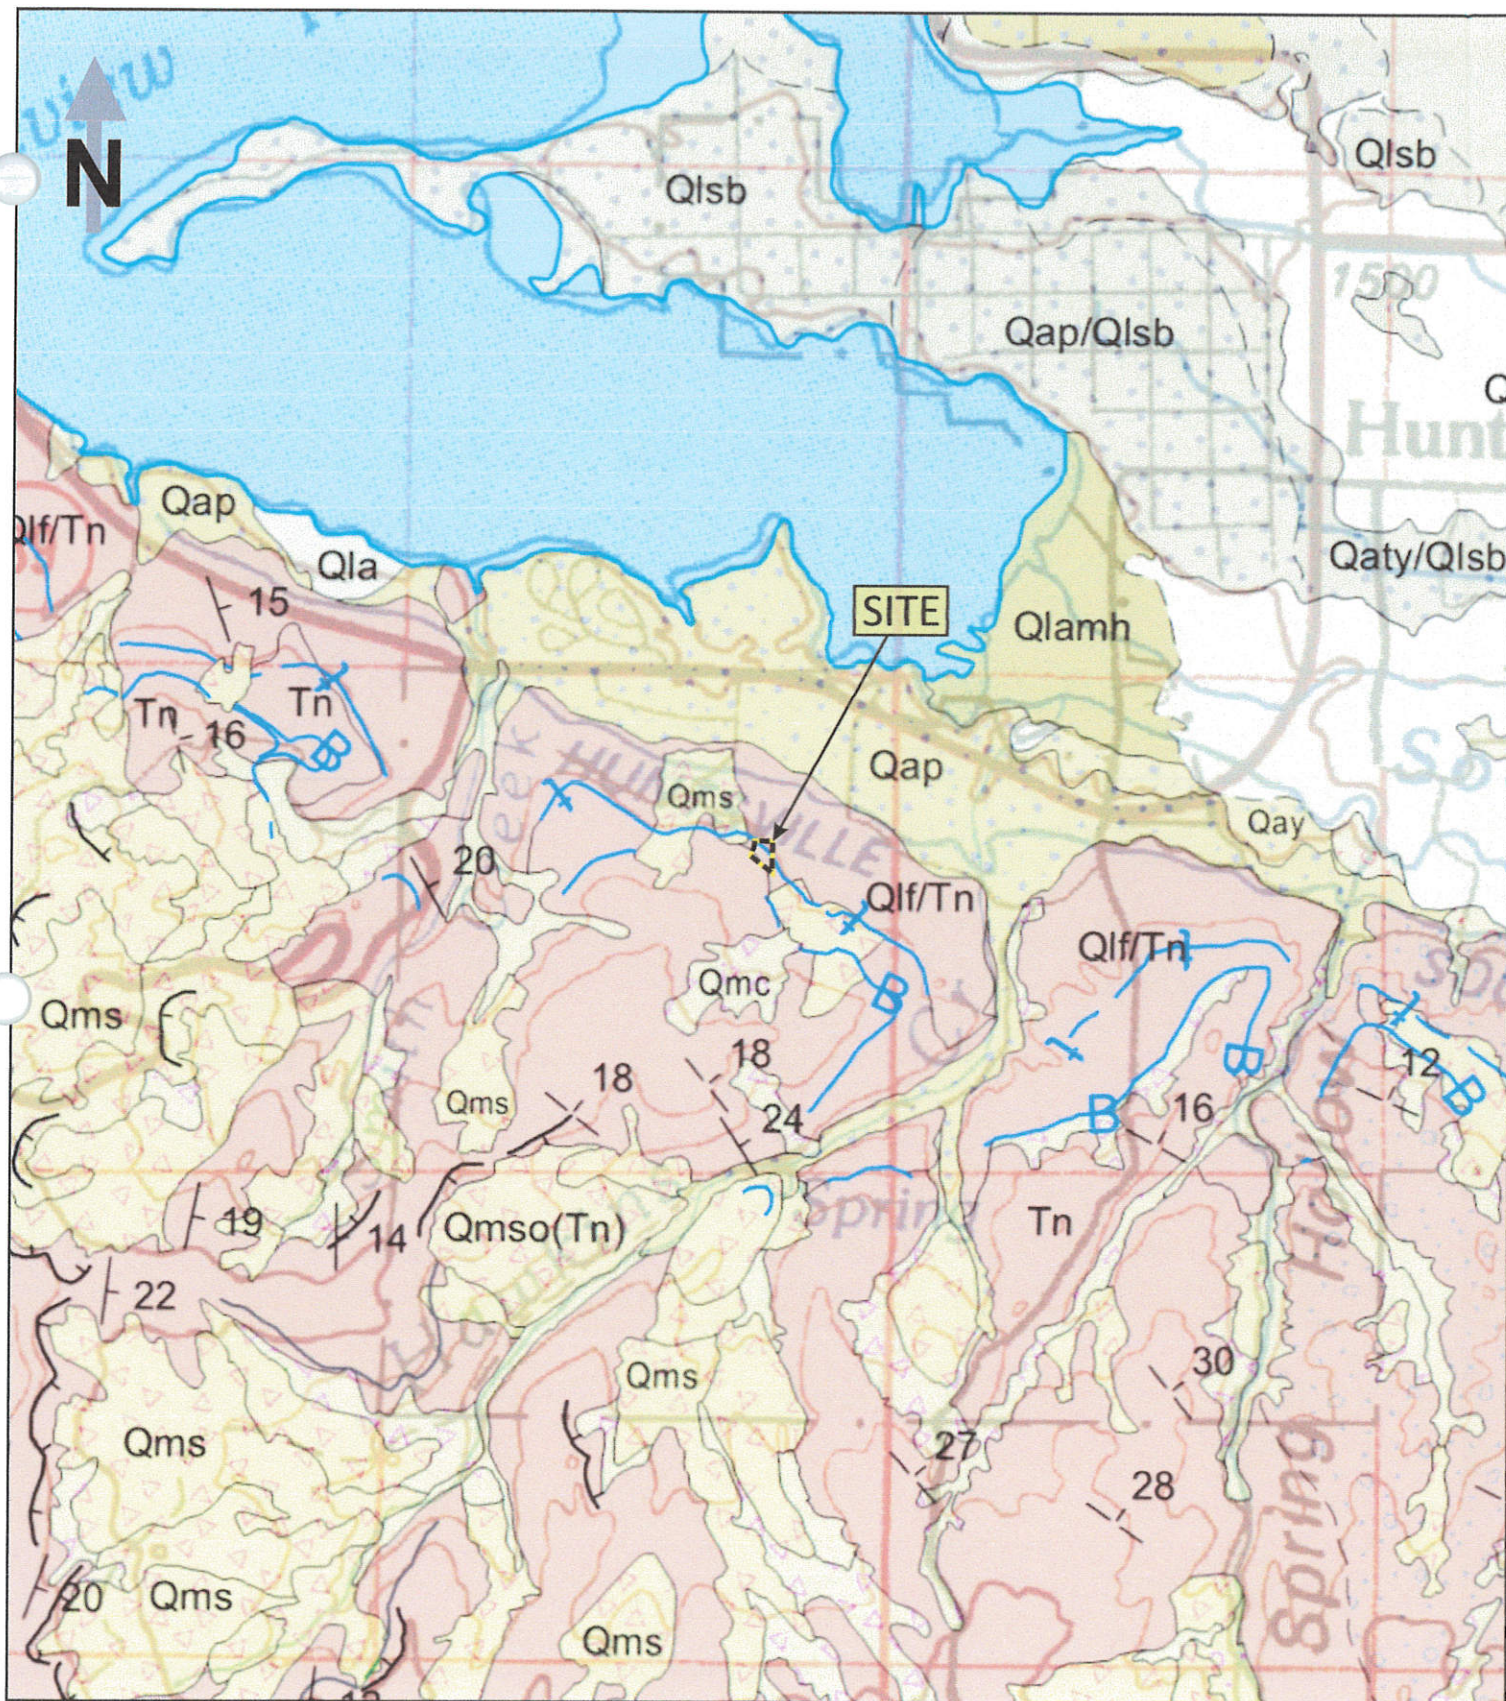
2

Base:
Interim Geologic Map of the Ogden 30' x 60'
Quadrangle (Coogan and King, 2016).

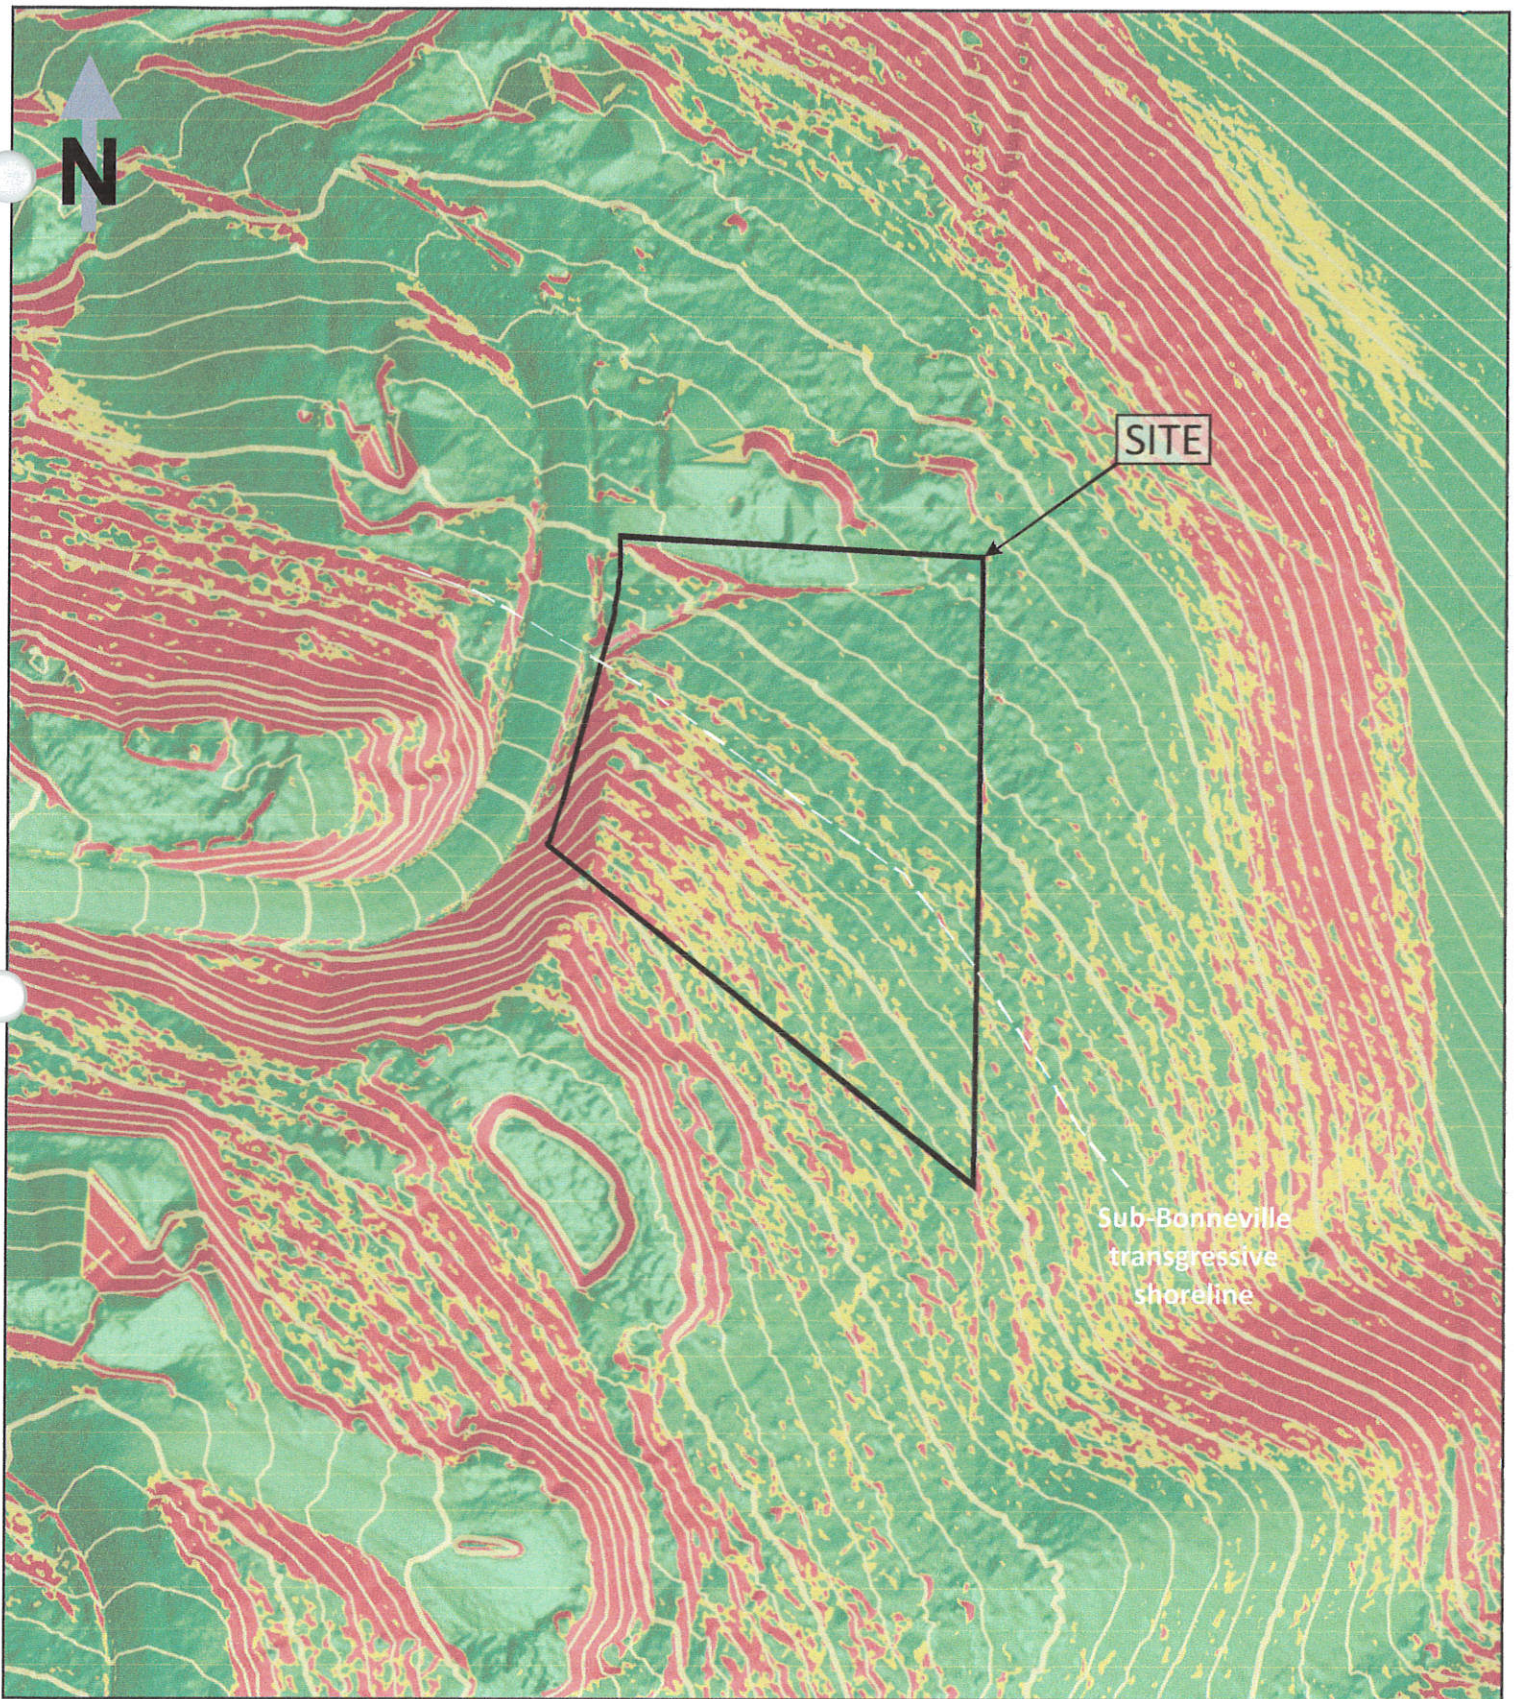
Figure
3

Base:
2016 LIDAR, 50cm resolution; slopes <25%
shaded in green, 25-30% in yellow, and >30%
red; 4-foot contour interval.

Surface slopes at the Project developed from our LiDAR analysis, as shown on **Figure 3**, are mainly gentler than 25% (in green). Slopes steeper than 30% on **Figure 3** (in red) are found in the southwest part of the Project, but become gentler northeastward. Overall slope across the Project from southwest to northeast is 10.95 degrees (19.3% gradient or 5.2:1 horizontal:vertical).

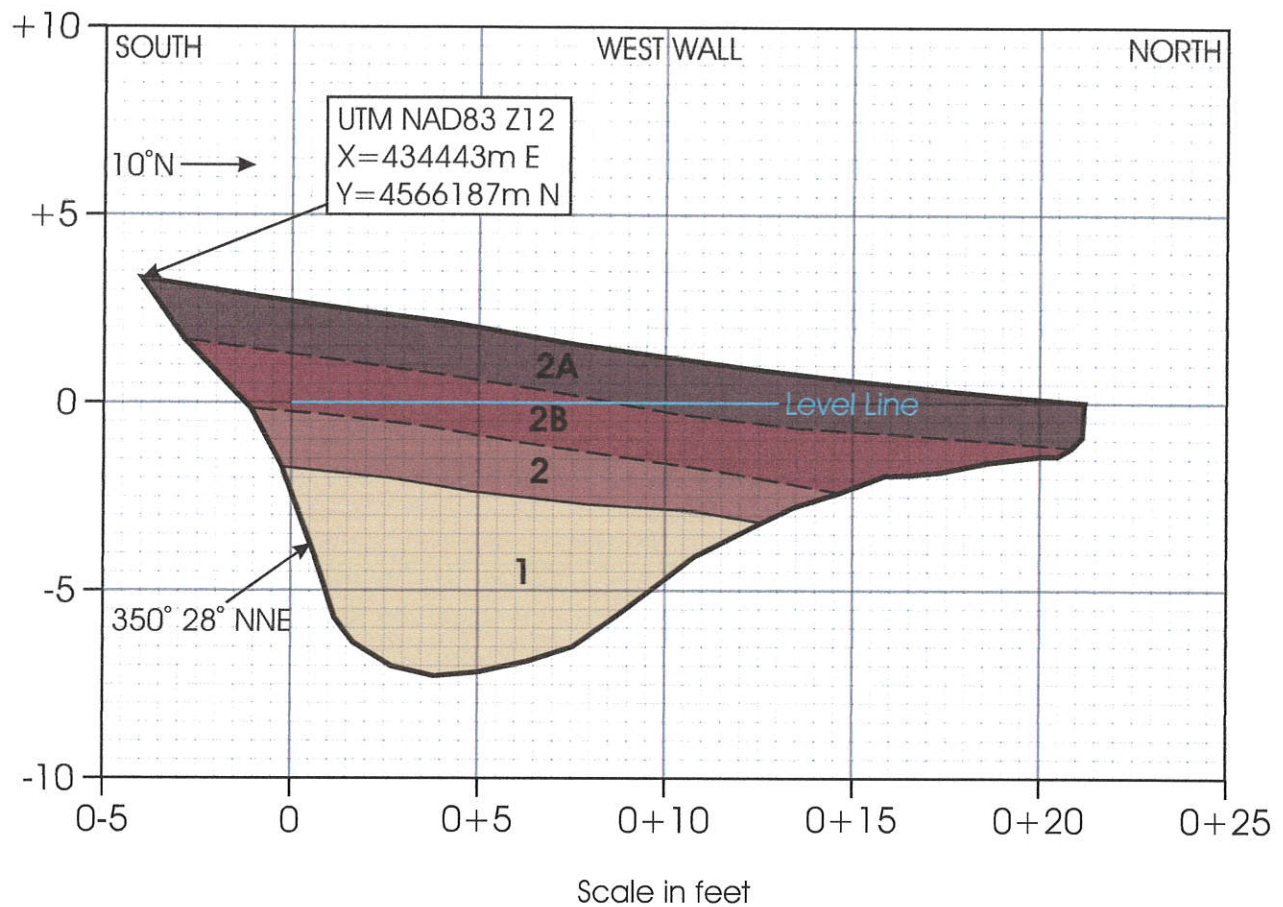
5A

UNIT DESCRIPTIONS

Unit 1. *Tertiary Norwood Formation bedrock* - Weathered pale-brown, dense, poorly to well bedded, tuffaceous sandstone to siltstone.

Three test pits were excavated throughout the property to evaluate subsurface soil conditions at the locations indicated on **Figure 4**. Test pits TP-1 and TP-2 (**Figures 5A-B**) exposed a similar sequence of clayey lacustrine sediments overlying weathered sandstone to siltstone bedrock of the Norwood Formation, which correlates well with the surficial geologic mapping on **Figure 2**. Test pit TP-3 (**Figure 5C**) did not encounter bedrock and instead exposed a fining-upward sequence of near-shore sandy and clayey lacustrine sediments. The sandy sediments in test pit TP-3 appeared to be a beach deposit correlating to the sub-Bonneville transgressive shoreline on **Figures 2 and 3**. No groundwater was encountered in any of the test pits to their explored depths. Detailed stratigraphic unit descriptions are shown on the test pit logs.

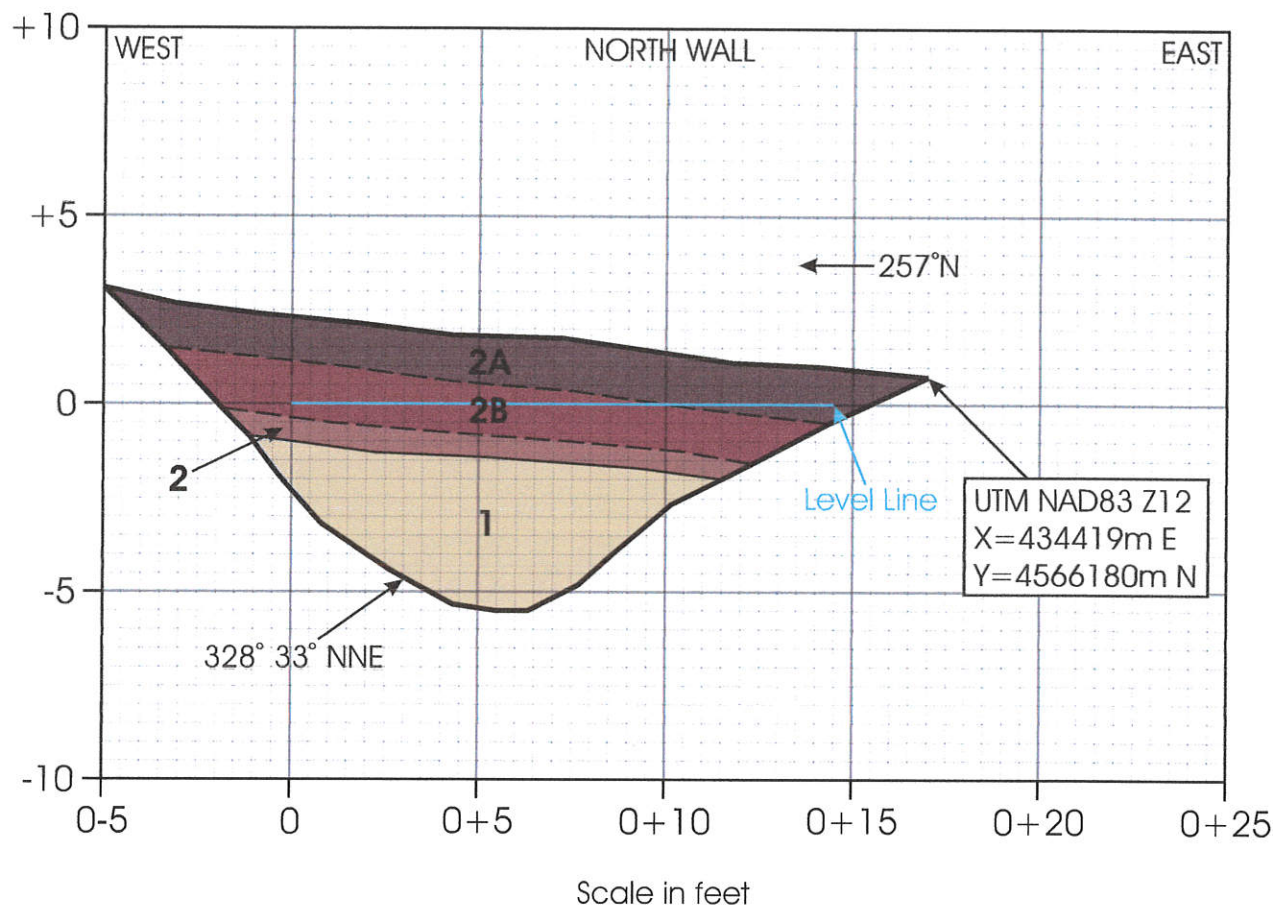
5B

UNIT DESCRIPTIONS

Unit 1. *Tertiary Norwood Formation bedrock* - Weathered pale-brown to brownish-olive, dense, poorly to well bedded, tuffaceous sandstone to siltstone.

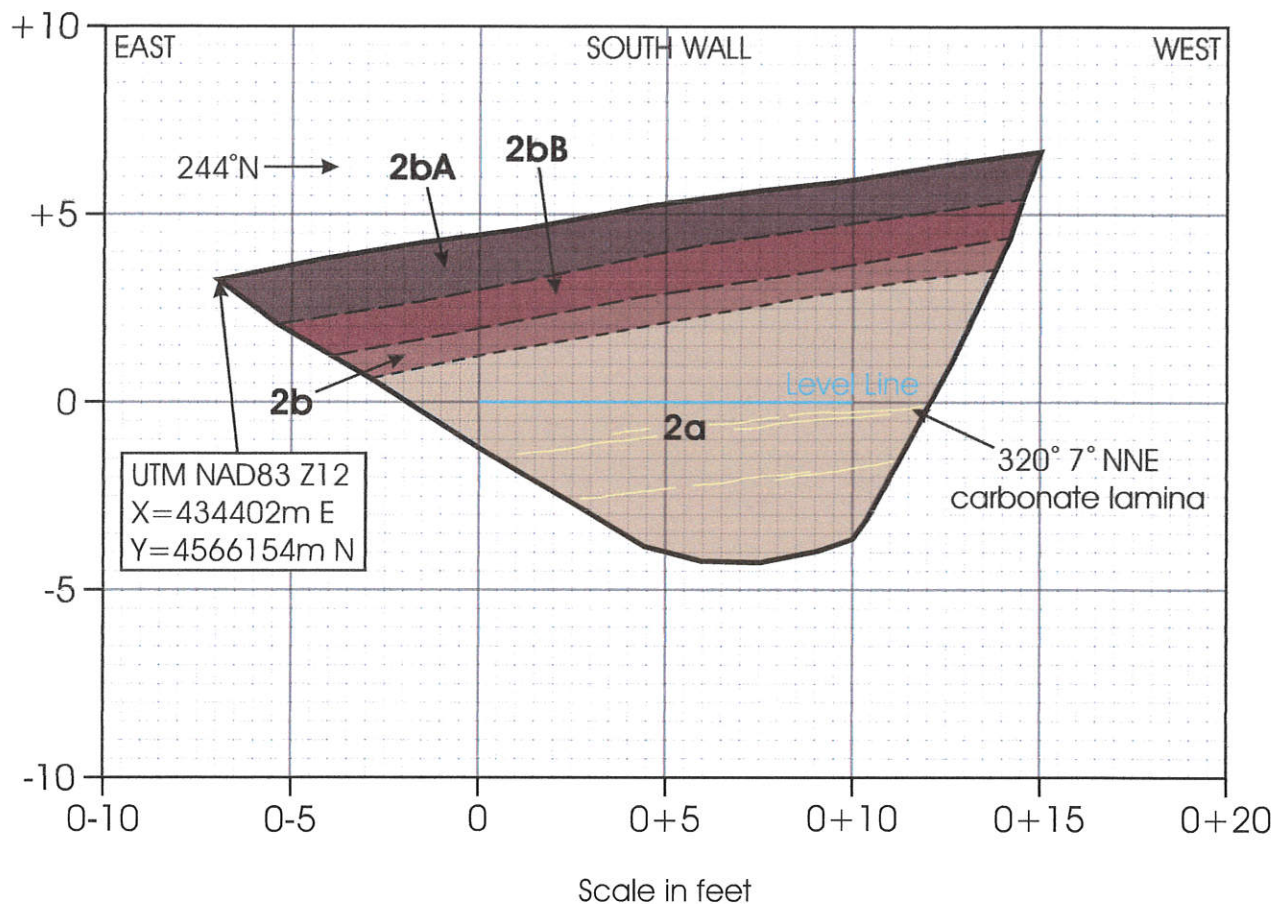
UNIT DESCRIPTIONS

Unit 2. *Lacustrine sediments related to late Pleistocene Lake Bonneville* - Fining-upward sequence of sand to clay comprised of a lower (unit **2a**) brown, moderate density, well-bedded, poorly graded sand (SP) with thin carbonate and clay lamina, likely transgressive beach deposit; and an upper (unit **2b**) reddish- to dark brown, poorly bedded to massive, moderate density, sandy clay (CL); modern A-horizon soil and Bt horizon forming at surface (units **2bA** and **2bB**, respectively).

Liquefaction potential has not been studied or mapped for the Project area, but subsurface data from the test pits suggest the risk from liquefaction is likely low. Susceptible soils were encountered in test pit TP-3 (**Figure 5C**) at the Project, but no evidence for shallow groundwater or past liquefaction was observed in this test pit and no soils susceptible to liquefaction were encountered in the remaining test pits at the site.
