# MURRAY FLAG LOT SUBDIVISION

A PART OF THE S. E. 1/4 OF SEC. 22 T. 6 N., R. 3W., S.L.B. & M.  
WEBER COUNTY, UTAH  
APRIL 2013

### IMPROVEMENT DRAWING

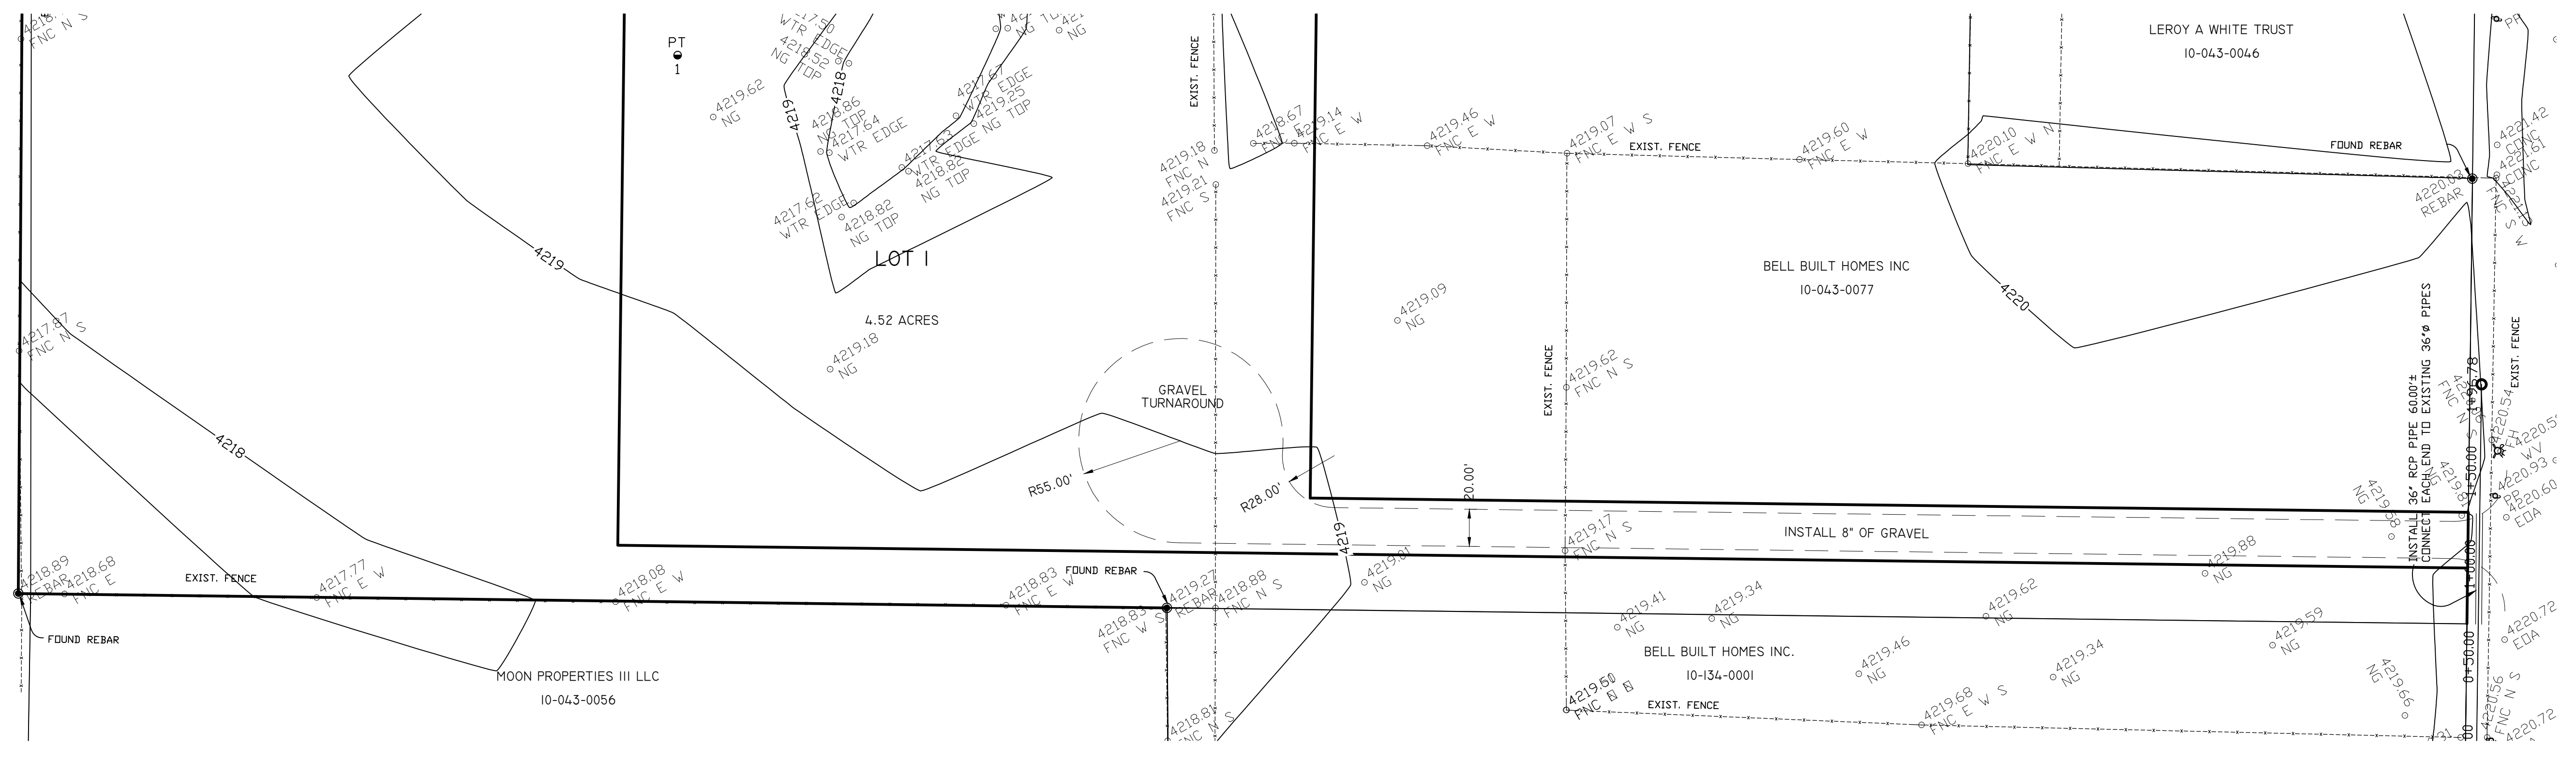
SCALE: 1" = 50'

- = 5/8"Ø x 24" REBAR WITH CAP STAMPED 172757
- = FOUND REBAR
- PT 1 = PERCOLATION TEST PIT
