GEOTECHNICAL ENGINEERING AND GEOLOGIC STUDY

Proposed Huntsville 13 Development

Parcel/Tax ID: 20-036-0035
About 947 East Old Snow Basin Road
Huntsville, Weber County, Utah
CMT PROJECT NO. 900131

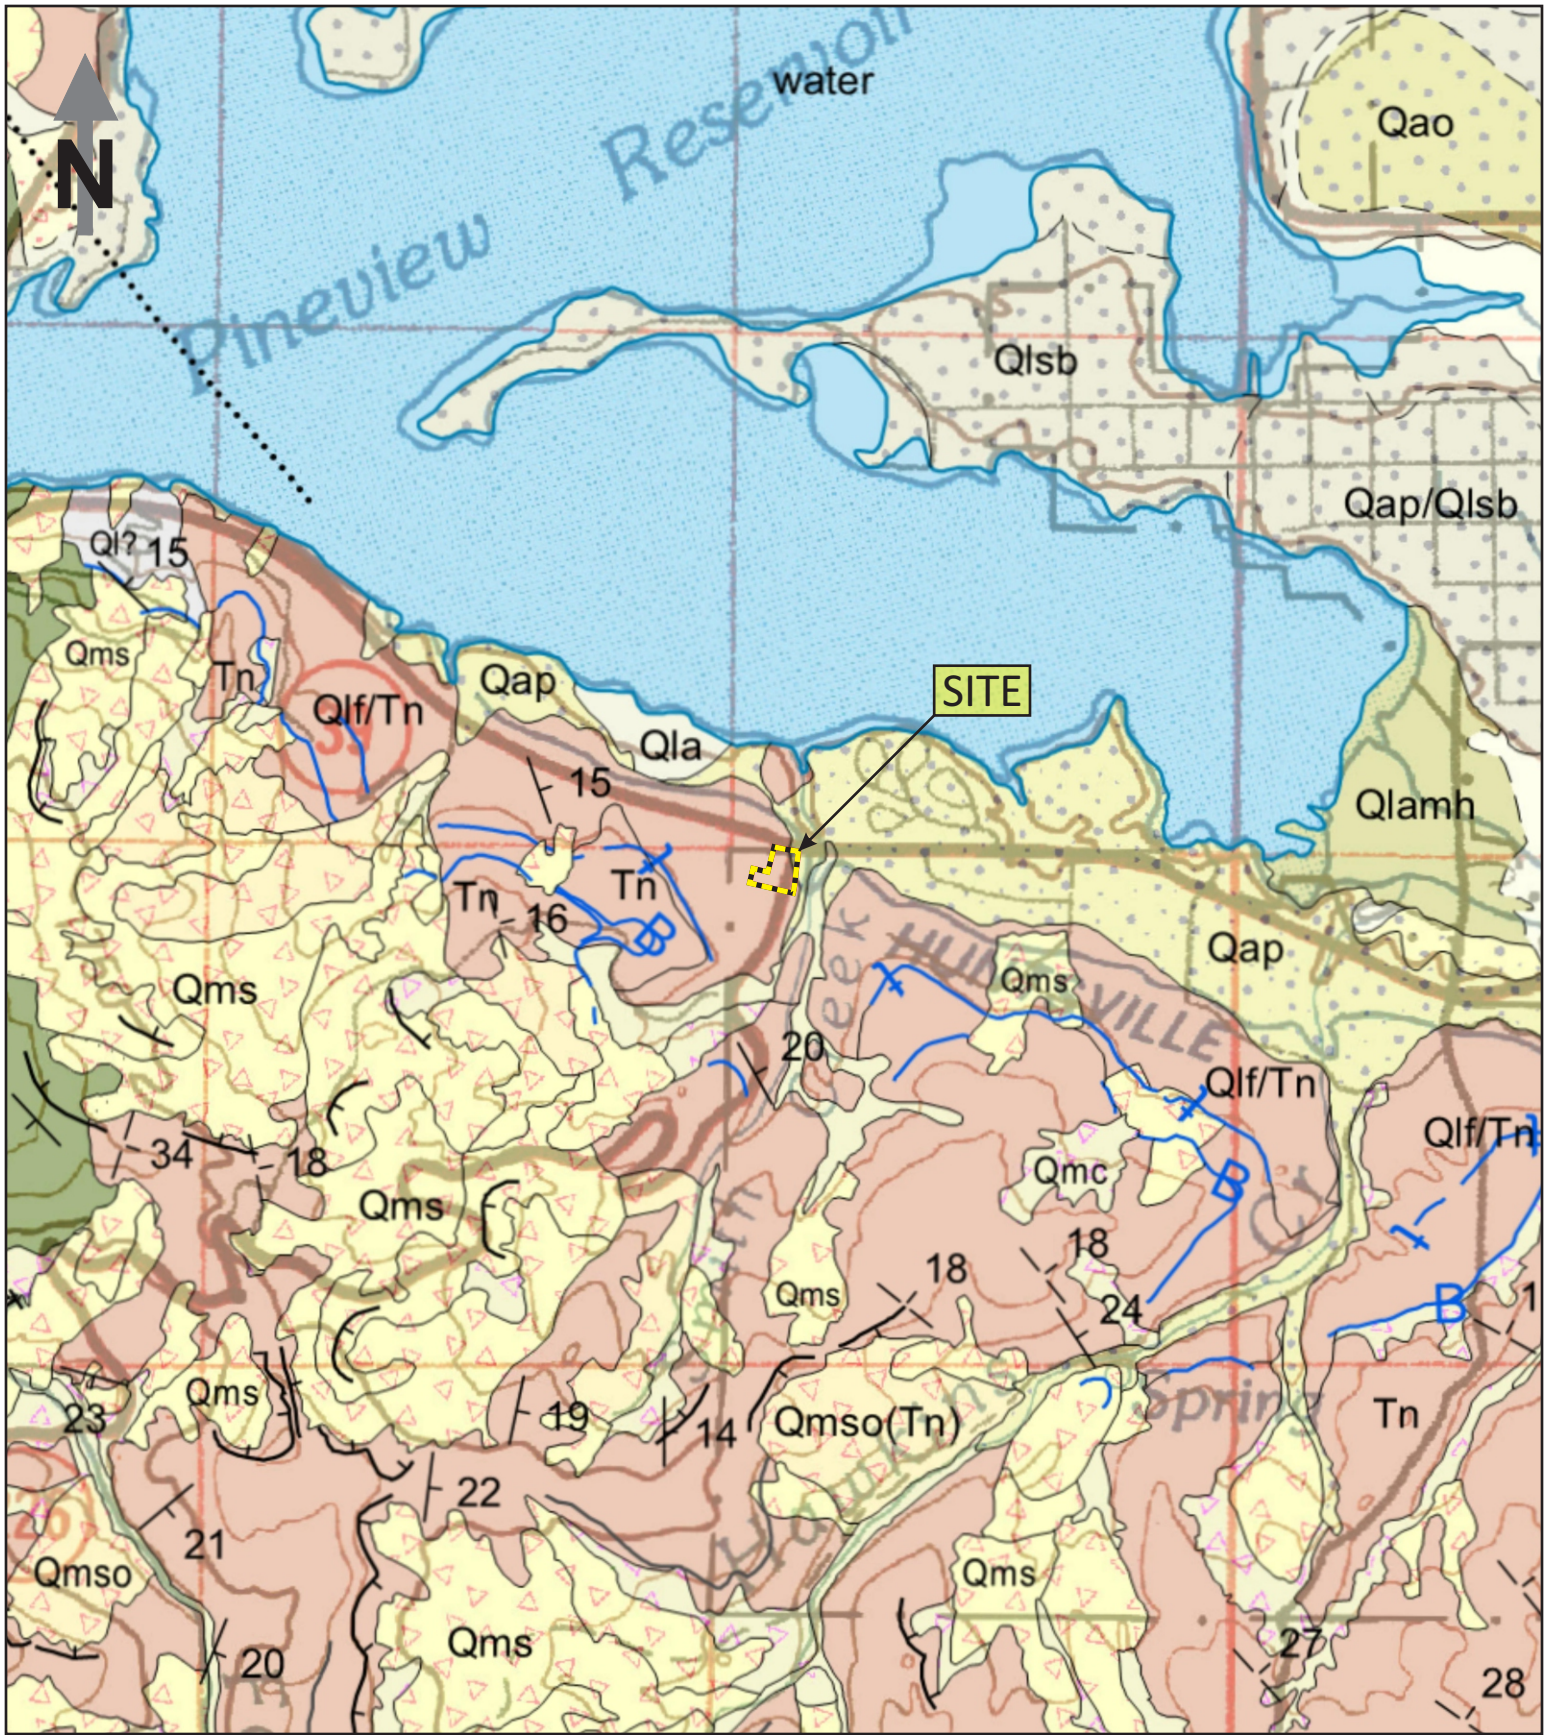
Figure
2

Base:
Interim Geologic Map of the Ogden 30' x 60'
Quadrangle (Coogan and King, 2016).

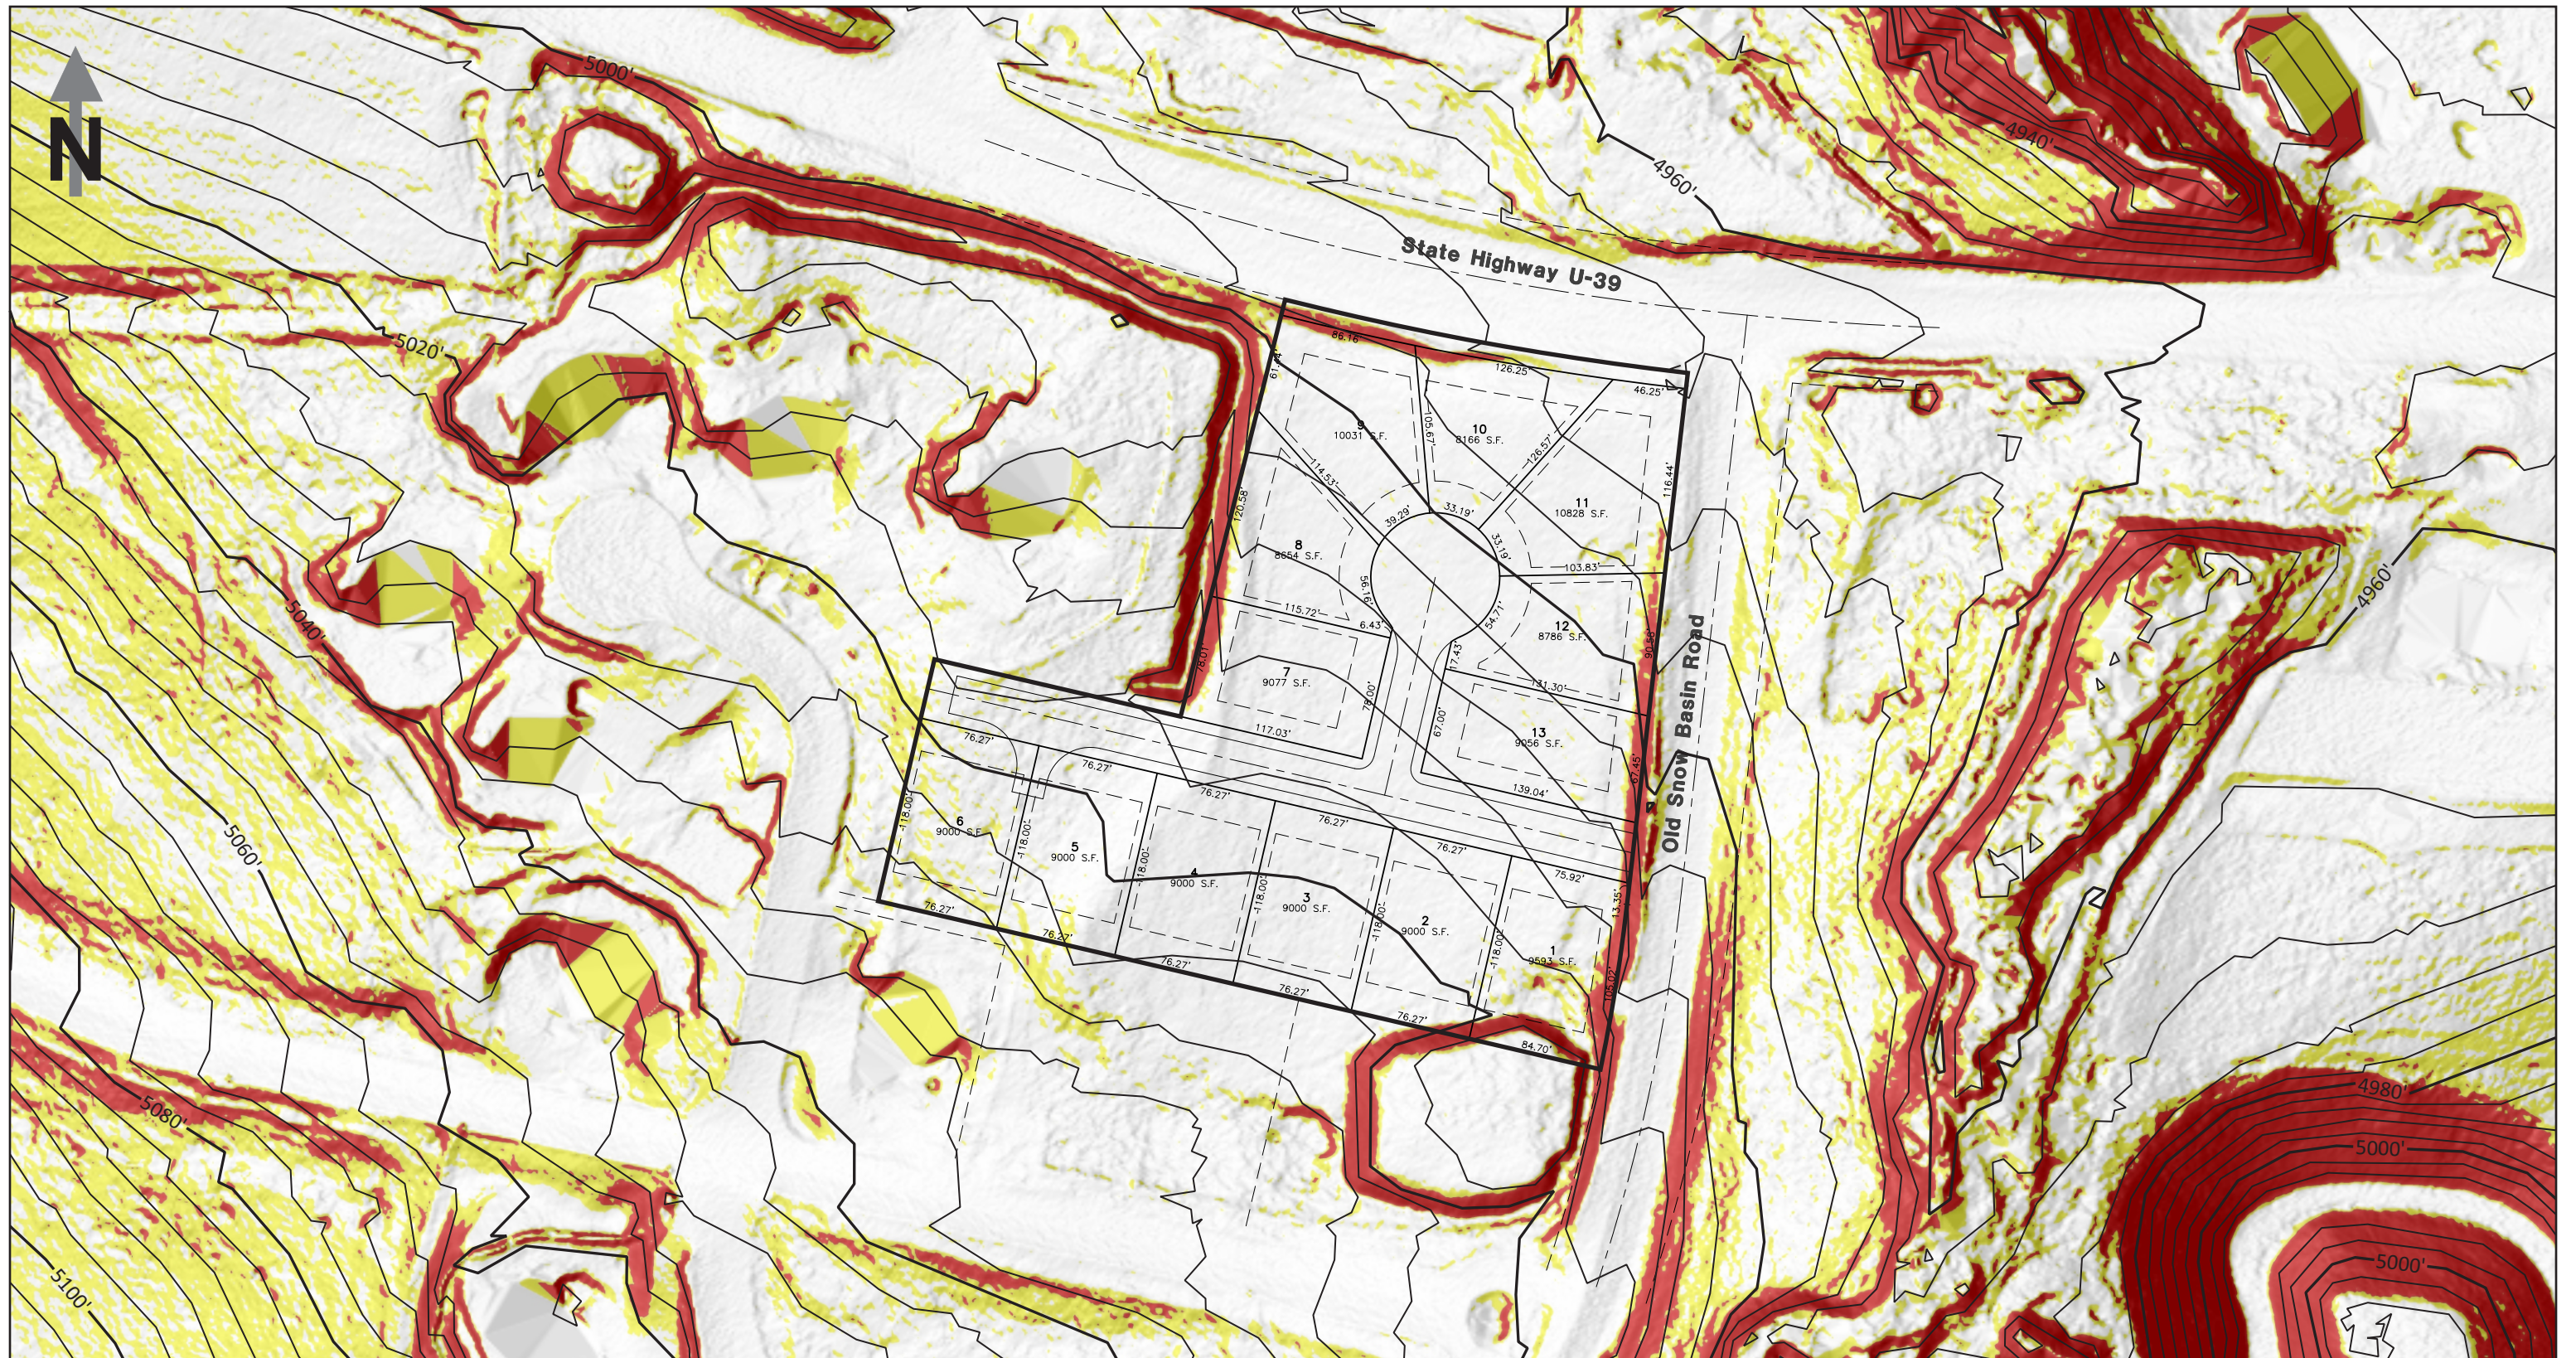
Figure
3

Base:
 Utah AGRC 2016 LIDAR bare earth DEM, 50cm resolution. Slopes <15% unshaded, 15-25% shaded in yellow, and >25% shaded in red. Contours generated by Global Mapper, 4 foot interval.

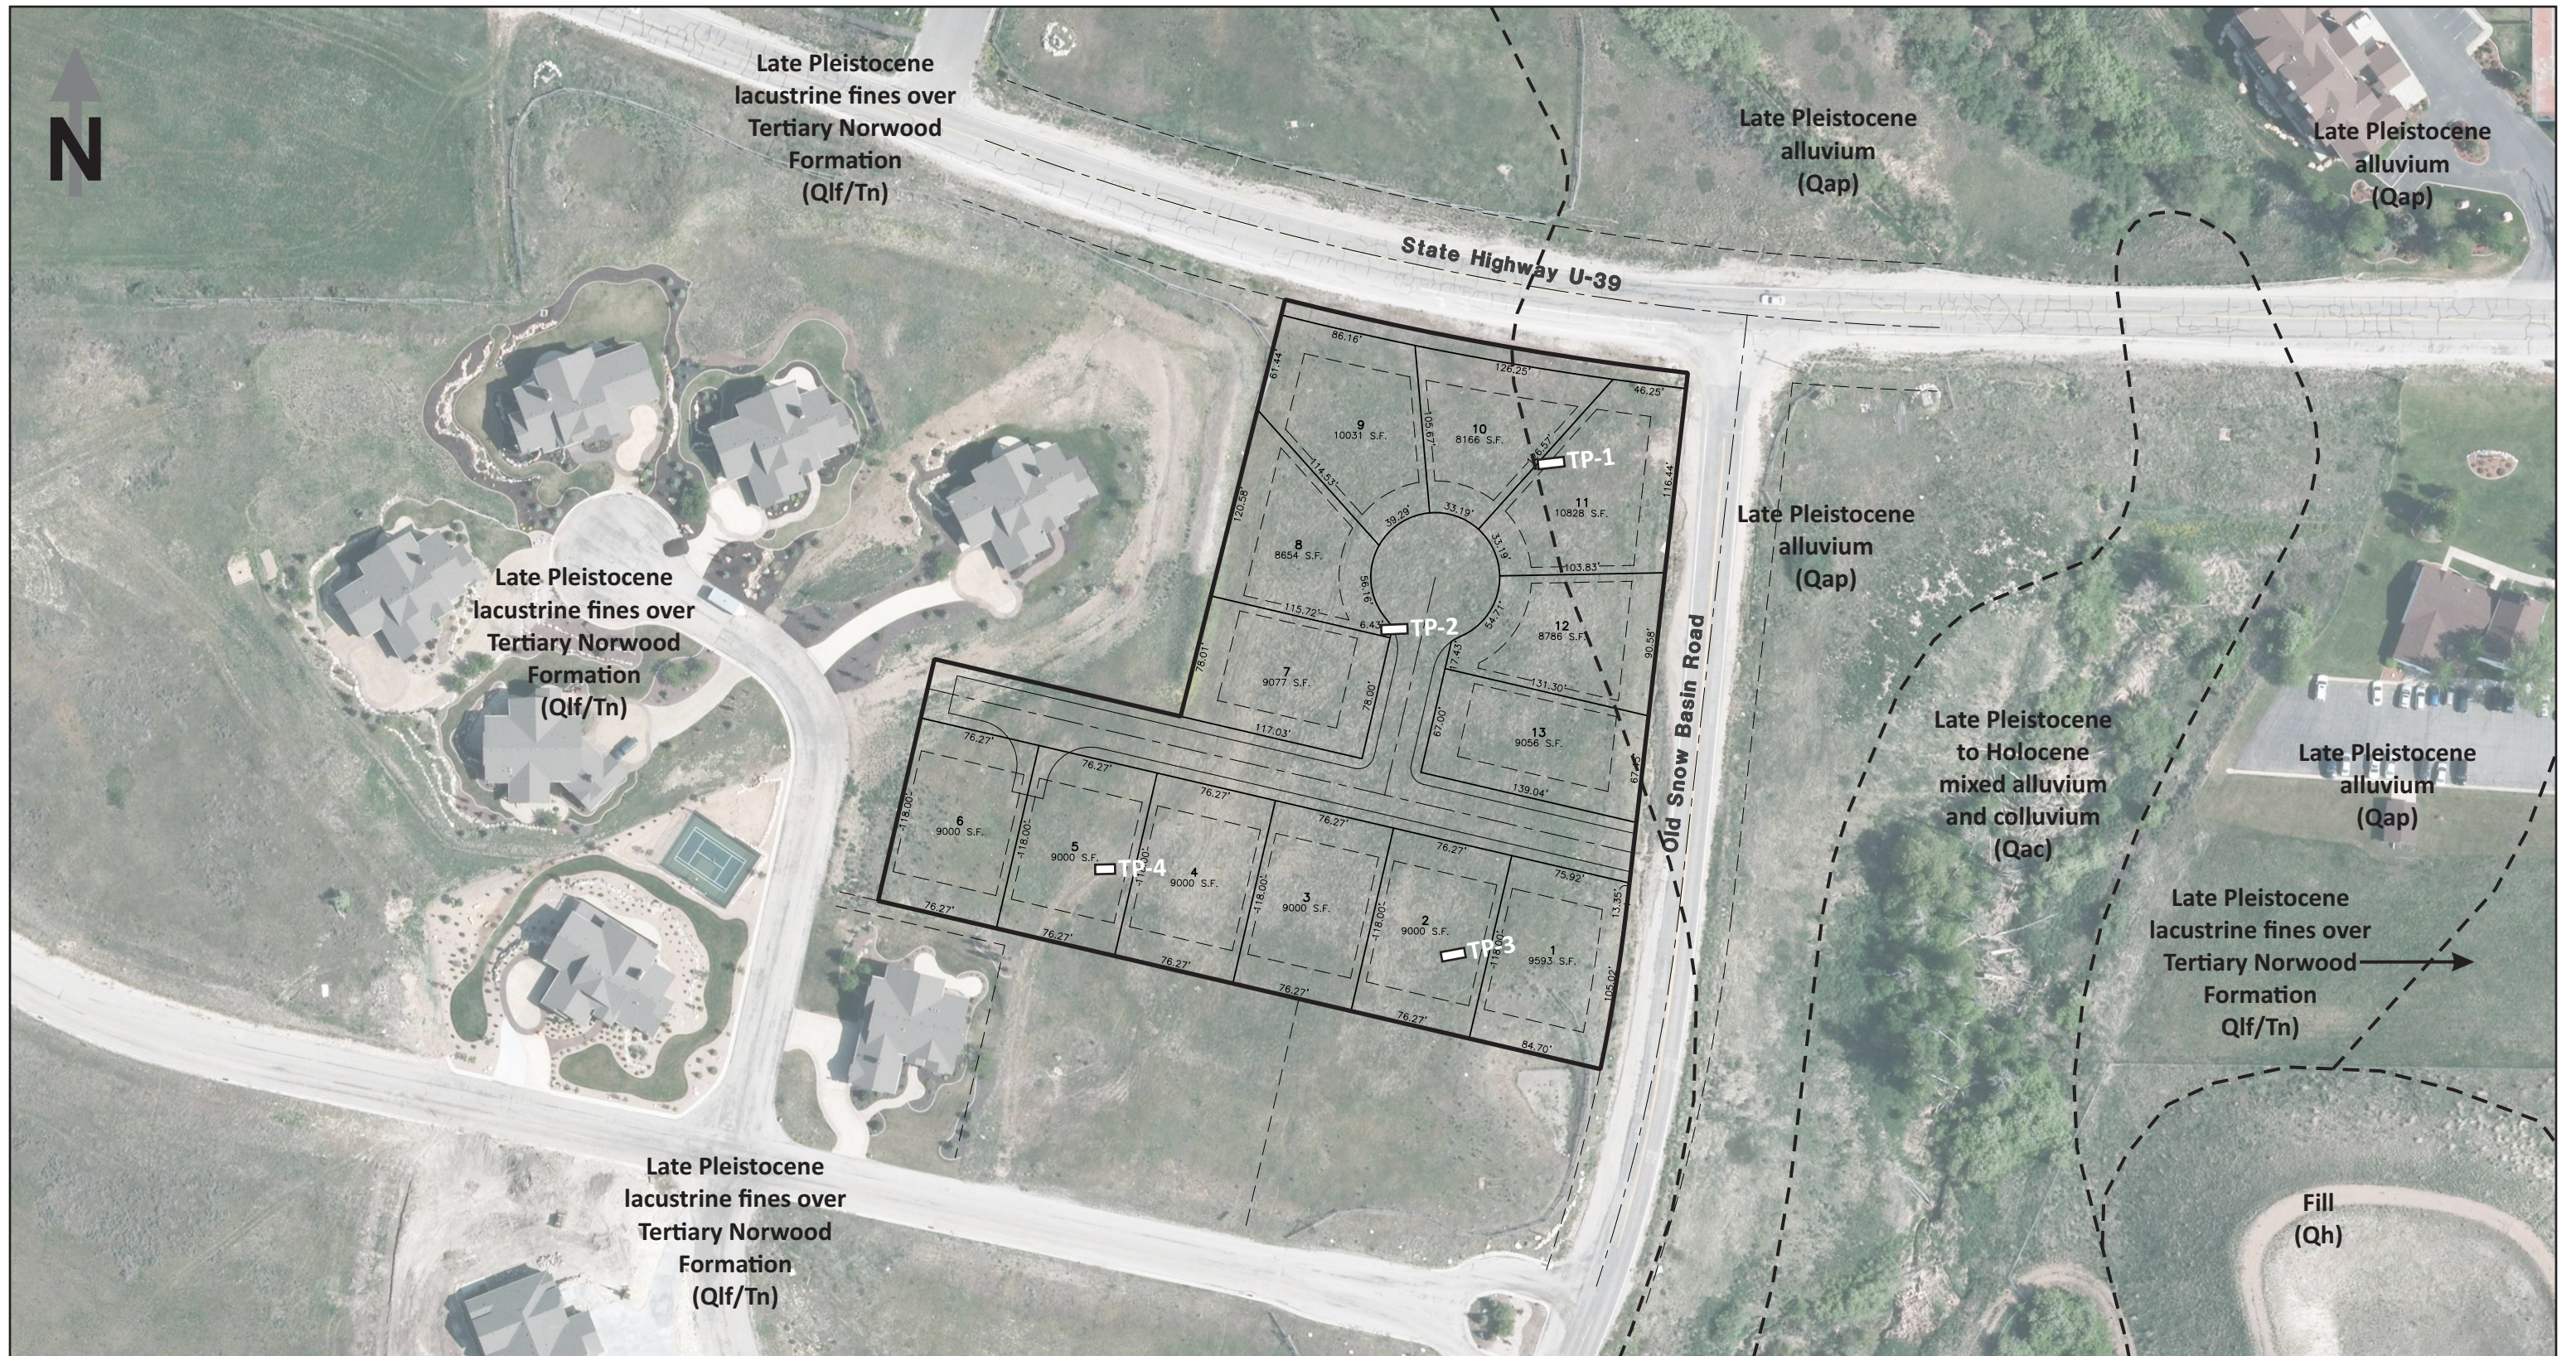
Base:
 2012 Utah AGRC high-resolution orthophoto, 12.5 cm resolution.
 Surficial geology modified from Coogan and King (2016).

Subsurface soil conditions at the site were explored by excavating four walk-in test pits (short trenches) as located on **Figure 4**. The test pits were excavated using a track-mounted excavator to depths of 7.1 to 9.4 feet below the ground surface for geologic/geotechnical logging and sampling. During the course of the excavation operations, a continuous log of the subsurface conditions encountered was maintained. Undisturbed tube, block and disturbed bulk samples of representative soils encountered in the test pits were obtained for subsequent laboratory testing and examination. The representative soil samples were placed in sealed plastic bags and containers prior to transport to the laboratory.

Four test pits were excavated at the site to evaluate subsurface soil conditions, as located on **Figure 4**. Test pit TP-1 (**Figure 5A**) exposed silt/sandy clay alluvium overlying what we infer is highly weathered tuffaceous sandstone of the Tertiary Norwood Formation. Test pits TP-2 through TP-4 (**Figures 5B-D**) exposed a similar sequence of silty/sandy to clayey lacustrine sediments from Lake Bonneville overlying weathered pebble conglomerate and tuffaceous sandstone of the Norwood Formation. The upper about 2.5 feet at test pit TP-1 and the upper 6 feet of clayey soils at test pit TP-2 exhibit moderately high plasticity with some minor swell potential under light (floor slab type) loading. No groundwater was encountered in any of the excavations to their explored depths. Detailed stratigraphic unit descriptions are shown on the logs.
